**REPORT OF INVESTIGATION**

**Underground Metal Mine  
(Lead-Zinc Ore)**

**Fatal Exploding Vessels under Pressure Accident  
October 2, 2018**

**Empire State Mines  
Empire State Mines LLC  
Gouverneur, St. Lawrence County, New York  
Mine ID No. 30-01185**

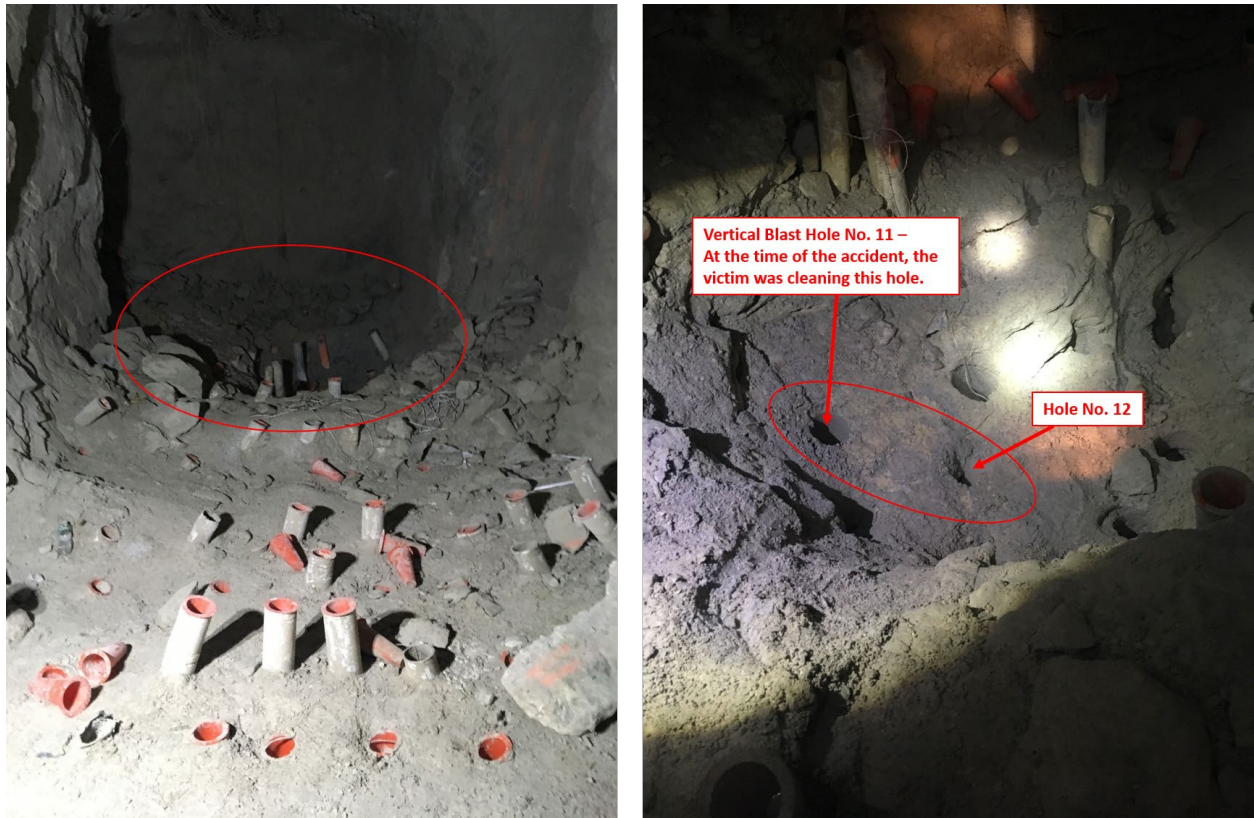
**Figure 3 - MP2730 Level - Stope 2805 Development Area - Accident Scene**

The accident occurred on the MP2730 level of the underground mine where a vertical stope was being developed to the MP2805 level below (see Figure 3).

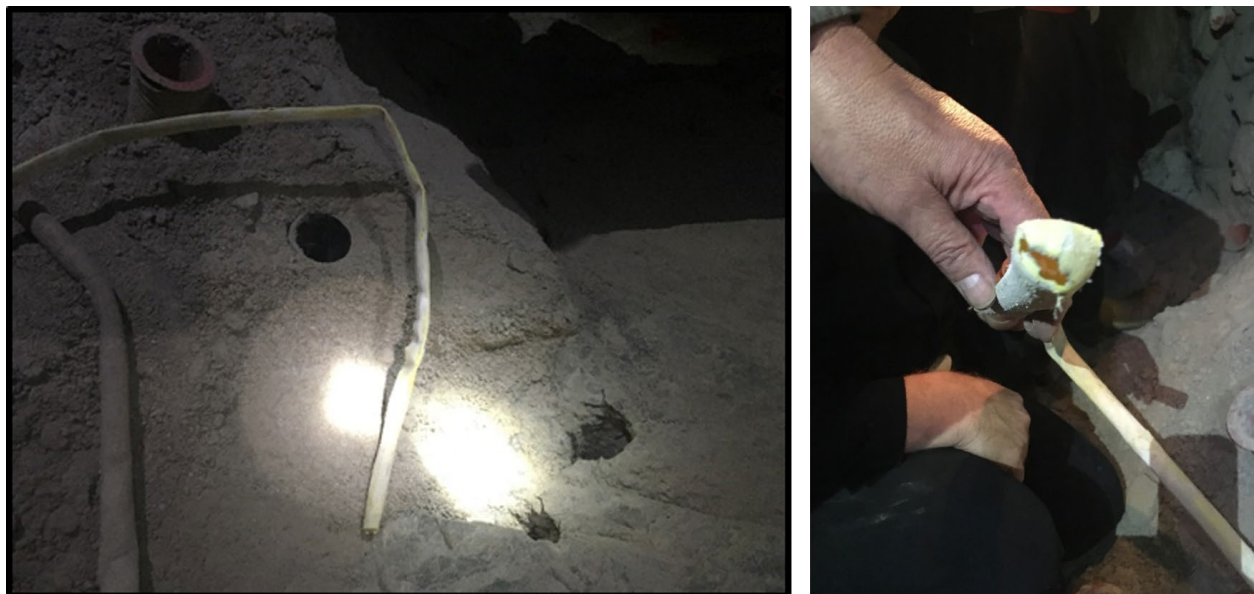
The high-pressure air hose used by the victim to clear the borehole was a high density polyethylene (HDPE) hose used for grouting. The contract employees referred to this hose as the grout line. The 7/8-inch diameter hose had a nominal 3/4-inch internal diameter with a 1/16-inch wall thickness. The specification sheet of the hose listed a working pressure rating of 170 psi and a burst pressure rating of 820 psi. Measurements taken during the investigation showed an approximate pressure of 115 psi at the end of the grout hose. The hose was in a degraded condition with 9 hose splits and multiple kinks in the first 9 feet 4 inches of the hose, as measured from the hose opening (see Figure 4). The hose splits were consistent with a hose burst, as the damage was from the interior of the hose. As shown in Figure 5, the entire working length of the outside of the hose showed very fine, hair-like fibers probably caused by abrasions.

**Figure 4 - Photos of Grout Line Used by the Victim (Note: Damaged End)**

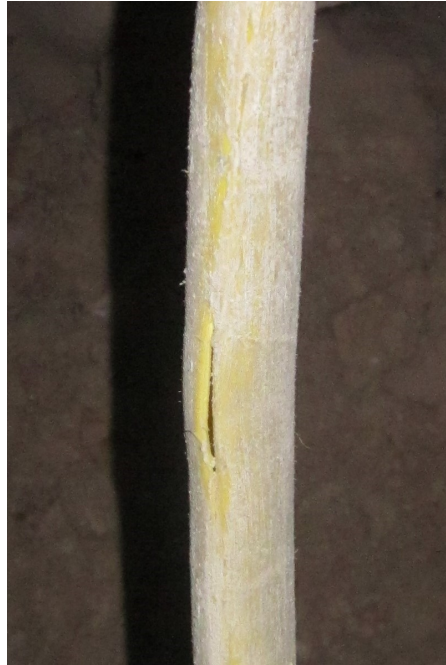
**Figure 5 - Photo of grout hose showing a split, abrasions, and fine fibers.**

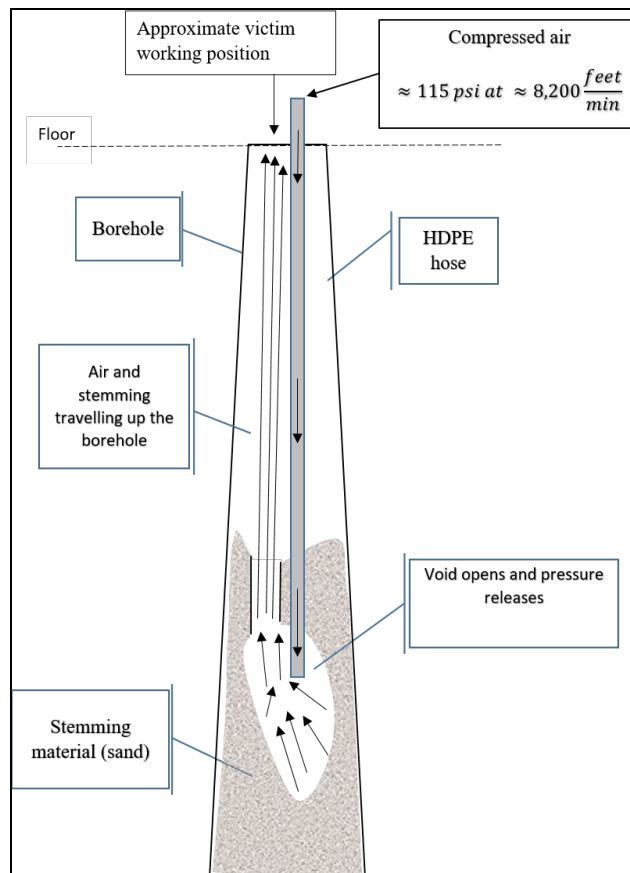
Interviews indicated one 50-pound bag of sand was used as stemming in each borehole, which Major Drilling Underground claimed would fill about 10 feet of a drilled hole. The No. 11 drill hole was a wet borehole and would have caused the sand to bond together, making it harder to clean out the hole. After reportedly blowing out approximately 3 feet of material, the contractor encountered a blockage. As the grout hose was pushed through the blockage, a pressure void was filled with the compressed air until it could no longer be contained (see Figure 6). When the air released, a column of stemming was thrust to the surface of the borehole. This evacuation of air and stemming material struck the contractor foreman, who was in close proximity to the borehole opening, causing fatal injuries. No evidence of residual explosive material was found in the hole.

**Figure 6 – Schematic Showing Pressure Release Propelling Stemming from No. 11 Hole.**

Corrective Action: The contractor developed a plan and procedures and then trained employees on the new plan with procedures for cleaning previously blasted vertical drill holes when an obstruction has been encountered. This plan addresses safe work procedures and where personnel are to be positioned during the various phases of drill hole cleaning process.
