MAI-2018-11

REPORT OF INVESTIGATION

**Fatal Falling, Rolling, or Sliding Rock Accident
October 11, 2018**

**Jet Mist tm Quarry
Georgia Stone Industries, Inc.
Rapidan, Culpeper County, Virginia
Mine ID No. 44-00141**

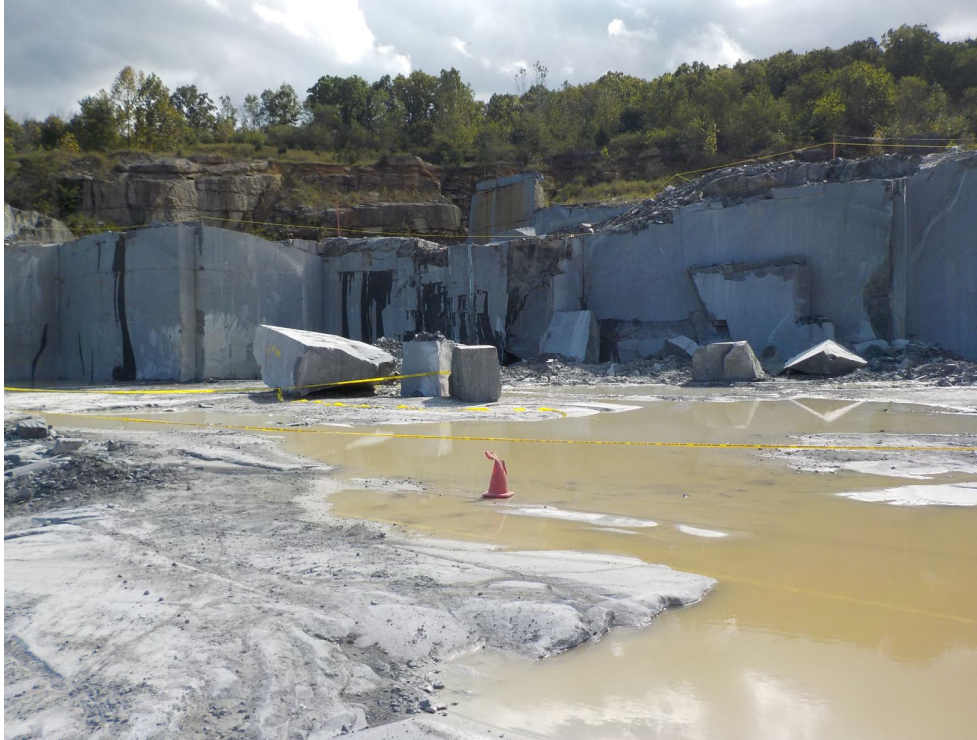
The accident occurred along the south facing highwall on the first level of the quarry. (See Appendix C Figures 1 and 2 for accident scene photos).

Figure 1 - Expanded View of the South Facing Highwall (Accident Scene)

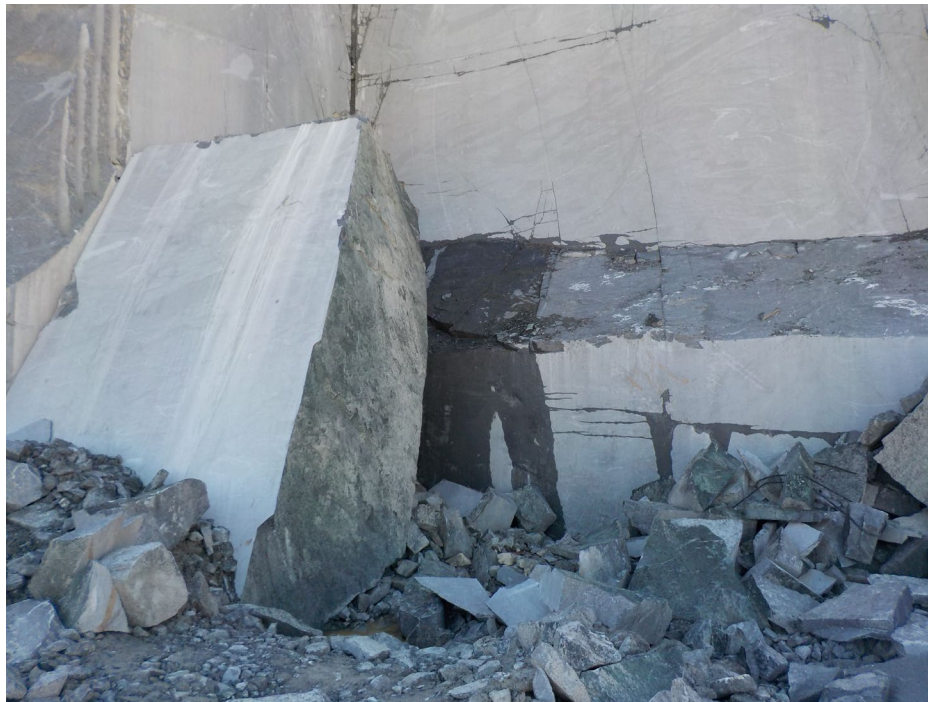
Figure 2 - Close-up View of the Location where the Victim was Found
