REPORT OF INVESTIGATION

**Surface Nonmetal Mine
(Dimension Granite Mine)**

**Fatal Falling, Rolling, or Sliding Rock Accident
October 11, 2018**

**Jet Mist tm Quarry
Georgia Stone Industries, Inc.
Rapidan, Culpeper County, Virginia
Mine ID No. 44-00141**

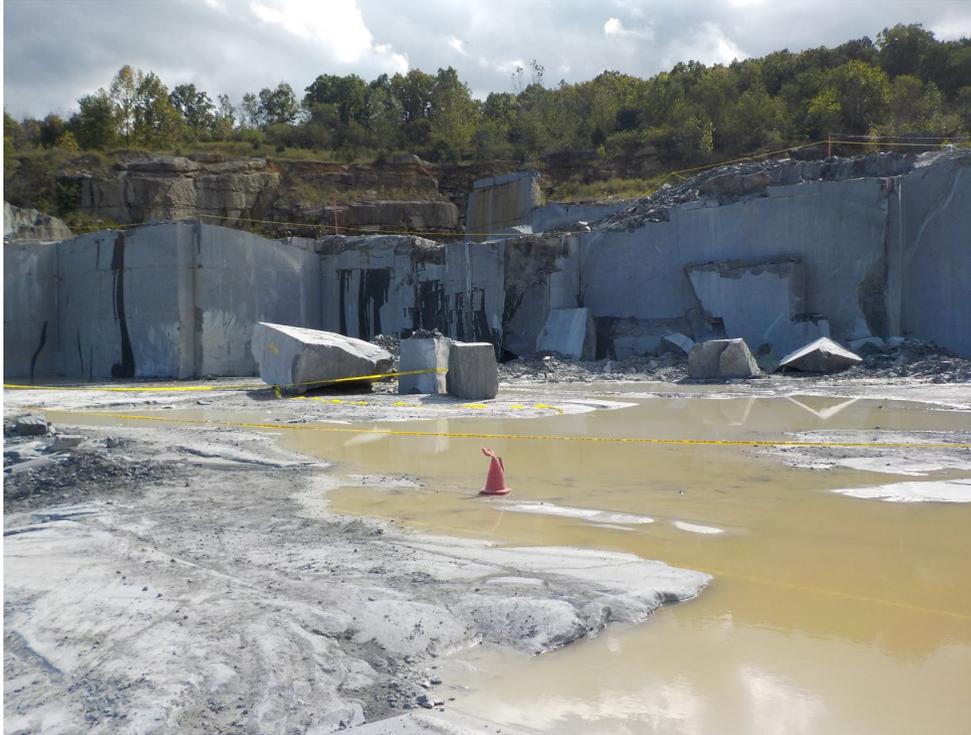
The accident occurred along the south facing highwall on the first level of the quarry. (See Appendix C Figures 1 and 2 for accident scene photos).

Figure 1 - Expanded View of the South Facing Highwall (Accident Scene)

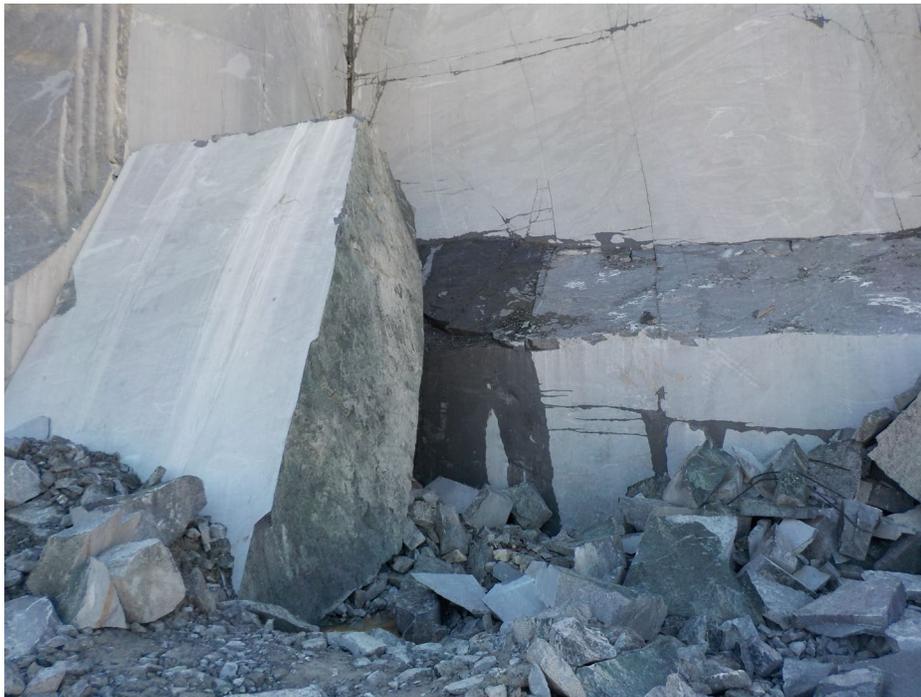
Figure 2 - Close-up View of the Location where the Victim was Found
