**REPORT OF INVESTIGATION**

**Fatal Powered Haulage Accident  
October 19, 2018**

**Montana Rockworks Inc.  
MCGREGOR  
Marion, Flathead County, Montana  
Mine ID No. 24-02226**

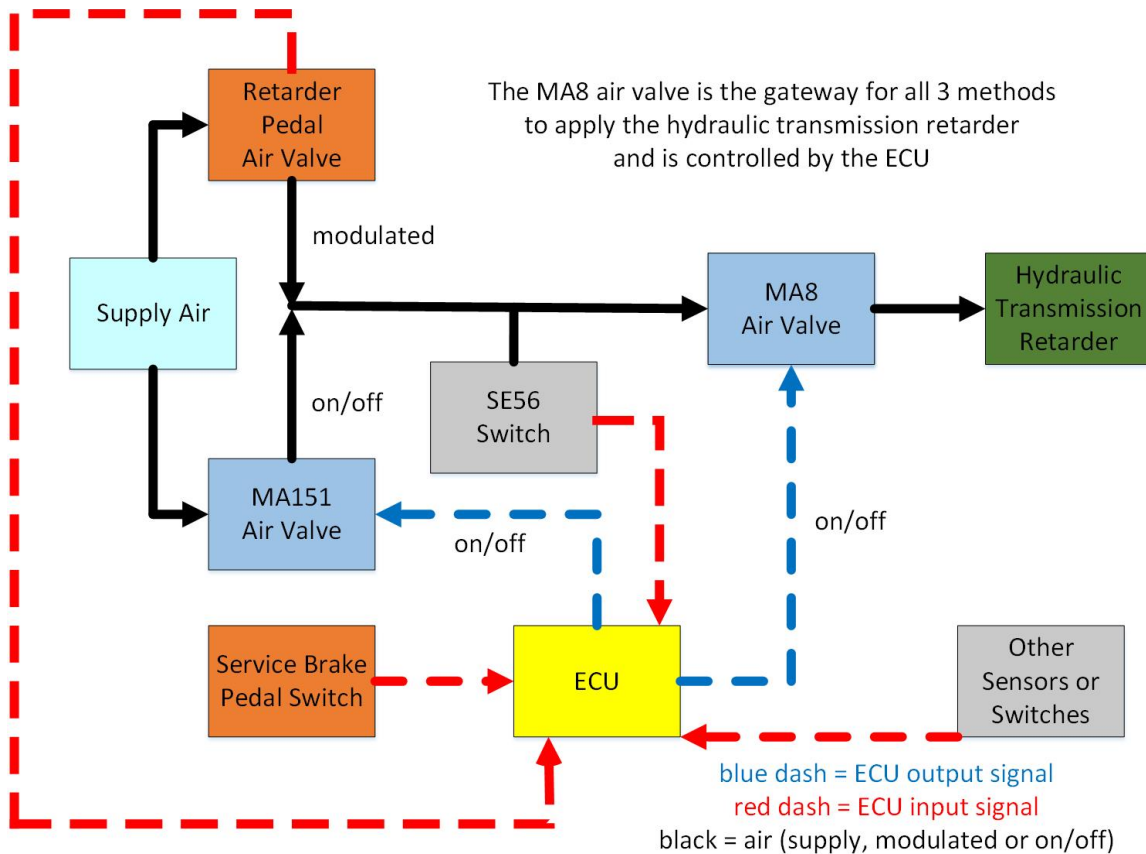
**Figure 1:** Illustration of the Retarder Control Circuit

Figure No. 1 shows the components of the ECU and how they interconnect.

Investigators encountered the following defects with the retarder system: the inability of a solenoid to correctly control the MA8 air valve made all three methods of applying the transmission retarder ineffective; and a defective SE56 switch that would not allow the ECU to recognize that the truck driver was pushing the retarder pedal, making that option ineffective even if the MA8 air valve operated properly. The defects in the Retarder System contributed to the accident.
