**UNITED STATES
DEPARTMENT OF LABOR
MINE SAFETY AND HEALTH ADMINISTRATION
Metal and Nonmetal Mine Safety and Health**

**REPORT OF INVESTIGATION
Surface Non-Metal Mine
(Cement)**

**Fatal Powered Haulage Accident
December 30, 2017**

**At
Lehigh Southwest Cement Co.
Permanente Cement Plant and Quarry
Cupertino, Santa Clara County, California
Mine ID No. 04-04075**

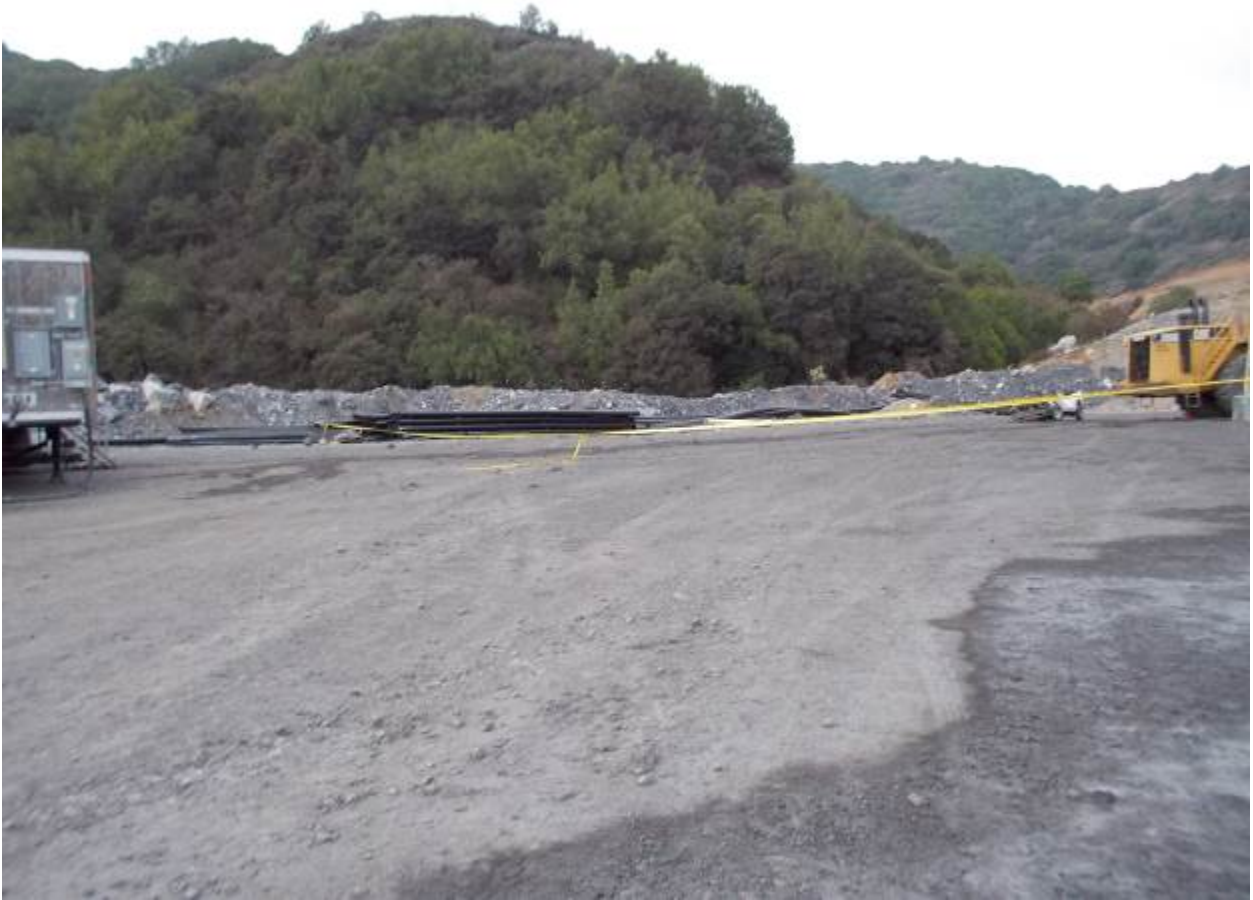
Appendix C
Overview of area looking South East

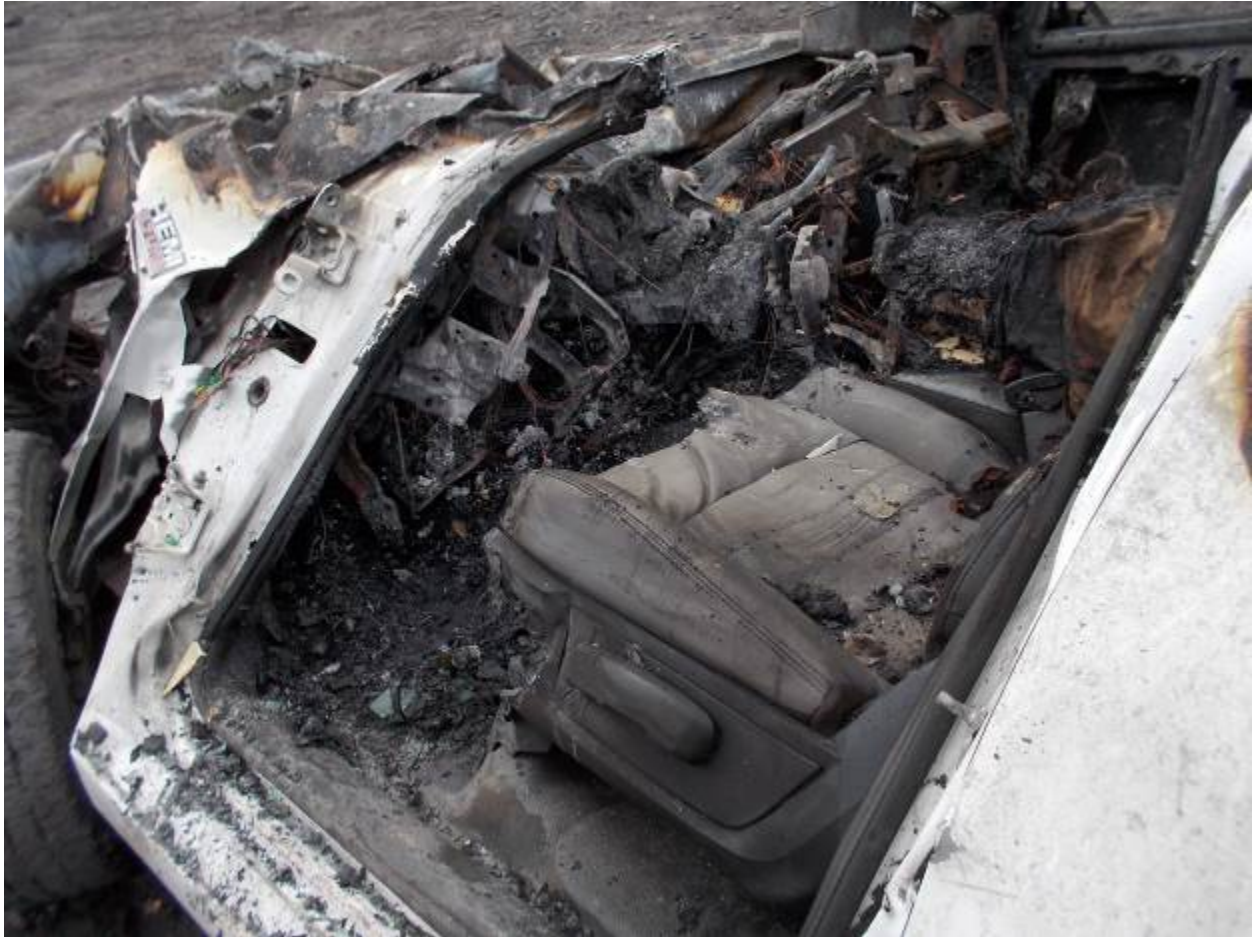
Attachment # C-2

Investigators examined the Dodge pickup truck and its position. Tire marks on the ground indicated the front end loader pushed the pickup approximately 17 feet. Because the driver's side of the cab was crushed inwards, recovery workers had to remove the cab's top to extract Rivas. Investigators found that the door damage also made the seat belt latch inaccessible to the victim. The fire burned the seatbelt webbing but the buckle was fastened. Severe damage to the vehicle prevented investigators from determining which gear was engaged on the truck. The pickup truck had no fixed radio installed. The fire destroyed the radio Rivas was carrying, so investigators were unable to determine the channel he may have used to communicate with the front end loader operator when he entered the stockpile area. Due to the fire, investigators could not test the vehicle for defects.

Showing driver's side of cab crushed inward

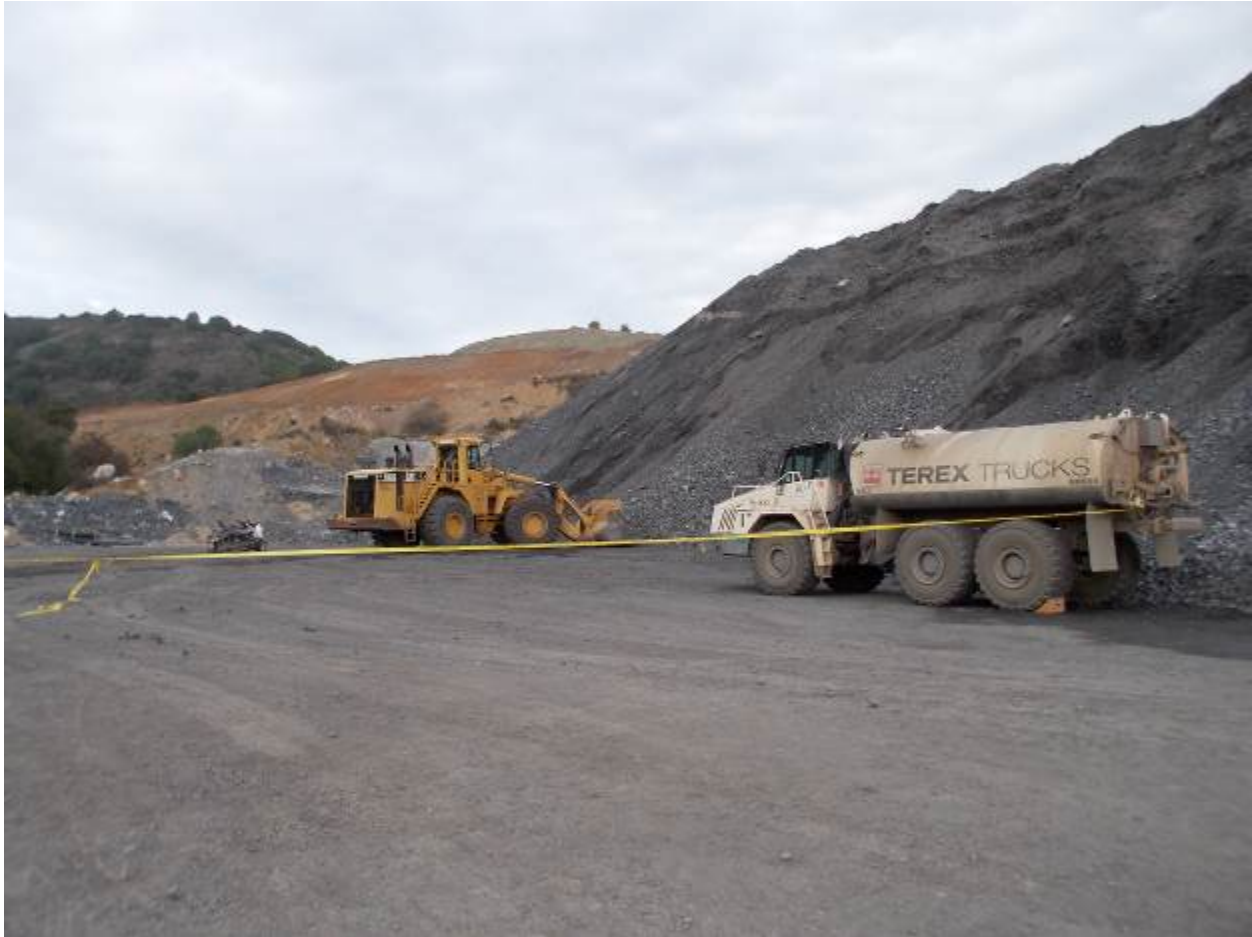
Attachment # C-3

Overview looking South West

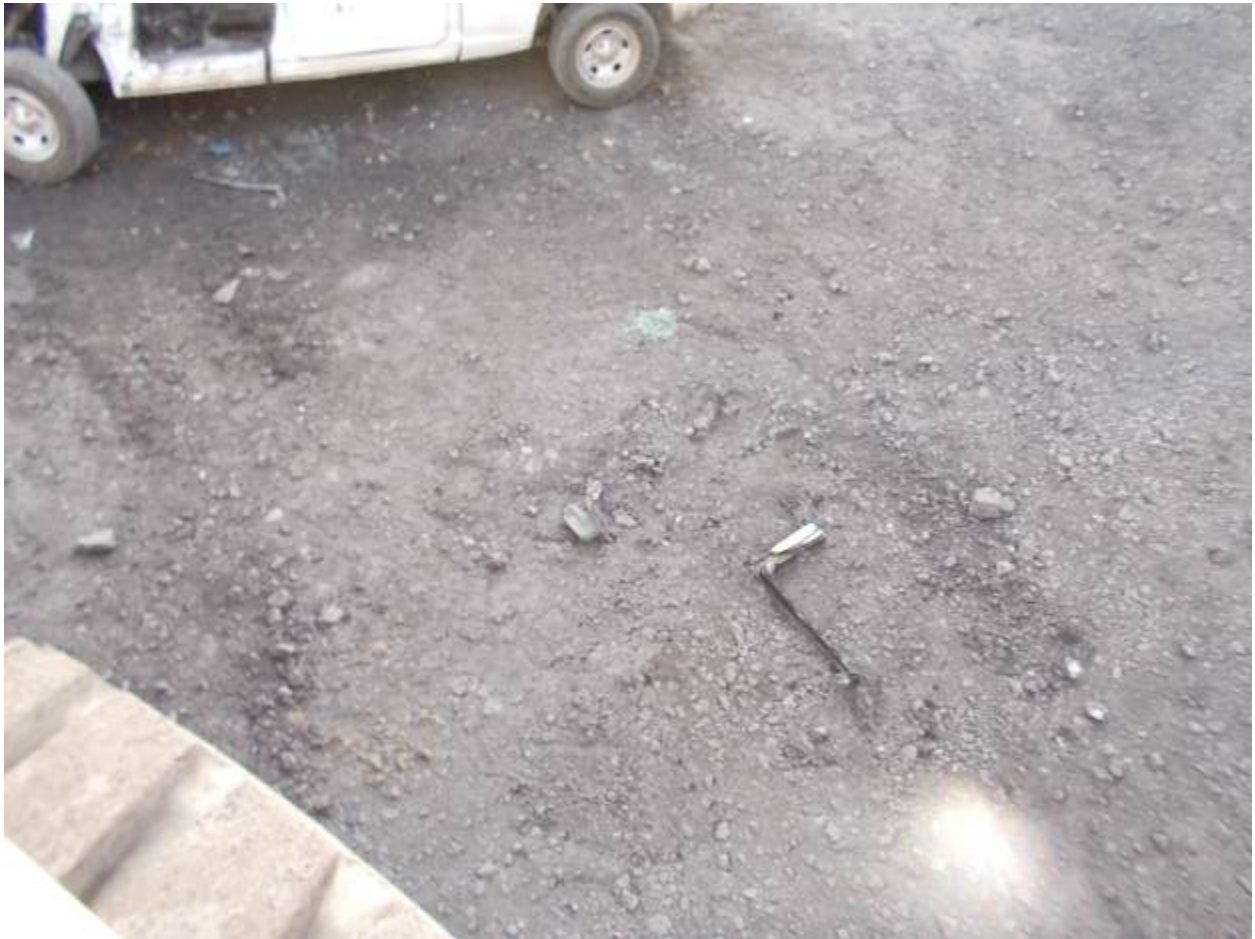
Attachment # C-4

Photo showing where Pickup had been pushed sideways
