REPORT OF INVESTIGATION

Underground Metal Mine
(Gold)

Fatal Fall of Back Accident
October 25, 2018

Lee Smith Mine
Small Mine Development LLC
Elko, Elko County, Nevada
Mine ID No. 26-02397

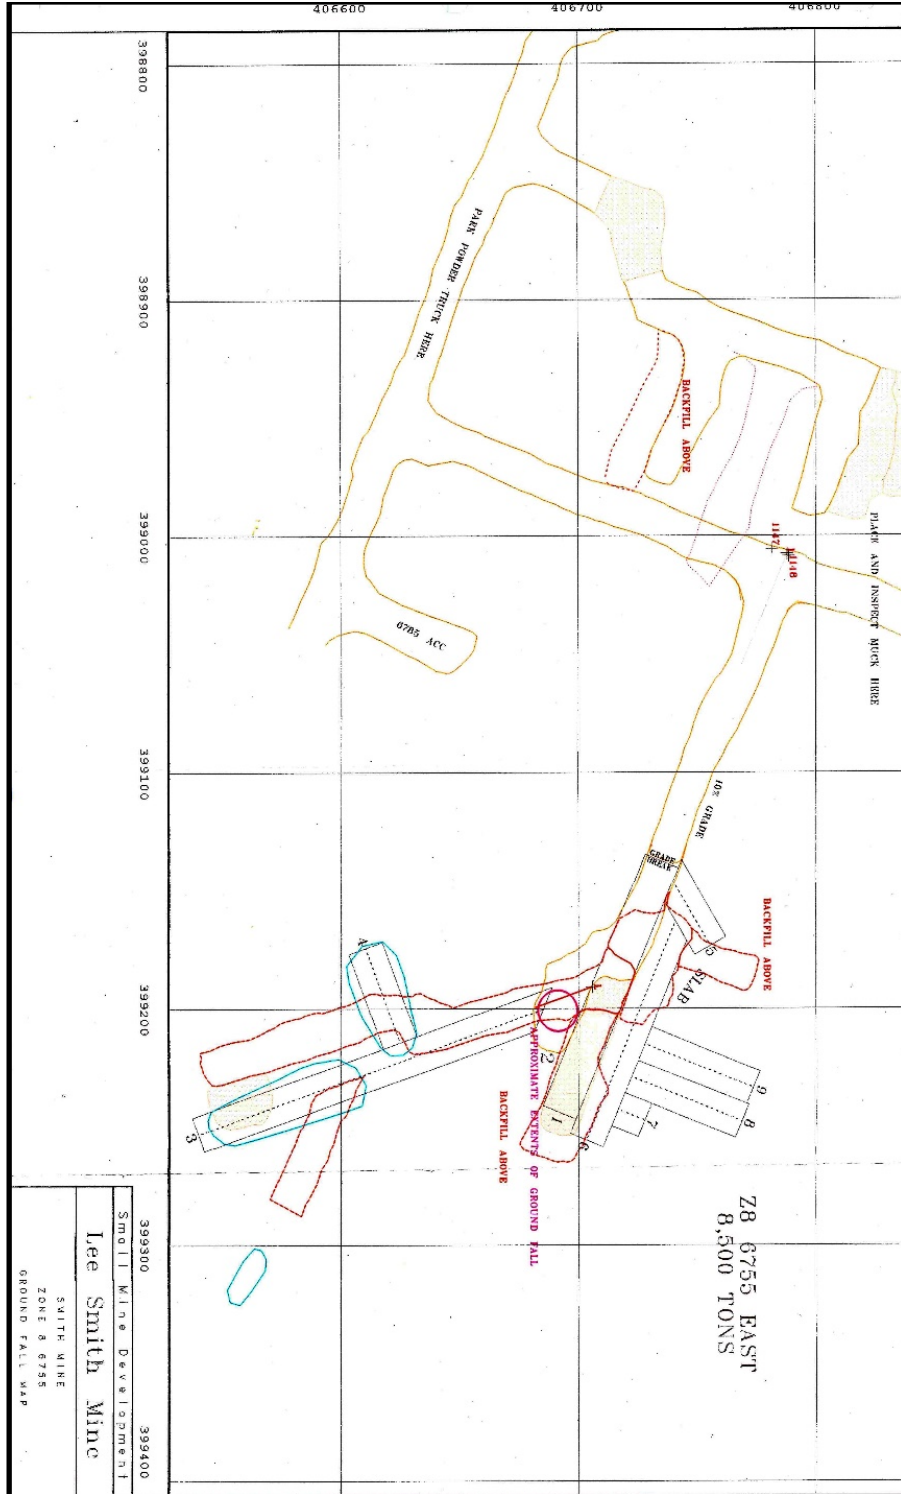
Figure 1
Level view showing the location of the accident.

The accident occurred in Zone 8-6755. The drift is driven underneath CRF and is approximately 18 feet wide and 21 feet high. The operator had installed CRF in the previously mined, overlying level (6770) approximately 2-1/2 months prior to the accident. The back/roof fall occurred directly above where Holman was loading blastholes. *(See Appendix B, Figure 1 & Figure 2)*

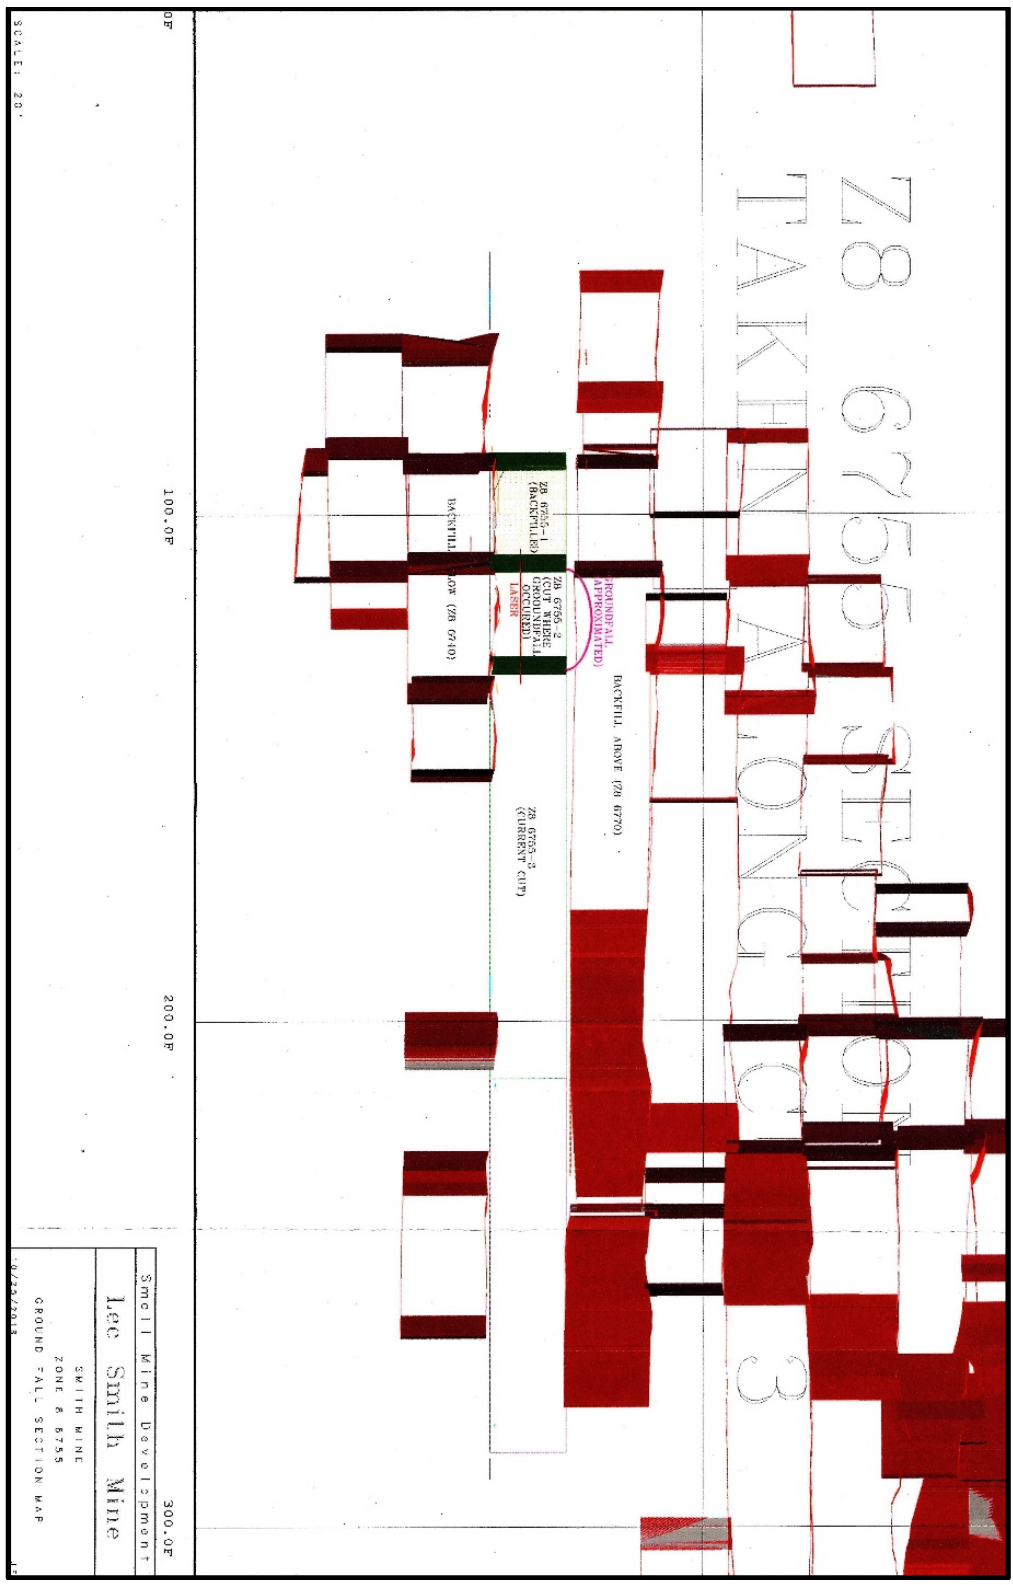
Figure 2
 Longitudinal section view showing an approximation of the roof fall cavity.

Subsequent to the accident, the mine operator performed a cavity monitor survey. The survey showed the fall cavity to be 7 feet in height. The base of the fall cavity was 19 feet wide, extending rib to rib. The profile of the cavity was smooth and "hump backed." No bolt holes or fractures were visible in the cavity.
