REPORT OF INVESTIGATION

Fatal Fall of Back Accident
October 25, 2018

Lee Smith Mine
Small Mine Development LLC
Elko, Elko County, Nevada
Mine ID No. 26-02397

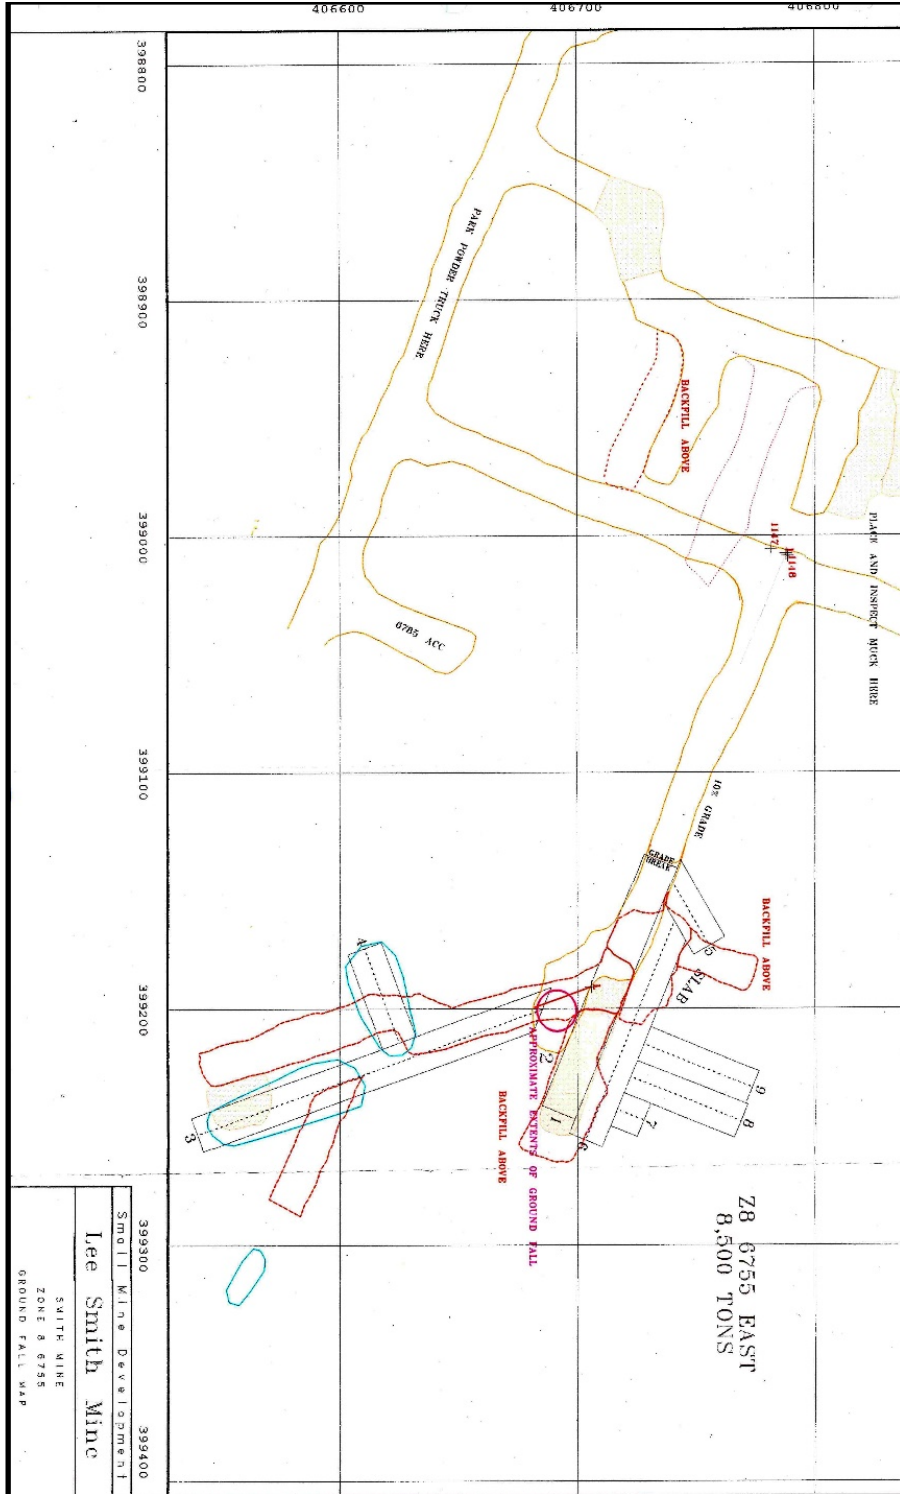
The accident occurred in Zone 8-6755. The drift is driven underneath CRF and is approximately 18 feet wide and 21 feet high. The operator had installed CRF in the previously mined, overlying level (6770) approximately 2-1/2 months prior to the accident. The back/roof fall occurred directly above where Holman was loading blastholes. *(See Appendix B, Figure 1 & Figure 2)*

Figure 1
Level view showing the location of the accident.
