**REPORT OF INVESTIGATION**

**Surface Nonmetal Mine  
Crushed/Broken Limestone**

**Fatal Powered Haulage Accident  
November 3, 2018**

**O-N Minerals (Michigan) Company  
O-N Minerals, Cedarville Operation  
Cedarville, Mackinac County, Michigan  
Mine I.D. 20-00061**

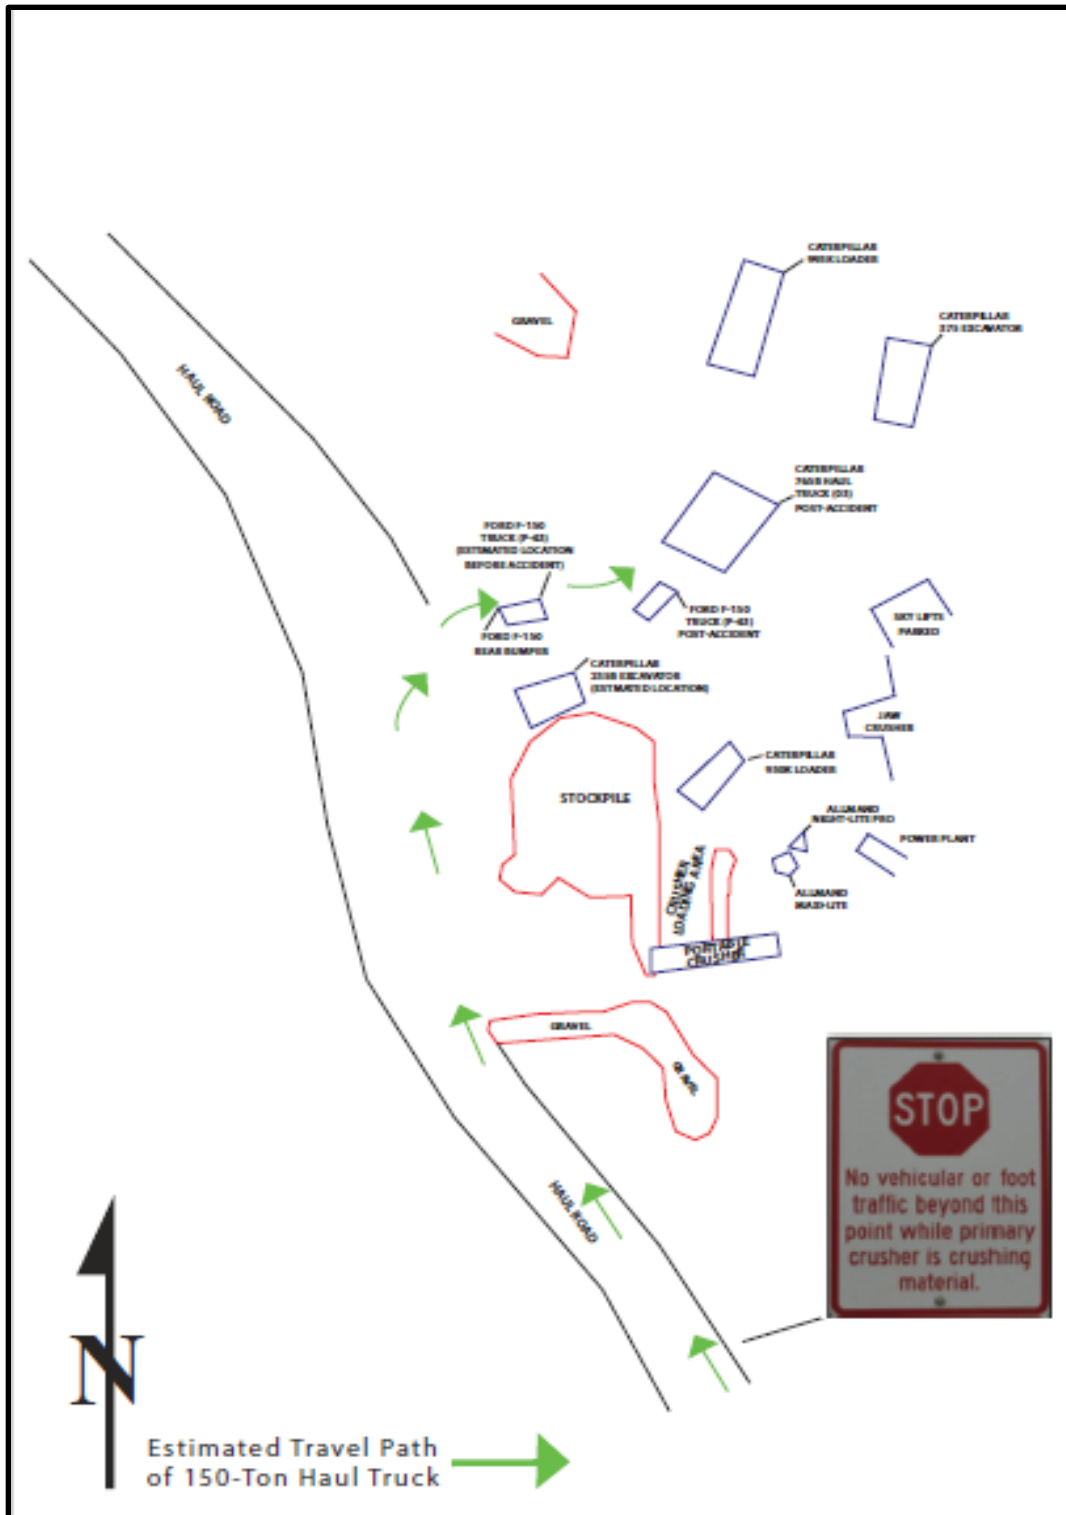
### Map of the Accident Site

The accident occurred in a stockpile area, north of the portable crushing plant and west of the primary jaw crusher. The terrain at the accident scene was relatively level.  
(See Appendix B)

(The map provided in the investigation was enhanced so as to provide more details in the approximate location the pickup truck was struck and 150-ton haul truck path)
