REPORT OF INVESTIGATION

Fatal Powered Haulage Accident
November 11, 2018

Newmont USA Limited
Pete Bajo Mine
Carlin, Eureka County, Nevada
Mine ID No. 26-02689

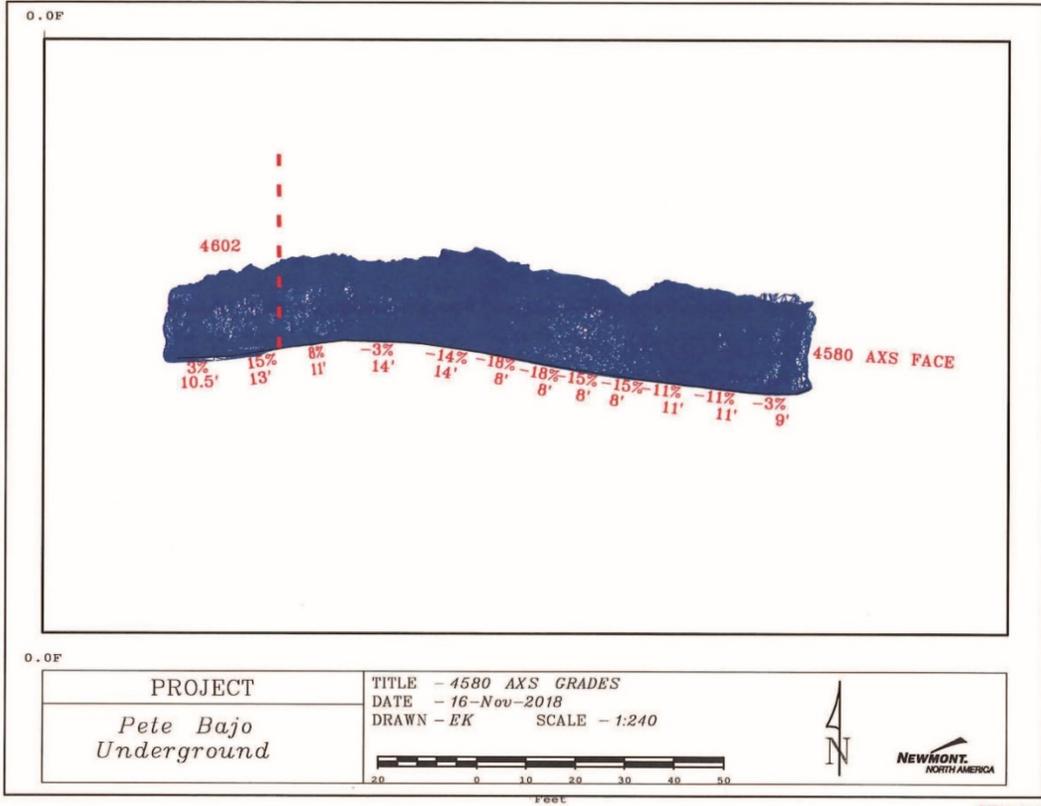
Figure 2

The accident occurred on the north end of the 4580 level at the backfilled face of the 100 heading. The 4580 level is accessed from the 4602 haulage road. The distance from the 4602 haulage intersection to the backfilled face of 4580-100 heading is approximately 102 feet. The 4580 level inclined an average grade of 6.5%, then declined toward the backfill face with an average grade of 12%. (See Appendix B Figures 1 and 2).
