REPORT OF INVESTIGATION

Fatal Powered Haulage Accident
November 11, 2018

Newmont USA Limited
Pete Bajo Mine
Carlin, Eureka County, Nevada
Mine ID No. 26-02689

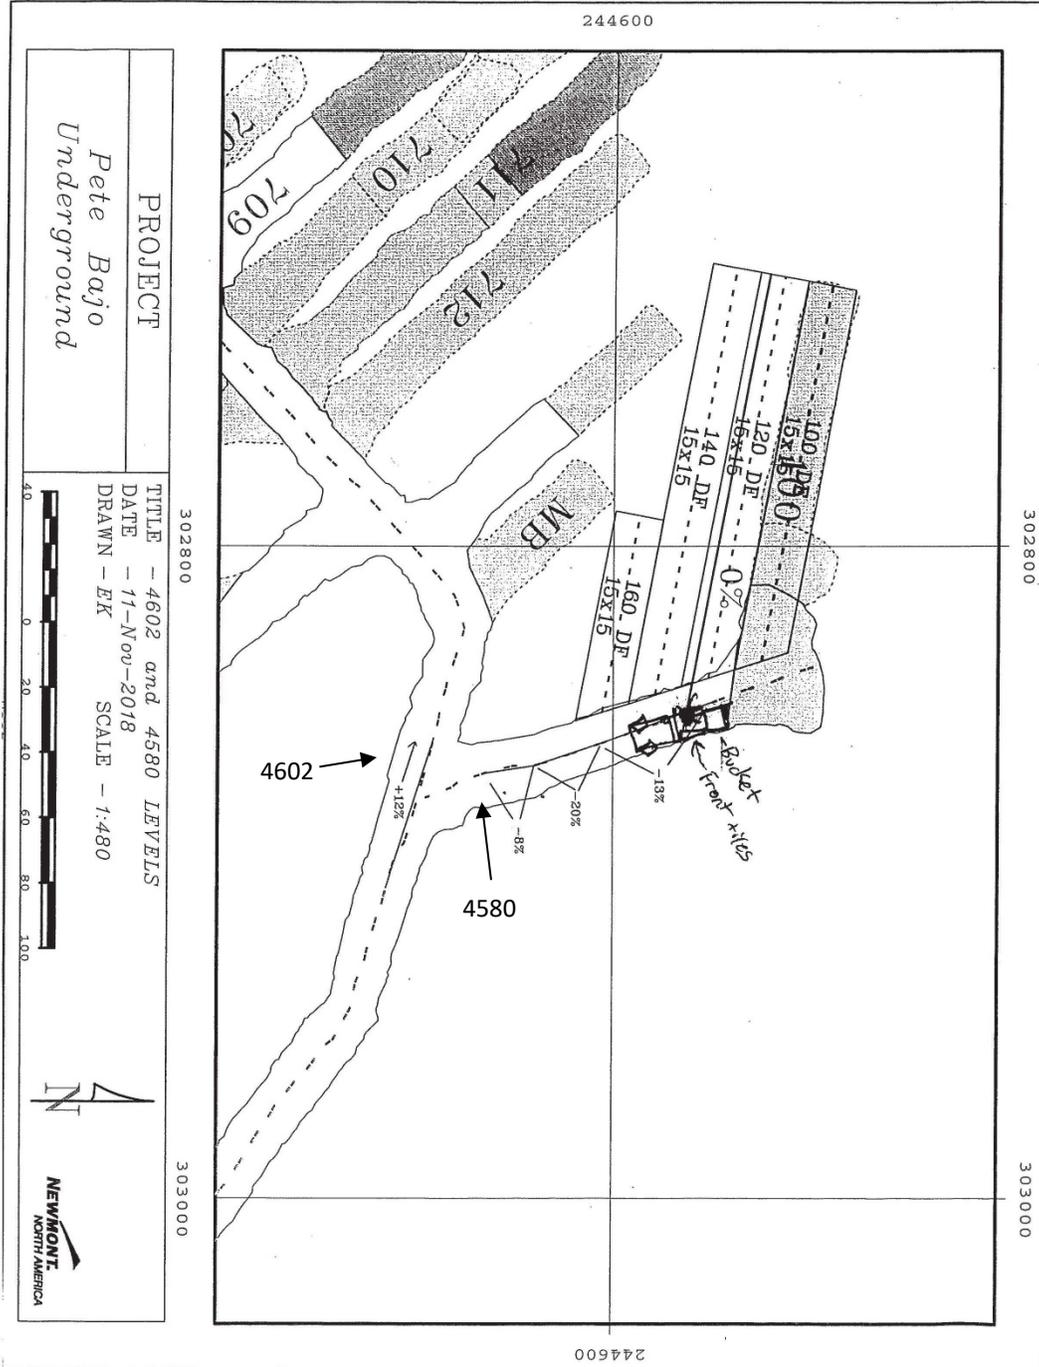
Figure 1

The accident occurred on the north end of the 4580 level at the backfilled face of the 100 heading. The 4580 level is accessed from the 4602 haulage road. The distance from the 4602 haulage intersection to the backfilled face of 4580-100 heading is approximately 102 feet. The 4580 level inclined an average grade of 6.5%, then declined toward the backfill face with an average grade of 12%. (See Appendix B Figures 1 and 2).
