REPORT OF INVESTIGATION

Open Pit Metal Mine  
(Copper)

Hoisting  
June 15, 2018

Freeport-McMoRan Chino Mines Company  
Chino Mines Co. Mine  
Grant County, New Mexico  
ID No. 29-00708

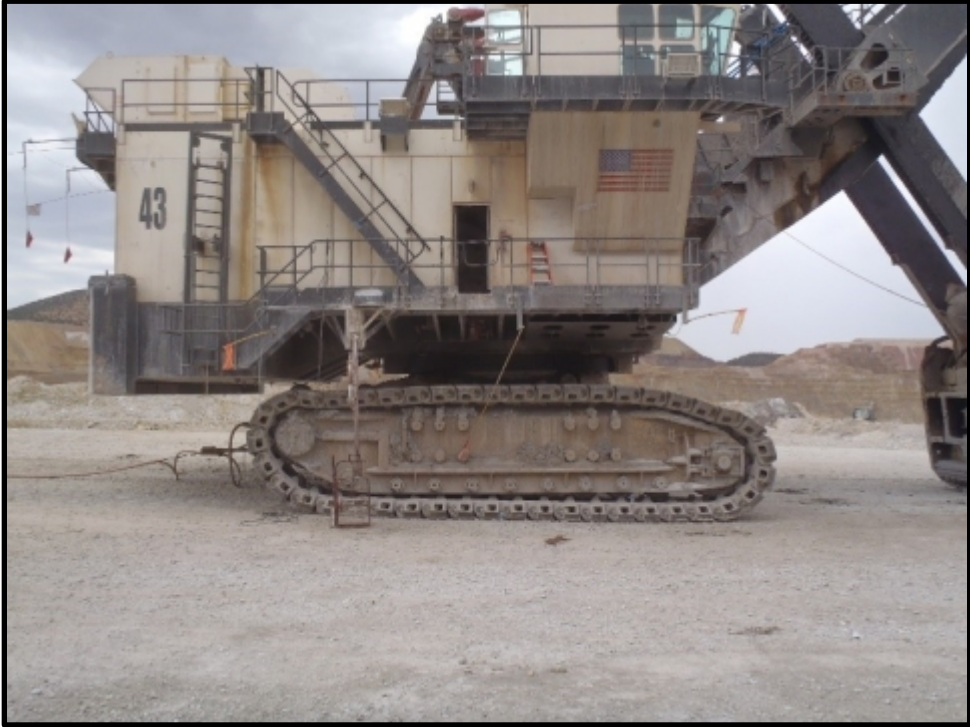
**Appendix B**  
#43 P&H 4100 Electric Shovel

The Electrohydraulic Aerial Lift was a Model No. SR96270112 manufactured prior to 2001 by Power Step, Inc. of Duluth, Minnesota and mounted on the electric shovel (see Appendix B). The frame of the lift consisted of a hydraulic cylinder mounted between the upper and lower arms that attach to a basket (transport platform). Based on information and data from the investigation, investigators could not determine the installation date of the lift. The lift was the primary means of access to the electric shovel and the maintenance history consisted of changing out worn parts and repairing hydraulic fluid leaks. A battery-powered electrohydraulic lift system raised the lift, with a hydraulic valve allowing for descent.
