**REPORT OF INVESTIGATION**

**Surface Nonmetal Mine  
(Construction Sand and Gravel)**

**Fatal Machinery Accident  
March 14, 2018**

**Hansen Pit  
Geneva Rock Products, Inc.  
Draper, Salt Lake County, Utah  
Mine ID No. 42-02107**

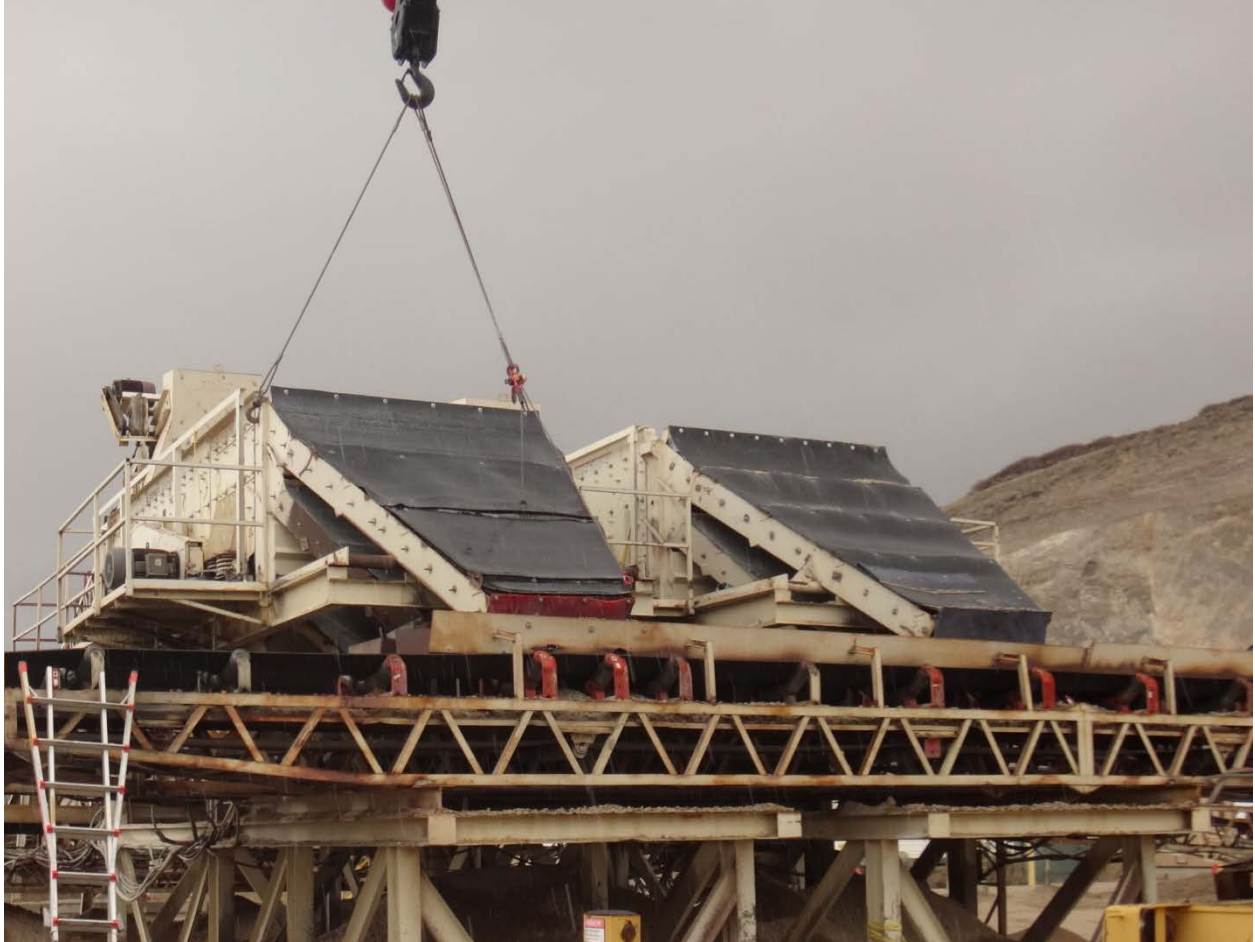
Lee G. Mackay, a 56 year old Crusher Maintenance Mechanic, died on March 14, 2018, while helping install a discharge chute assembly on a vibrating screen deck. As a crane operator lowered the discharge chute assembly, it wedged between the surrounding steel structures. Mackay and another miner tried to pry the chute assembly loose, and the victim suffered a fatal head injury when the discharge chute assembly shifted.
