MAI-2018-04

REPORT OF INVESTIGATION

**Fatal Ignition or Explosion of Gas or Dust Accident
May 9, 2018**

**Lhoist North America of Alabama, LLC, Alabaster Plant
Alabaster, Shelby County, Alabama
Mine I.D. 01-01264**

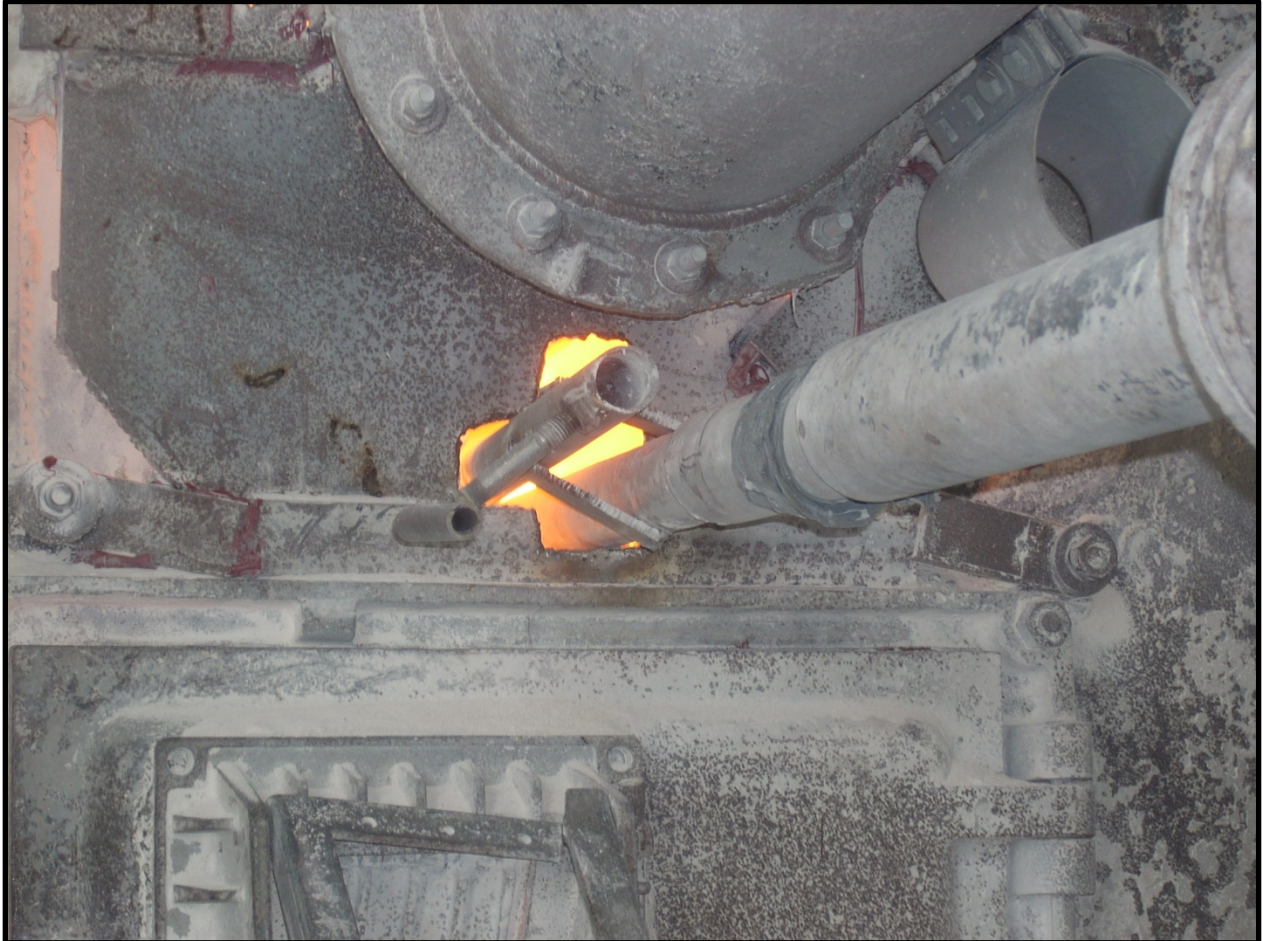
APPENDIX C – #2 Kiln Modification

- *Root Cause:* The mine operator's procedures required miners to be positioned in front of an open kiln access door while lighting the kiln.

Corrective Action: The mine operator developed procedures that require the miner to insert a rod with lit flare through a tube that extends into the chamber. The rod is clamped in place and the miner moves to a safe location before gas is applied. The kiln access door remains closed. (See APPENDIX C – Kiln #2 Modification)
