**REPORT OF INVESTIGATION**

**Open Pit Non Metal Mine  
(Sand) Non-Powered Haulage**

**June 23, 2018 Superior Silica Sands San Antonio Plant  
Superior Silica Sands, LLC  
San Antonio, Texas  
Mine ID No. 41-01126**

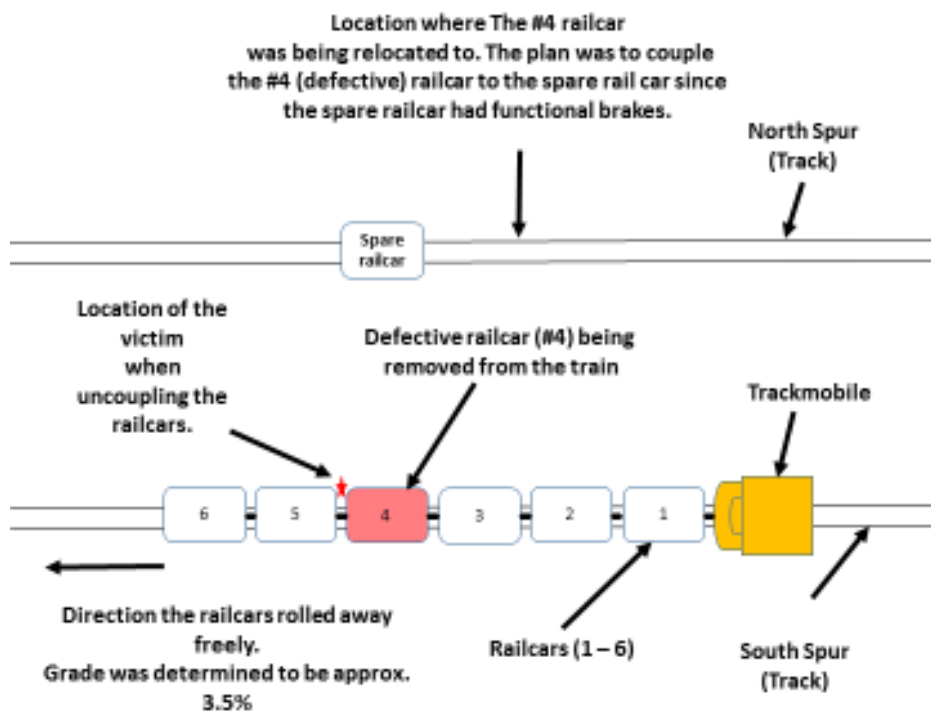
## Appendix C (Accident Diagram)

The accident occurred on the south section of the company owned rail spur. The spur enters the mine from a Union Pacific mainline on the west side of the plant. The overall length of the south section is approximately 1,680 feet. The accident occurred approximately 533 feet from the Union Pacific mainline. The runaway cars traveled approximately 586 feet from the point where they were uncoupled to where they were derailed by a Union Pacific owned derailer. The two loaded cars passed over and destroyed a Hayes EBX #6 derailer that had been placed on the track by the mine operator at approximately 102 feet from the railcar's original point of origin. On March 2, 2018 this mine operator experienced a separate event where a railcar ran away and damaged the mines derailer. The Hayes EBX #6 derailer was installed in approximately the same location by a contractor after that incident.

Investigators estimate Fernandez rode the front of the number six car for approximately 321 feet before slipping or jumping and getting struck by the railcars. The track's overall grade is approximately 3.5 percent and the railcars were traveling at approximately 18 miles per hour when Fernandez slipped or jumped from the railcar.
