REPORT OF INVESTIGATION

Surface Nonmetal Mine  
(Construction Sand and Gravel)

Fatal Powered Haulage Accident  
July 31, 2018

Susag Sand & Gravel Inc  
Orrin, Pierce County, ND  
Mine ID No. 32-00250

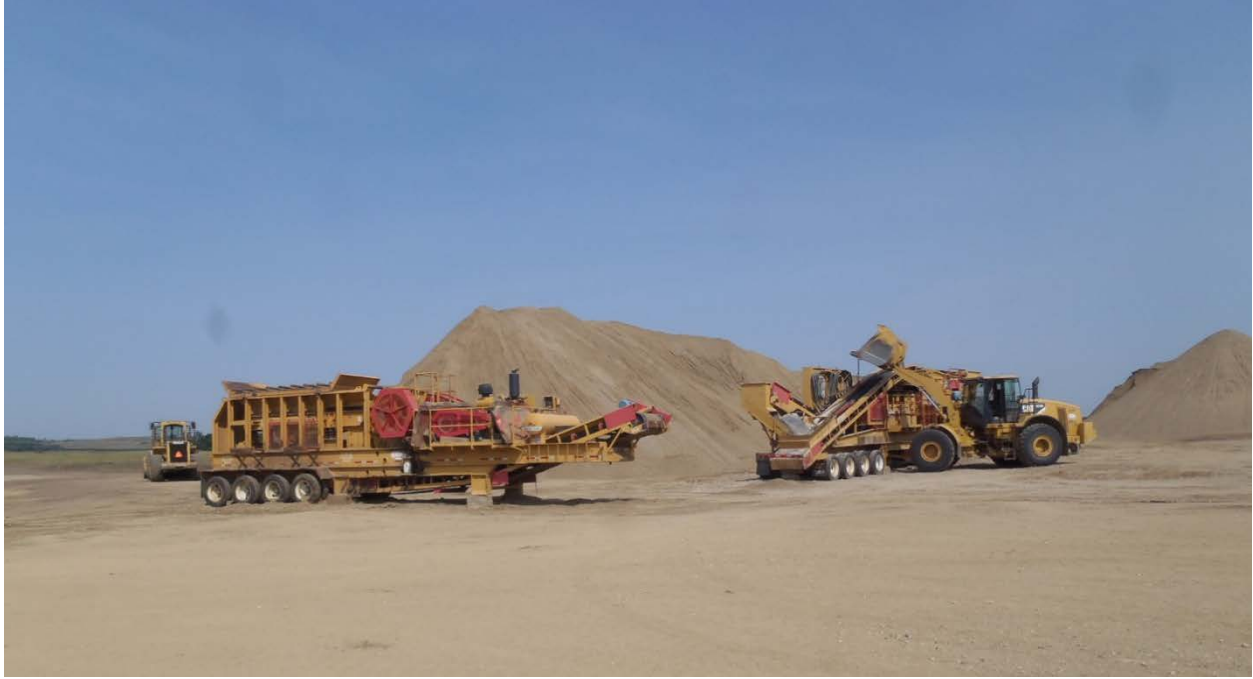
The accident occurred on the JCI screen feed conveyor at the Mack Pit.

Figure 1: Accident Scene Taken from the South

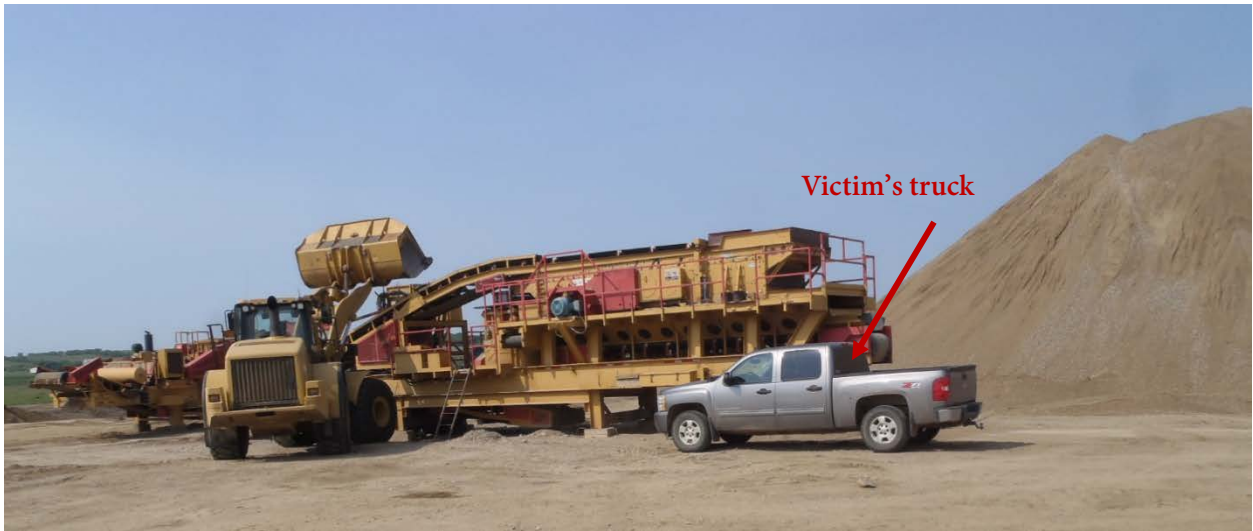
Figure 2: Accident Scene

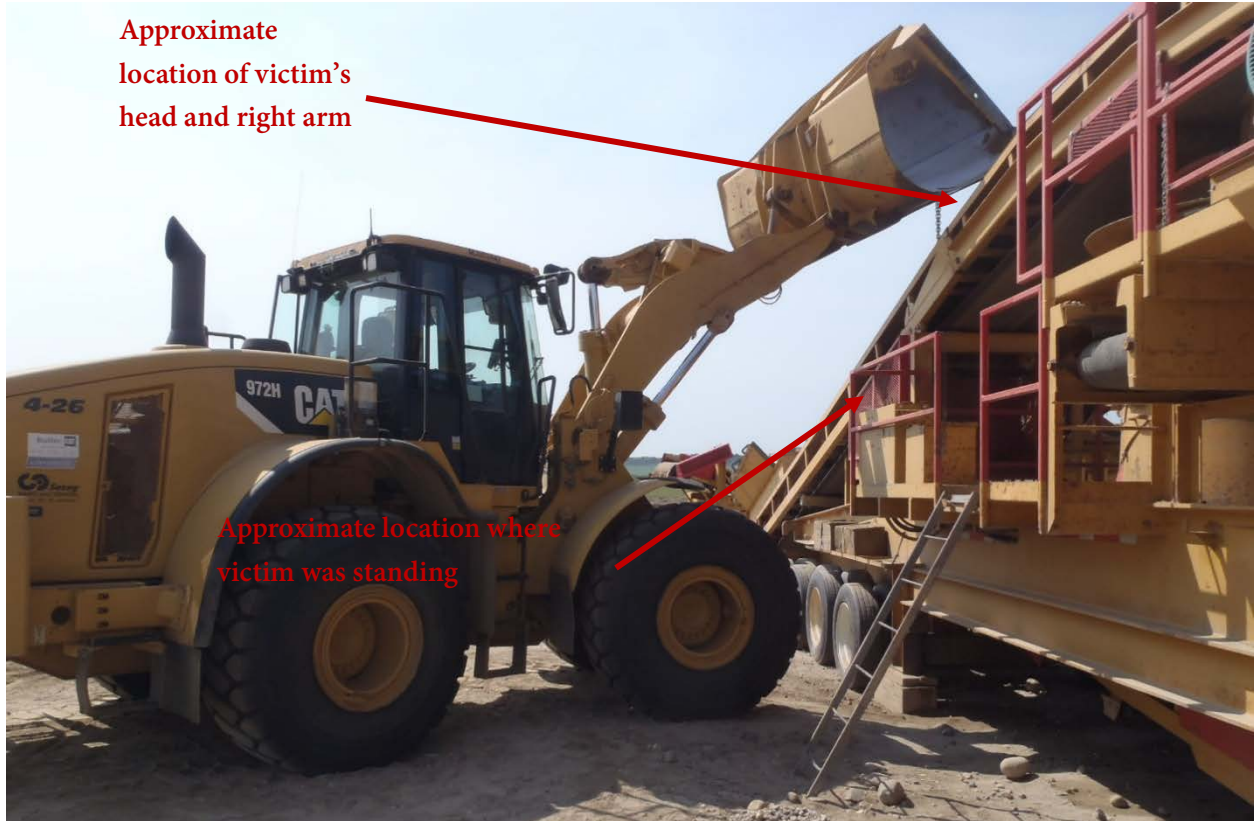
Teets raised the bucket of the loader to place the steel tube onto the JCI screen feed conveyor. Schimke positioned himself beneath the bucket and attempted to guide the steel tube into place along the inclined belt. Teets lowered the bucket of the loader to place the tube on the conveyor. In the process of positioning the tubing, Teets raised the bucket again. When Teets raised the bucket, he saw Schimke fall.

*A fatal accident occurred at this operation on July 31, 2018 when the supervisor was crushed by the bucket of a Caterpillar 972H loader. The victim was positioned under the loader bucket while holding on to a 20 foot long steel tube. He was steadying the tube as it was lowered onto the conveyor.*

Figure 3: Location of Victim at the Time of the Accident

Corrective Action: The company developed policies, procedures and new training materials to prevent miners from working under raised equipment buckets. The workforce at the mine was retrained using the new policies, procedures and training materials, with additional emphasis on not working under suspended loads.

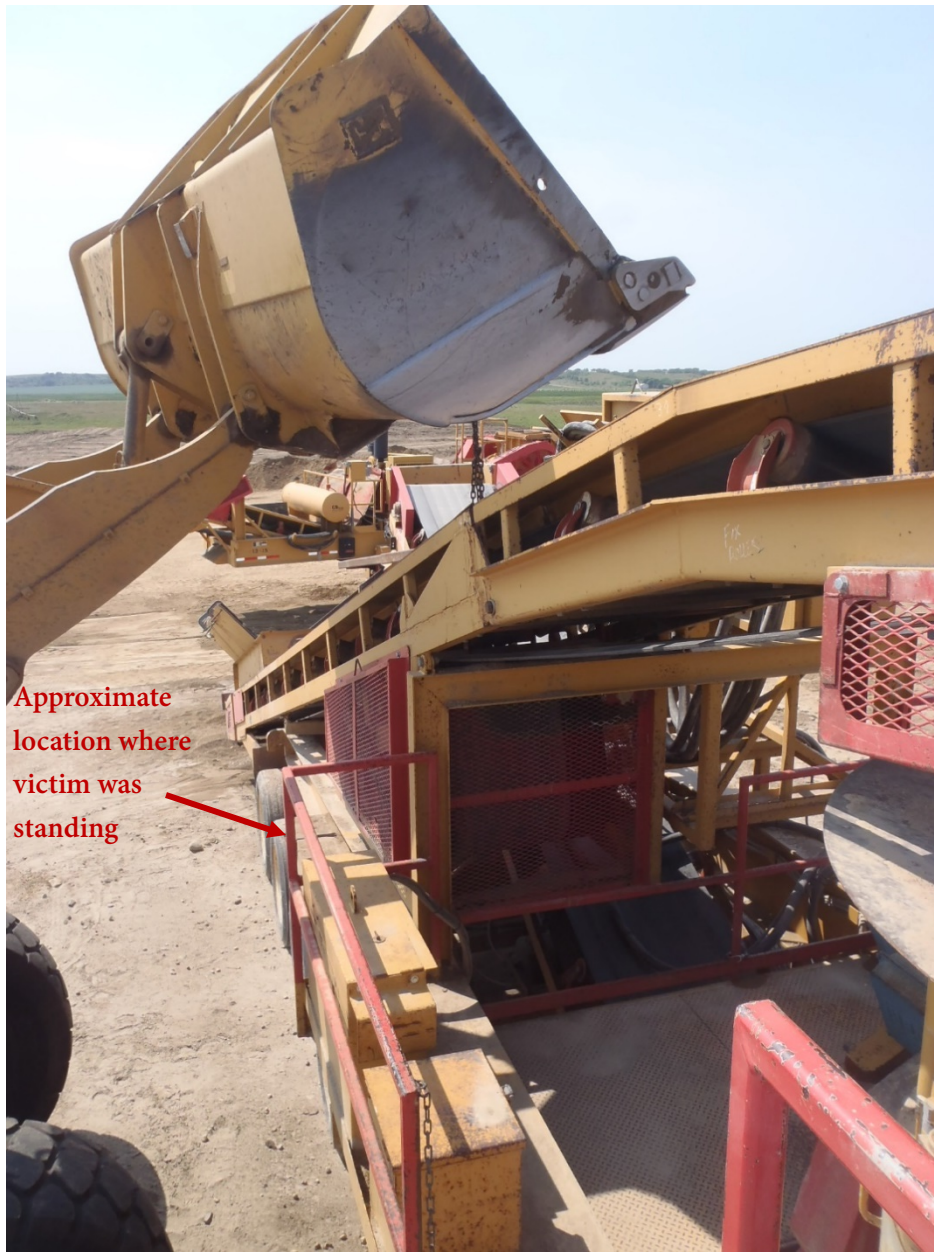
*A fatal accident occurred at this operation on July 31, 2018 when the supervisor was crushed by the bucket of a Caterpillar 972H loader. The victim was using his hand to steady a 20 foot long steel tube which was suspended from the loader bucket instead of utilizing a tag line. As a result, he was positioned under the loader bucket.*

Figure 4: Close up of the Location of Victim at the Time of the Accident

Corrective Action: The company developed policies, procedures and new training materials to use taglines to control suspended loads. The workforce at the mine was retrained using the new policies, procedures and training materials, with additional emphasis on not working under suspended loads.

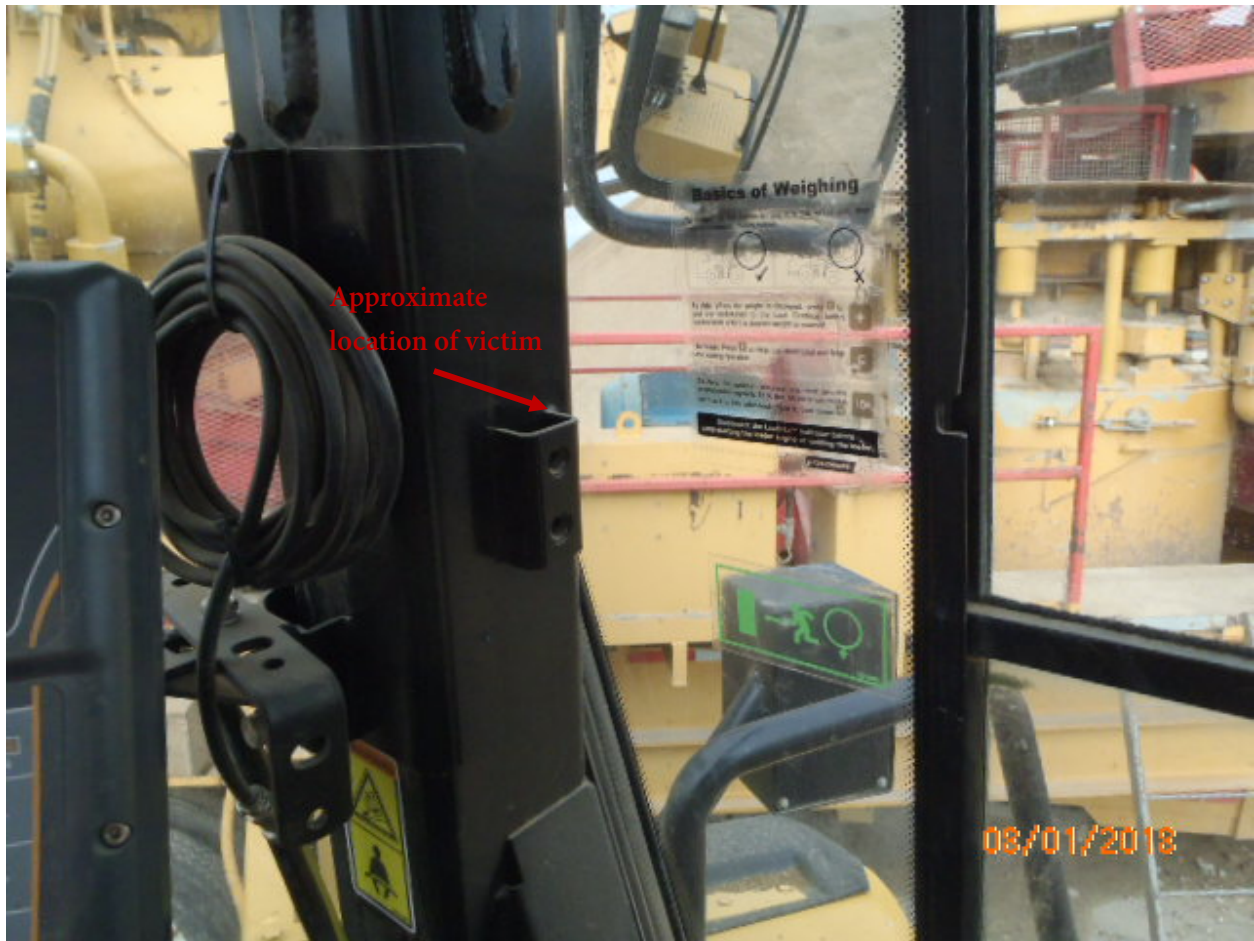
Figure 5: Photo from Operator's Cab of Caterpillar 972H Front End Loader

Best Practice: Proximity detection technology exist today which can prevent this type of injury. Consideration should be given to the use of this technology whereby an incident between the operator and other employees does not result in a fatality.

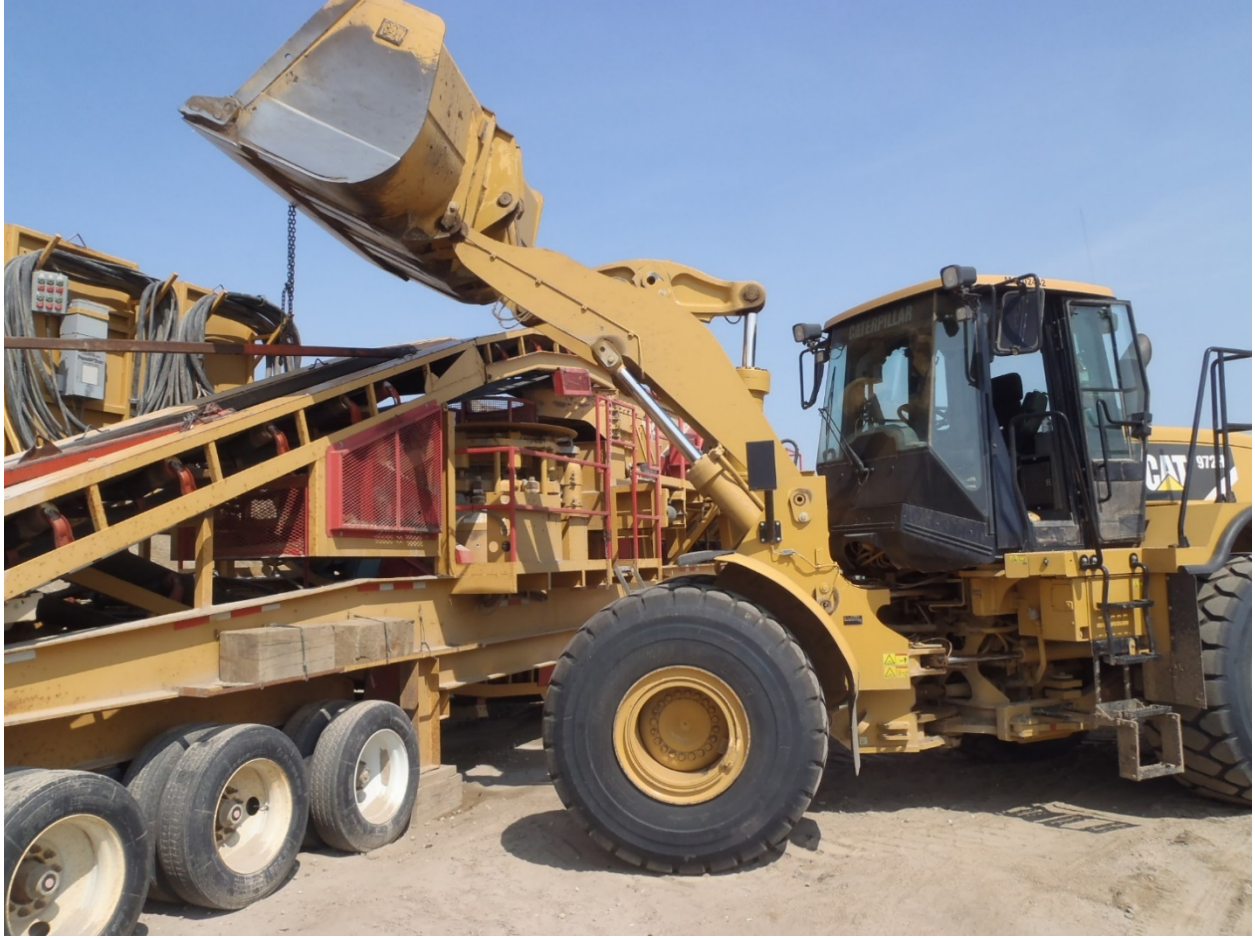
Figure 6: Additional Angle of Accident Scene
