REPORT OF INVESTIGATION

Fatal Equipment Fire Accident
September 7, 2018

Bear Run Mine
Peabody Bear Run Mining LLC
Carlisle, Sullivan County, Indiana
ID No. 12-02422

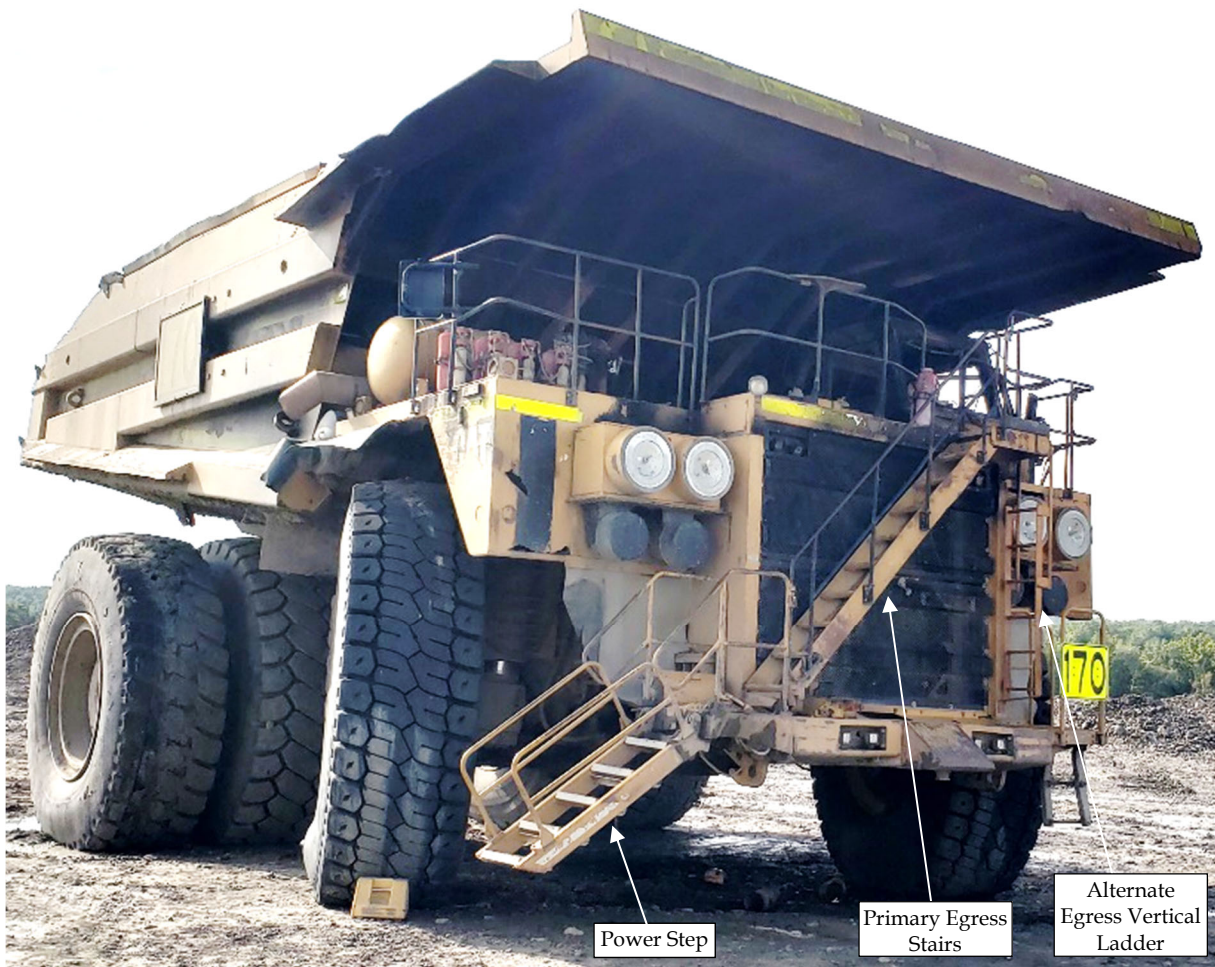
APPENDIX B
Company Truck 2-170 with Power Step Lowered

A folding stairway -- Power Step model number TS793C2 -- had been installed to provide safe access to the ground from the end of the primary stairs, which ended more than 5 feet above the ground (see Appendix B). The electro-hydraulic unit was powered by the truck's battery and controlled by switches at the top of the stairway and at ground level.

Tests and visual observations of the step assembly concluded that the electro-hydraulic unit itself was functional but the power supply cable had sustained fire damage. It is likely that fire damage to the power supply cable caused the unit to malfunction when Grostefon tried to use it.

The hydraulic system had an internal leak which allowed the stairs to drift down when not latched, which explains why it was found by investigators in the fully lowered position even though a witness reported that it had been stuck halfway during the accident. A manual release intended to lower the folding stairs when electrical power was lost was inoperable because the pull rod was broken off inside the power unit housing.

The toggle switch, located at the top of the folding stairs, used to lower and raise the stairs was labeled incorrectly, reversing the up and down functions. Also, the ground level switch, which was designed to be mounted on the top of the front bumper, was found stuck between the platform frame and the front bumper.

Corrective Action: The mine operator removed all of the Power Step boarding ladders from the Caterpillar 793 end dumps and replaced them with a fixed boarding ladder that is similar to the one installed by the original equipment manufacturer. The mine operator examined all alternative vertical egress ladders on end dumps and repaired/replaced any deficiencies to make sure they are readily accessible as per the original equipment manufacturer's design. The mine operator has trained miners on the installation, maintenance, and preoperational examination of the alternative egress vertical ladder.

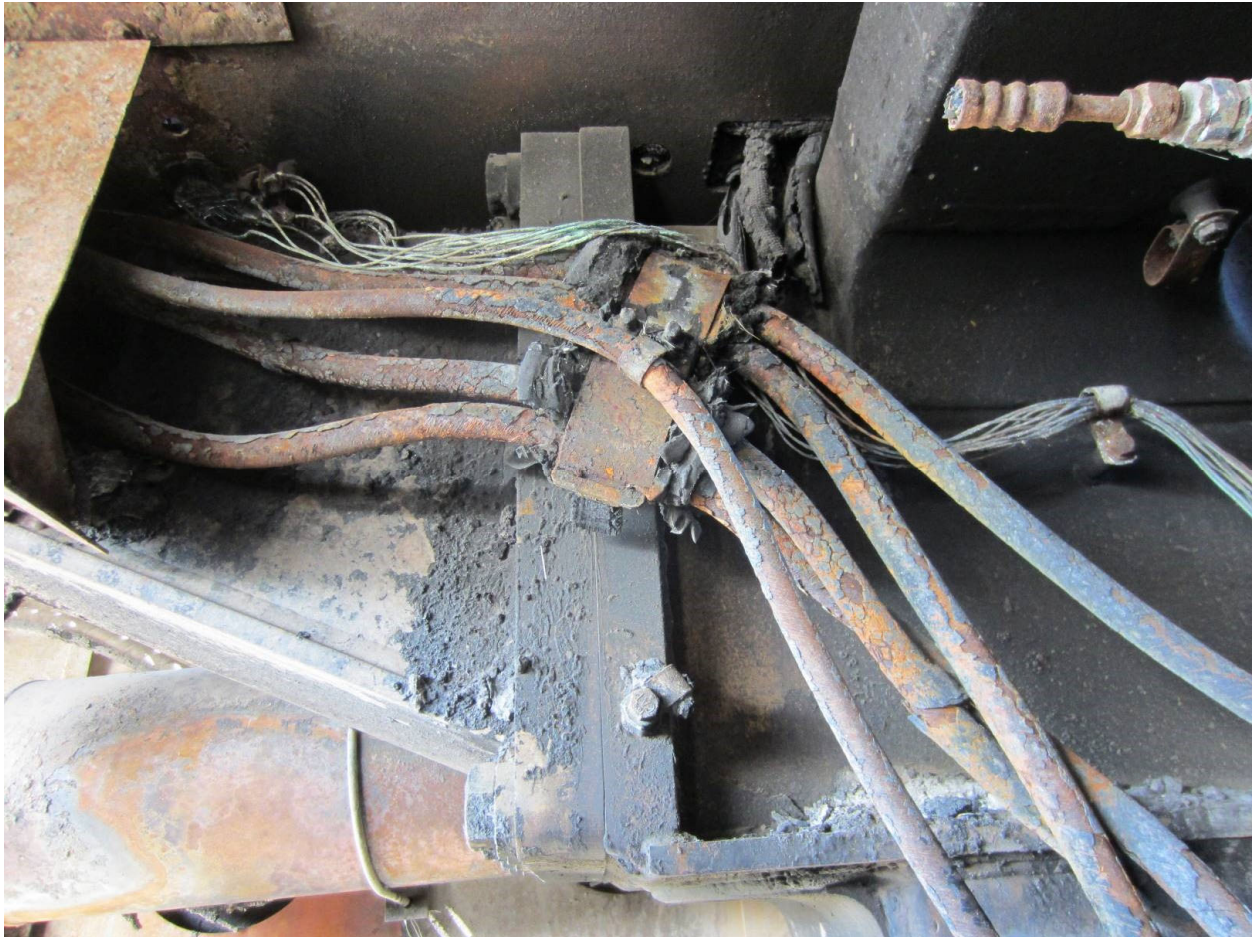
APPENDIX C
Ruptured Steering Hose

The likely cause of fire was traced to a ruptured steering hose underneath the operator's cab (see Appendix C). The hose, which supplied the primary hydraulic pressure from the steering valve to the steering metering pump, had multiple broken steel wire braids in an area about 1-1/2" by 1-1/2". The interior hose liner also had a hole about 1/8"-inch wide by 1-inch long. Investigators were not able to determine why the hose ruptured.

According to the manufacturer, pressure in the hose can reach 3,100 psi during steering operations. At the time the fire started, the operator would probably have been making a sweeping turn to line up the truck with the dump point location. That turn would have provided full pressure to the hose that failed, possibly causing the rupture and allowing high pressure hydraulic fluid to spray onto the hot surfaces of the engine. This would have resulted in a fast-growing fire.
