REPORT OF INVESTIGATION

**Surface Nonmetal Mine
(Crushed, Broken Trap Rock)**

**Fatal Powered Haulage Accident
August 22, 2018**

**Birdsboro Materials
Haines & Kibblehouse Inc.
Birdsboro, Berks County, Pennsylvania
Mine ID No. 36-08803**

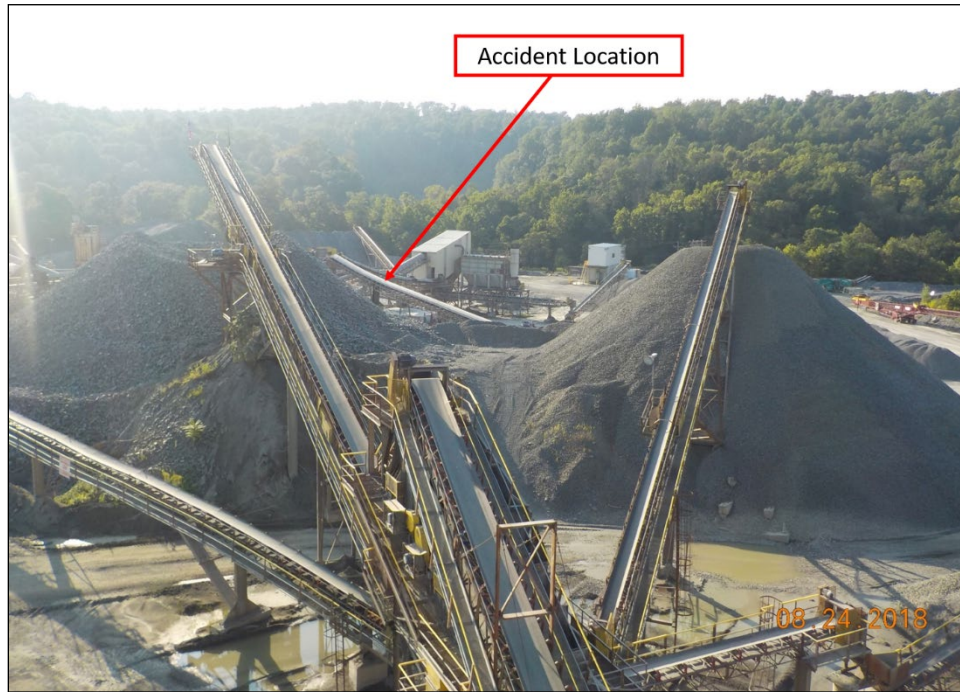
The accident occurred at the take-up assembly of the No. 3 tunnel belt conveyor located at the secondary plant. The victim was entangled between the rotating west bend pulley and the moving conveyor belt.

Figure 1 - View from the Primary Control Shack to the No. 3 Tunnel Conveyor (Accident Location)

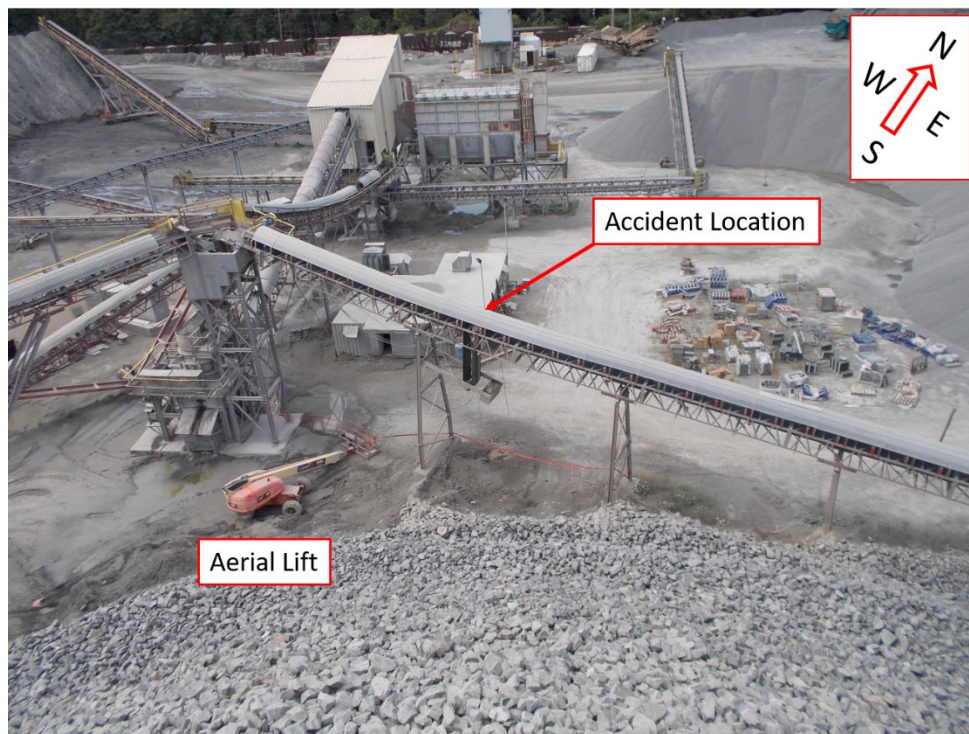
Aerial Lift: The aerial lift used by the victim was a Model JLG 600S telescopic boom lift manufactured by JLG Industries, Inc. in 2004. With the boom extended, the maximum working height is 66 feet with a continuous 360° swing. The personnel basket included a 3-foot by 8-foot solid working platform completely surrounded by a handrail, mid-rail and toe boards. The victim accessed the basket through a slide bar, side entry, inward swinging, self-closing gate. The platform capacity is rated as 500 pounds. At the time of the accident, the aerial lift basket was

positioned approximately 36 feet above the ground. The victim was not wearing fall protection and was found entangled and suspended outside of the perimeter of the working platform handrails.

Figure 2 - View of Secondary Plant showing Accident Location and Aerial Lift used by the Victim

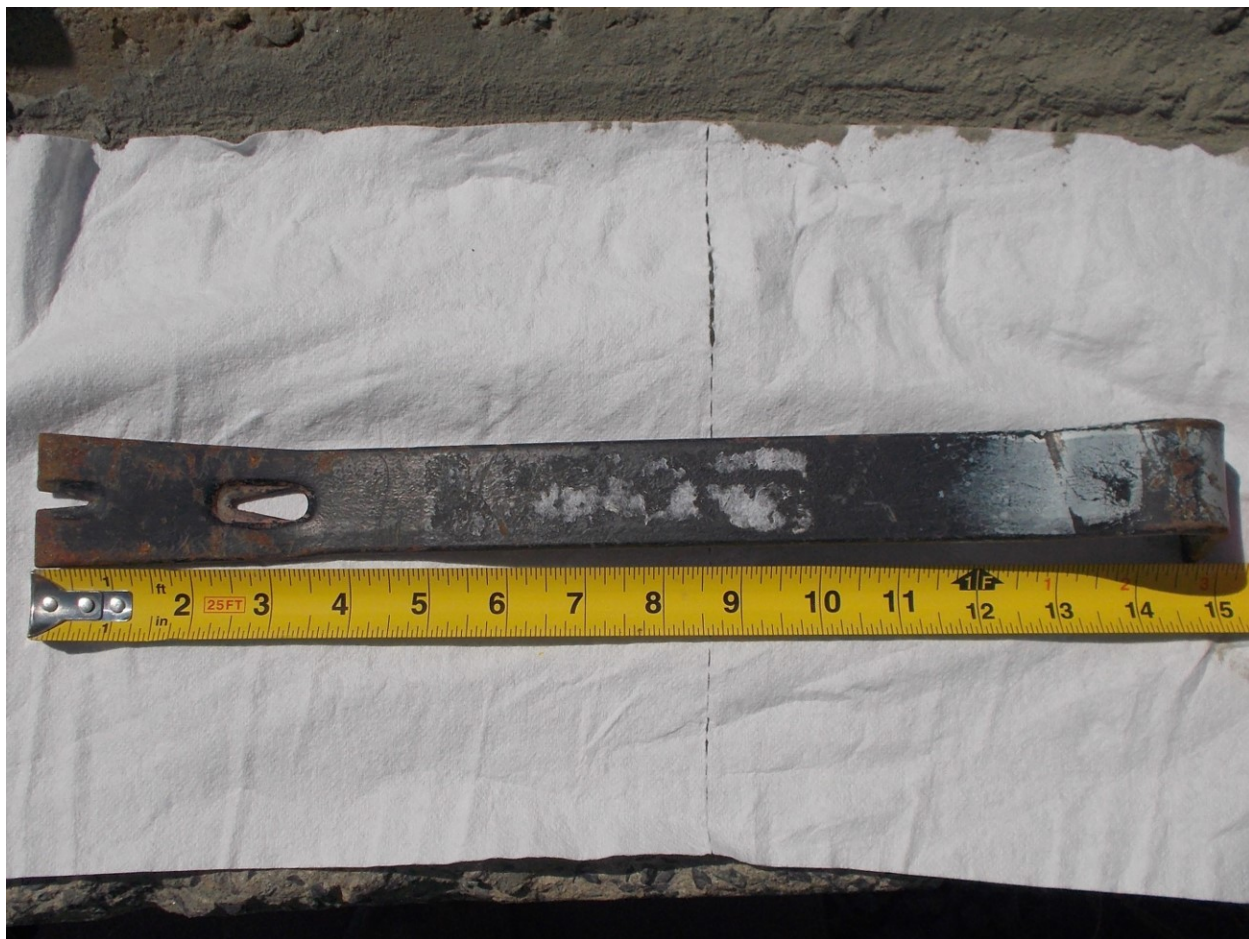
The victim used the aerial lift to access the No. 3 tunnel belt conveyor take-up assembly to clean the west side bend pulley with a 15-inch pry bar. The victim did not de-energize, lock out, and block the conveyor against motion prior to performing this task.

Figure 3 - 15-inch Pry Bar found at Accident Scene
