REPORT OF INVESTIGATION

Underground Salt Mine

Fatal Electrical Accident

M.C. Electric LLC (Z2V)  
Morgan City, Louisiana  
at  
Cote Blanche Mine  
Compass Minerals Louisiana, Inc.  
Franklin, St. Mary Parish, Louisiana  
ID #16-00358

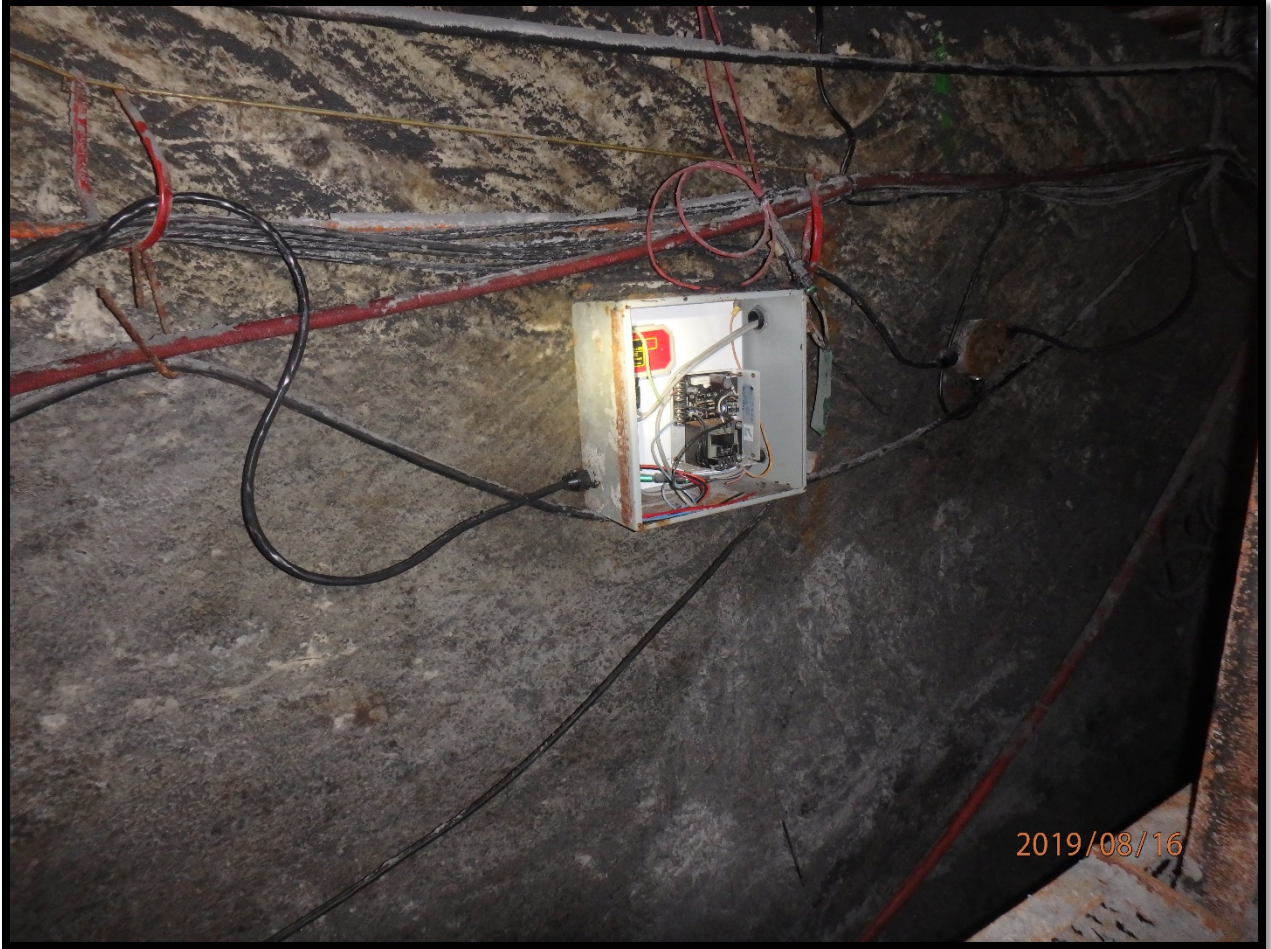
**APPENDIX B**  
C-3 Trench

The accident occurred underground in the C-3 trench area of the Cote Blanche mine.

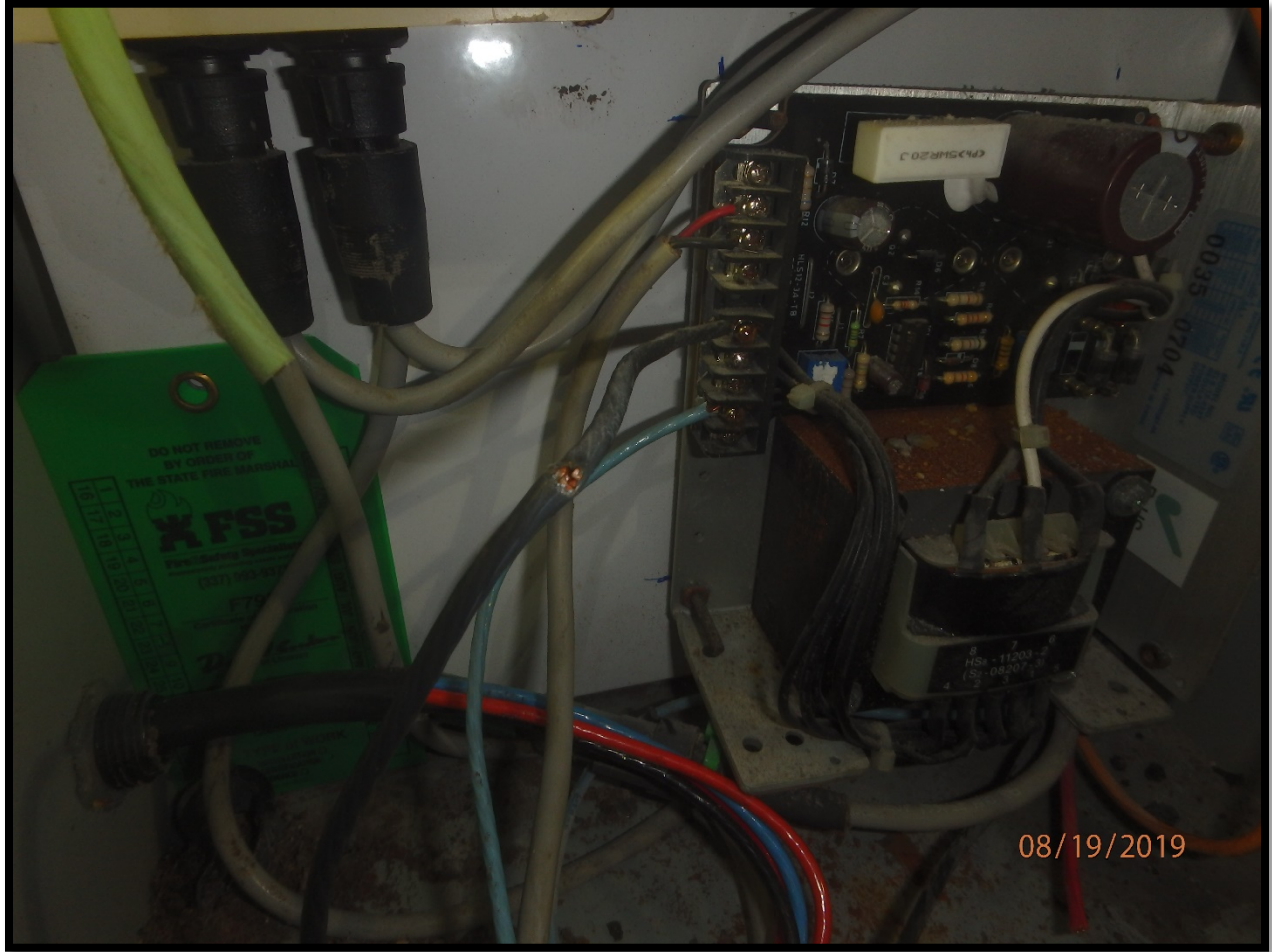
**APPENDIX C**  
Damaged 120-Volt Line

The underground C-3 belt conveyor is equipped with a fire suppression system to alert mine personnel of a potential belt conveyor fire as well as to apply a chemical agent to suppress fires when activated. The fire suppression system is 120 VAC. A voltage transformer reduces the control voltage to 24 VDC. The voltage transformer is located in a control box on the rib of the C-3 trench adjacent to the C-3 belt conveyor (see Appendix B). Based on interviews and site investigation, investigators determined the electricians were working on an energized electrical circuit. The circuit breaker for the fire suppression system, which controls the lights and outlets in the C-3 tunnel, was energized when the accident occurred. Investigators found a cut in the insulation of the 120 VAC wire and determined Clements came in contact with this energized wire (see Appendix C).

- 2) A 104(a) Citation No. 8966039 was issued to Compass Minerals Louisiana Inc., for violation 30 CFR § 57.12017 on 11/13/2019 at 7:08 a.m. A contract electrician received fatal injuries while working on an energized electrical circuit in the C-3 trench. The fire suppressions system's 120 VAC electrical circuit remained energized and not locked out prior to performing work. The electrician was installing a new electrical circuit to the fire suppression system control box in the trench when he contacted the energized wiring from the existing circuit in the control box.

Corrective Action: The mine operator had a safety stand down with all miners: hourly, salary and contractors, at the mine and reviewed the lock-out and tag-out policy along with other safety procedures. Mine operator revised their training procedures to ensure new contract employees receive training in their lock-out and tag-out program and record such training.
