REPORT OF INVESTIGATION

Fatal Hoisting Accident
December 3, 2019

Alimak Hek Elevator Company (Z674)
Webster, Texas

Holcim (US) Inc. Holly Hill Facility
Holcim (US) Inc.
Holly Hill, Orangeburg County, South Carolina
ID No. 38-00014

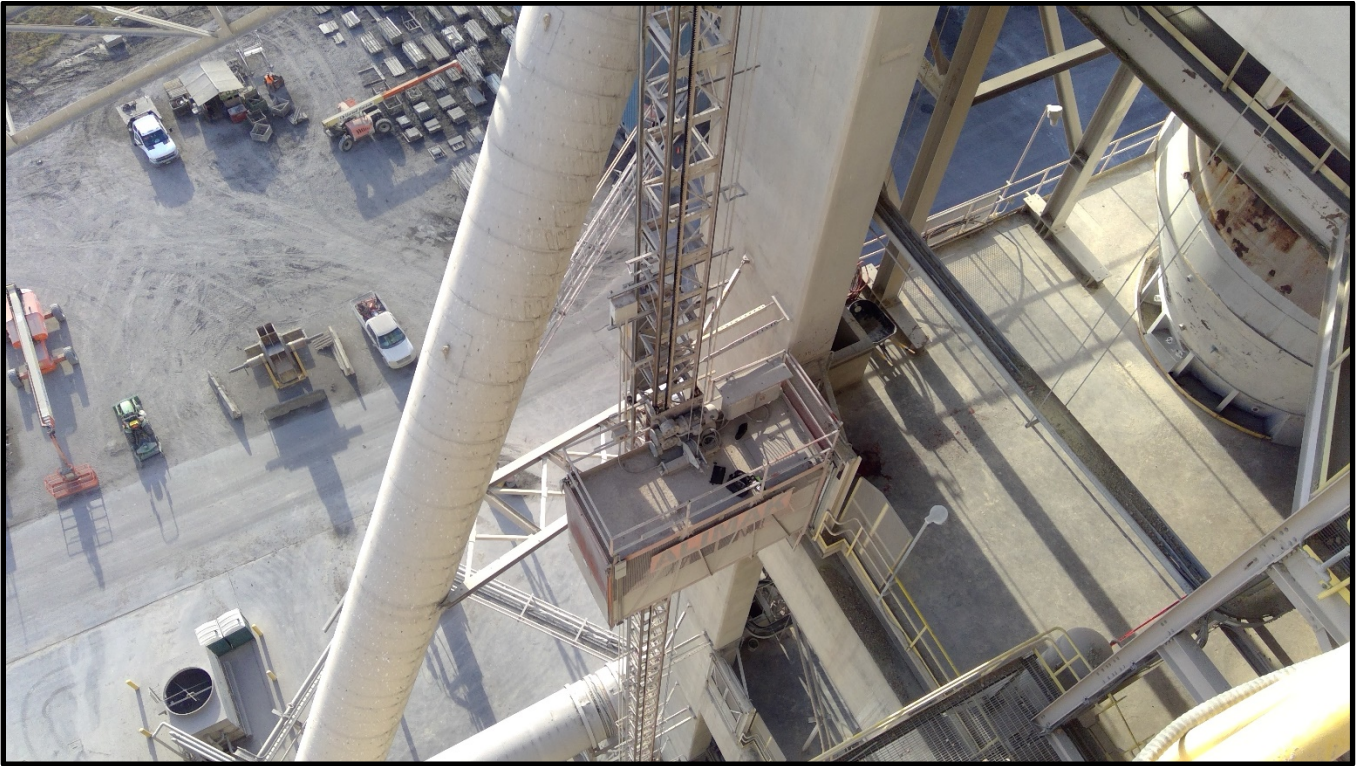
The accident occurred between levels 3 and 4 of the pre-heater tower. The victim then fell onto level 3 after striking the elevator platform.

APPENDIX B
(View from the Level 4 with the elevator car stopped at Level 3)

Corrective Action: Alimak has installed lock boxes on the call buttons on each level of the plant. Alimak has revised its training plan to require the locking of call buttons prior to performing any maintenance on the elevator. Also, the contractor reinstructed their maintenance staff on the requirement to turn off the power to the elevator while performing maintenance.
