REPORT OF INVESTIGATION

Open Pit Non Metal Mine
(Limestone)

Fall of Person
March 7, 2019

Robben's Fabrication and Mechanical, LLC
Contractor ID (B6573)
at
CEMEX Construction Materials South, LLC
Balcones Quarry
San Antonio, Texas
ID No. 41-00994

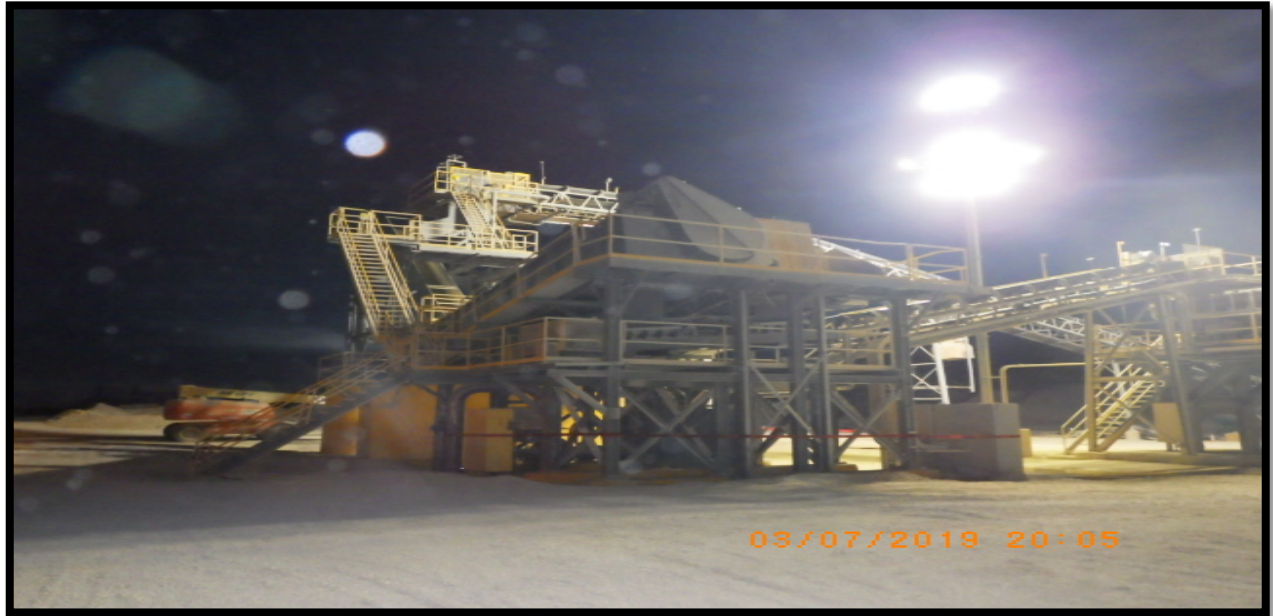
APPENDIX B
Log Washer Photos

The accident occurred at the wash plant where two log washers are side by side. The north log washer is a McLanhan Super Mudmaster 46' x 35' and the south log washer is a 44' x 35' unit. The gap between the log washers ranges from 15 ¾-inches at the motor drive end to 16-inches on the opposite end and is approximately 35 feet long. (See Appendix B)

The miners were replacing the drive belts on the motor of the north log washer when the accident occurred. They stood on top of the north log washer, which was covered by a metal screen. There were catwalks on all sides of the north and south log washers except for the gap between them.

While tightening the front bolt, Dominguez stood while he was bending over and pulled the wrench toward himself. His wrench slipped, causing him to lose balance and fall backward. He stumbled when his left foot hit the electrical power cable and he fell through the narrow gap between the log washers.

Corrective Action: The operator retrained miners and contract employees on the requirement of wearing fall protection and their “working at heights” policy. The operator also provided additional guarding at the log washers for working on top of the log washers.
