REPORT OF INVESTIGATION

Surface Nonmetal Mine
(Crushed, Broken Stone)

Fatal Machinery Accident
July 17, 2019

Northeast Aggregate Corporation
Northeast Aggregate Corporation
Swanton, Franklin County, Vermont
ID No. 43-00585

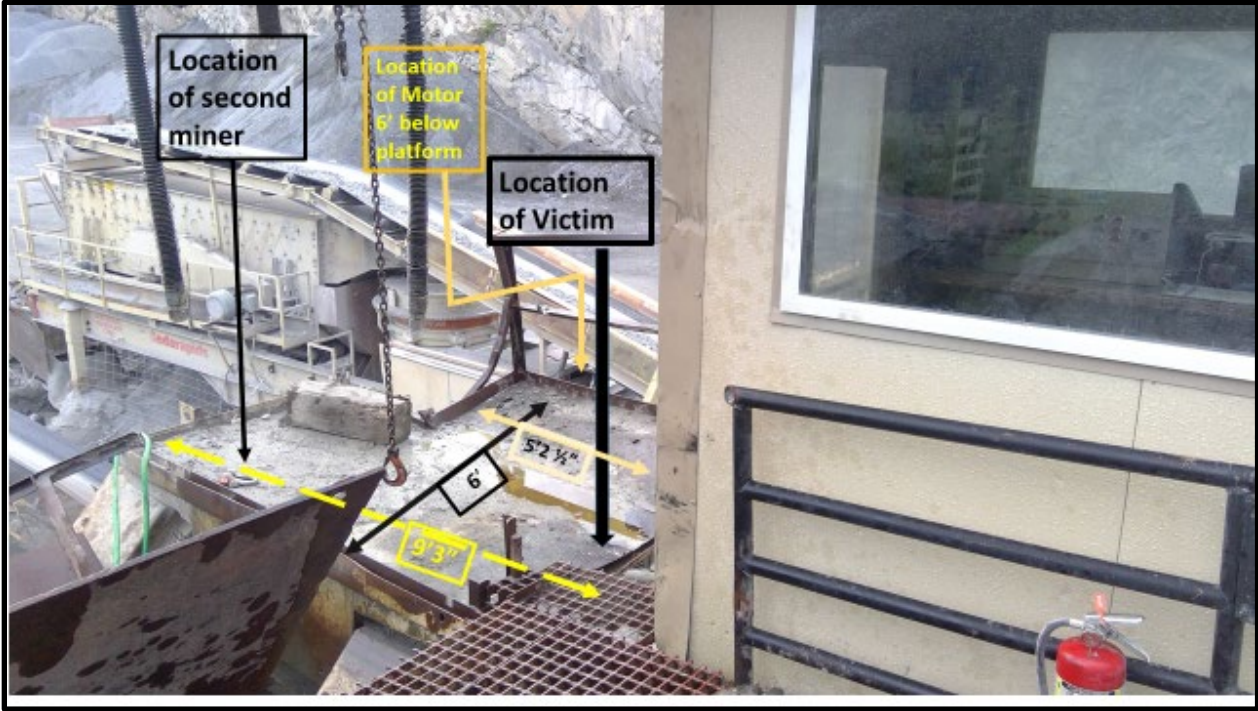
Appendix A
Location of Charbonneau and McAllister at the time of the accident

Charbonneau and McAllister walked to the crusher work platform to guide the excavator into position to remove the old motor. Charbonneau was standing next to the crusher booth on the east side of the platform. McAllister was standing on the west side of the platform, just above the crusher flywheel (see Appendix A). Root began to position the excavator's boom and hammer while Charbonneau and McAllister directed him with hand signals. Charbonneau was standing below the hammer, which was approximately 7.5 feet above the work platform. When Root rotated the hammer to the horizontal position, the hammer fell from the quick coupler, striking Charbonneau in the head, knocking him down, and pinning him to the work platform.

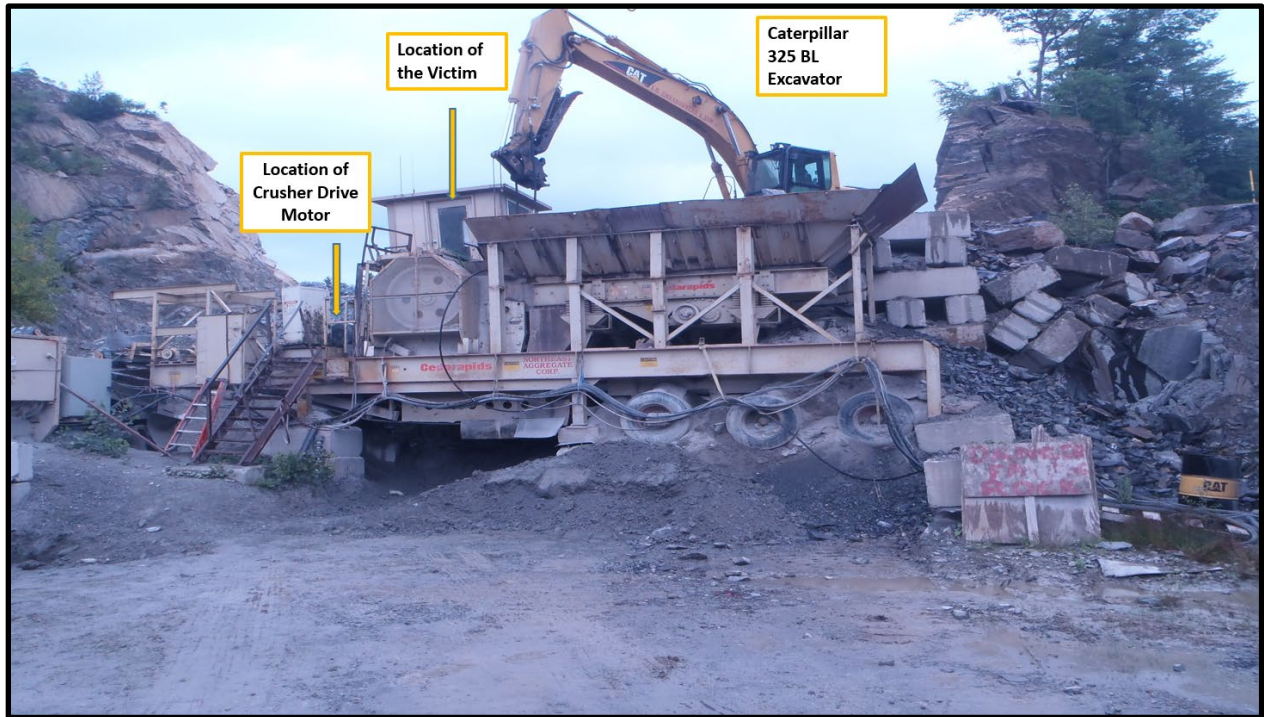
Appendix C

The accident occurred on the west side of the crusher control booth on a Cedarapids portable jaw crusher work platform (see Appendix C).

Cedarapids Portable Jaw Crusher Work Platform

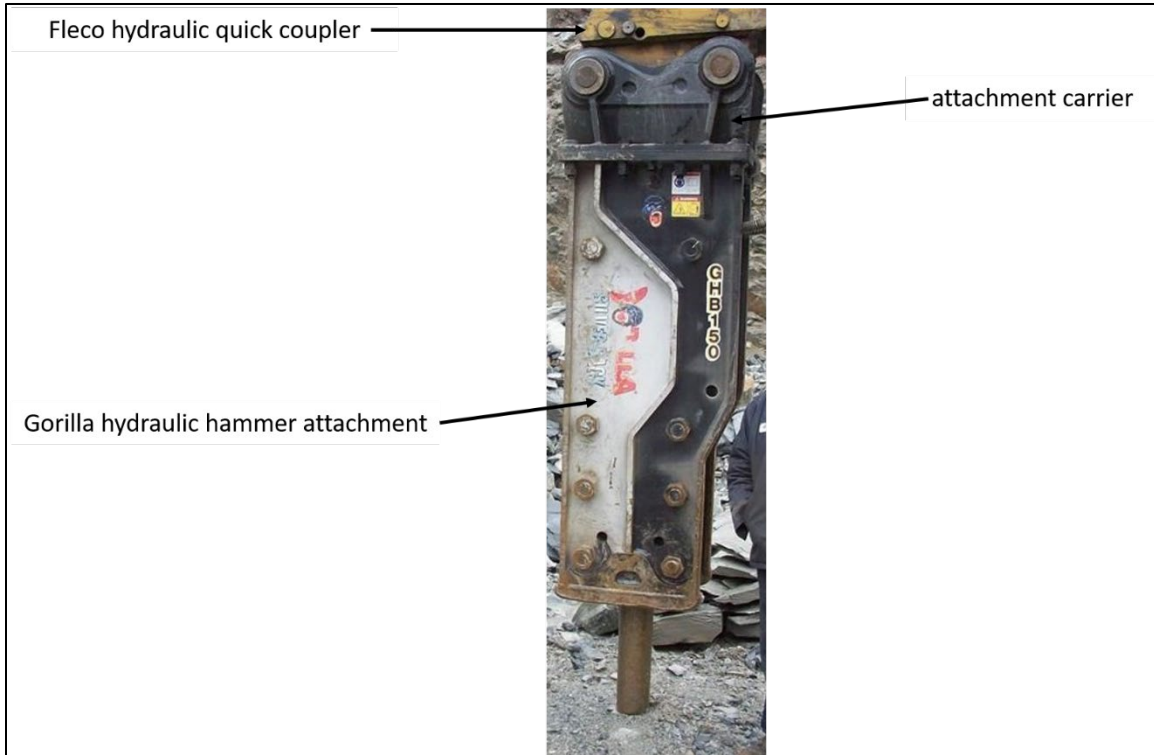
Appendix D

The equipment involved in the accident was a Caterpillar 325B L excavator, product identification number 2JR02784. At the time of the accident, the excavator was equipped with a Fleco 325B C-linkage quick coupler and a Gorilla GHB150 hydraulic hammer (see Appendix D). This attachment assembly was provided and installed by Perry's Equipment Inc. of Swanton, Vermont several years prior to the accident.

Arrangement and Identification of Components

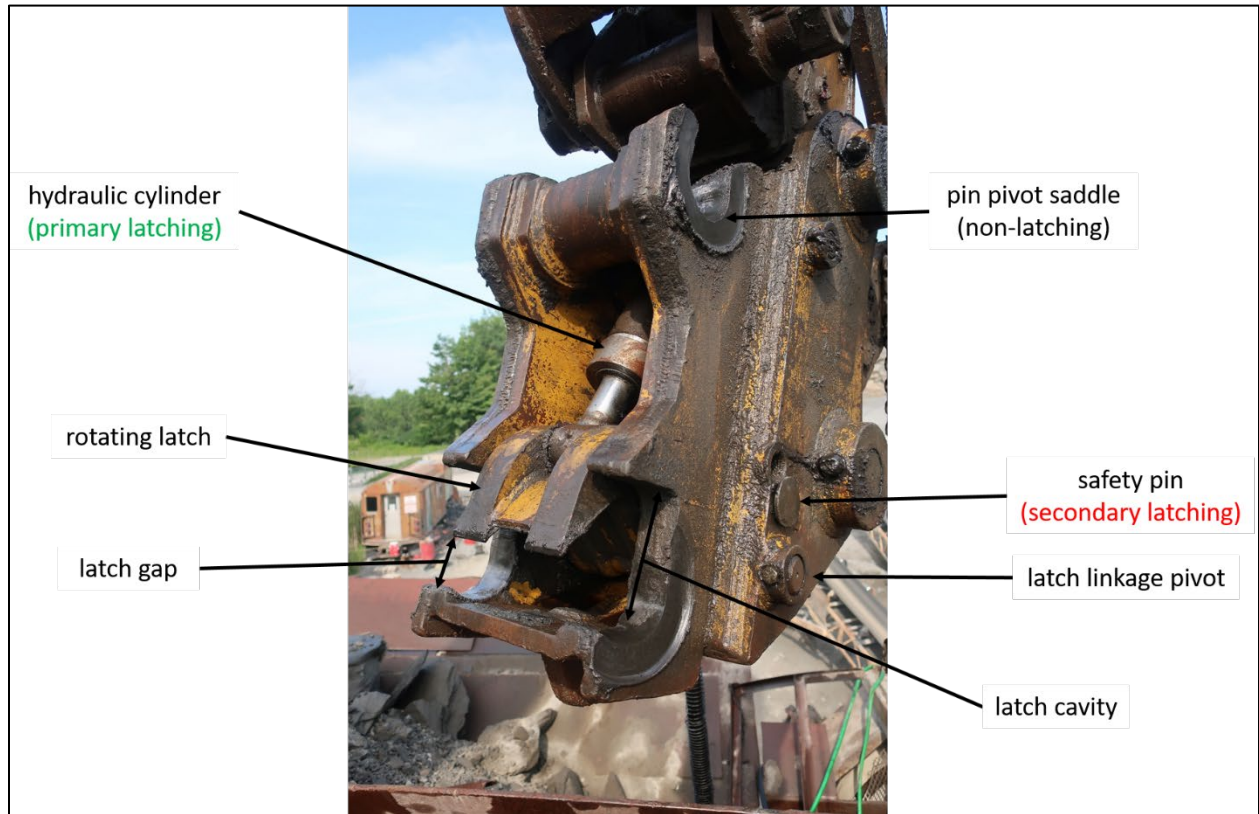
Appendix E

A secondary latching system used a safety pin arrangement to mechanically keep the latch from opening (see Appendices E and H). The safety pin can be inserted into one of two holes in excavator's quick coupler. The proper hole depends on the amount of separation of the two pins in the hammer's carrier. The operator's manual for the quick coupler indicated that the maximum recommended pin separation for the type of pins in the hammer's carrier, is 475 mm. The separation of the pins in hammer's carrier was 520 mm which circumvented the safety pin as a secondary means of securely holding the hammer's carrier.

Quick Coupler Arrangement

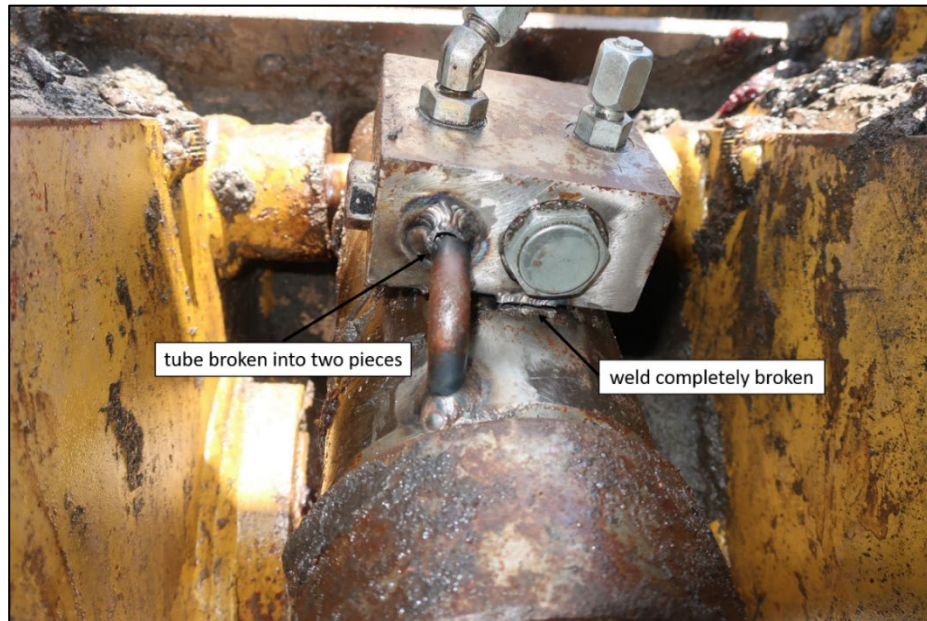
Appendix F

As mentioned earlier, Gilman removed the two hydraulic hoses connected to the hydraulic cylinder from the excavator and installed caps on all four fittings. In addition, investigators found that the tube welded to the extend side of the hydraulic cylinder was cracked and the tube welded to the retract side of the hydraulic cylinder was broken into two pieces. This defeated the load locking valve feature for the latch and allowed a constant flow of hydraulic oil to leak (see Appendices F and G).

When Root rotated the hammer to the horizontal position, the weight of the hammer on the latch and hydraulic cylinder forced hydraulic oil out of the cracked tube and through a broken weld where the load locking valve arrangement was welded in place. As the hydraulic oil evacuated the tube, the latch opened. The secondary means also failed due to the incompatibility of the quick coupler and hammer's carrier. The hammer fell because the primary and secondary latching systems could not serve their intended function.

Condition of Tube to Retract Side of Hydraulic cylinder and Broken Attachment Weld (one of two) for the Load Locking Manifold Block

Corrective Action: The quick coupler involved in the accident was removed from service. Mine management and miners have been reinstructed on the provisions of 30 CFR § 56.14100 including the removal of unsafe equipment that affects the safety of miners.

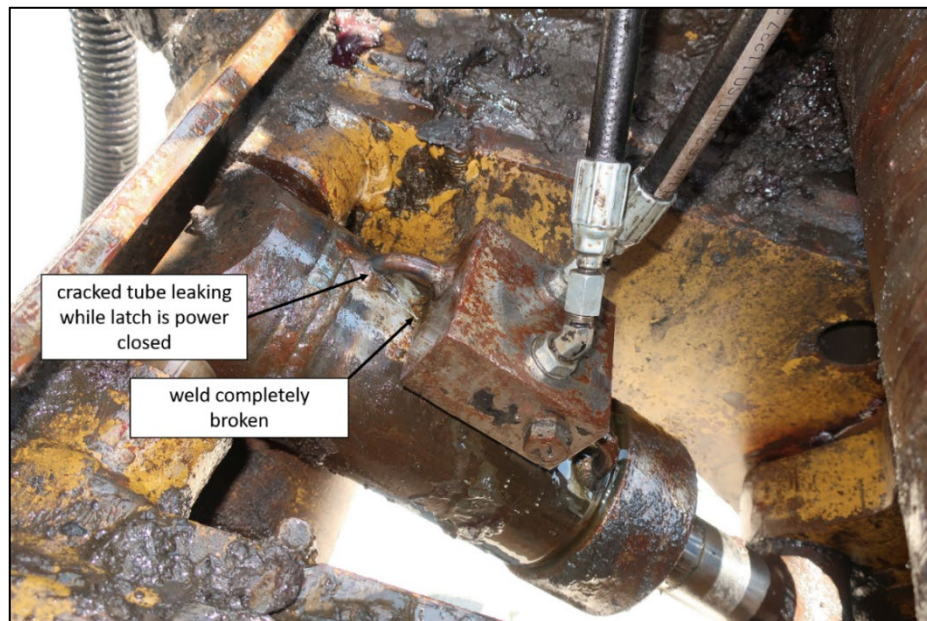
Appendix G

Hydraulic Leak at Tube to Extend Side of Hydraulic Cylinder during Excavator's Normal Operating Mode and Broken Attachment Weld (two of two) for the Load Locking Manifold Block

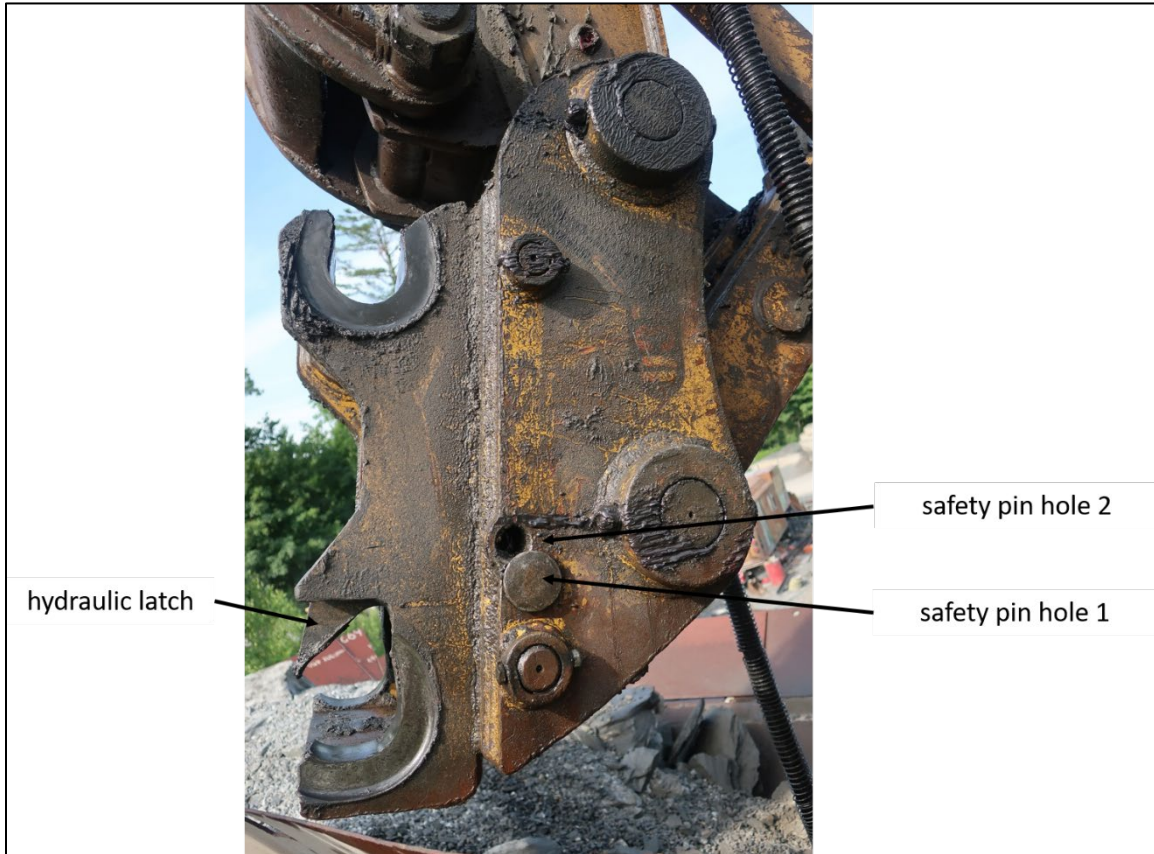
Appendix H

2. **Root Cause:** The accident occurred because the operator used an incompatible carrier attachment. The mismatched equipment components circumvented the secondary latching system allowing the hammer to disengage from the quick coupler when the primary means of latching failed.

Safety Pin Arrangement and Pin Location (hole 1)at Time of Accident

Corrective Action: Management removed the quick coupler from the excavator and adopted a policy eliminating the use of quick coupling devices at this operation. The operator will ensure that all equipment is used within the design capacity of the manufacturer.
