REPORT OF INVESTIGATION

Fatal Powered Haulage Accident
July 30, 2019

Hinesburg Sand & Gravel Company Inc.
Home Pit and Mill
Hinesburg, Chittenden County, Vermont
ID No. 43-00110

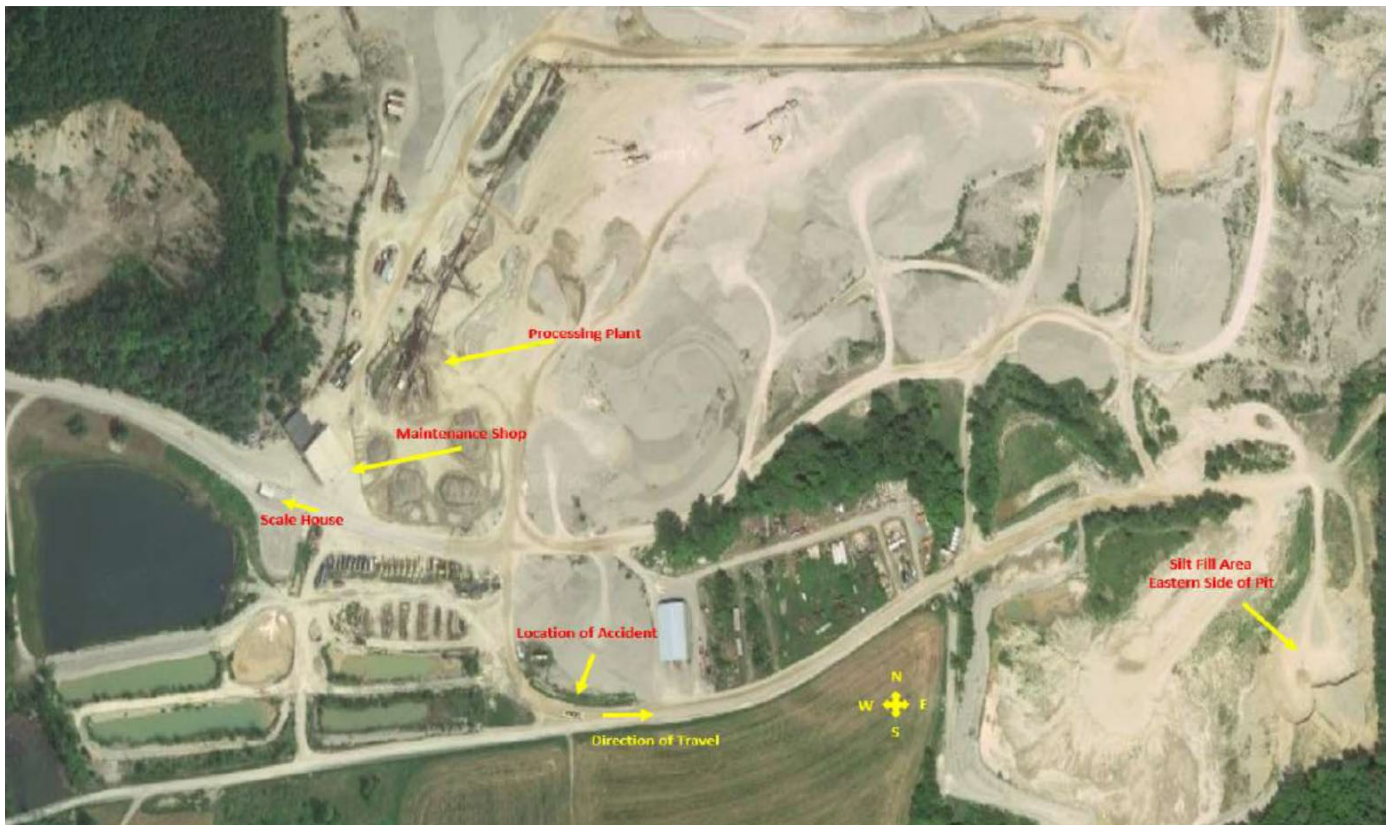
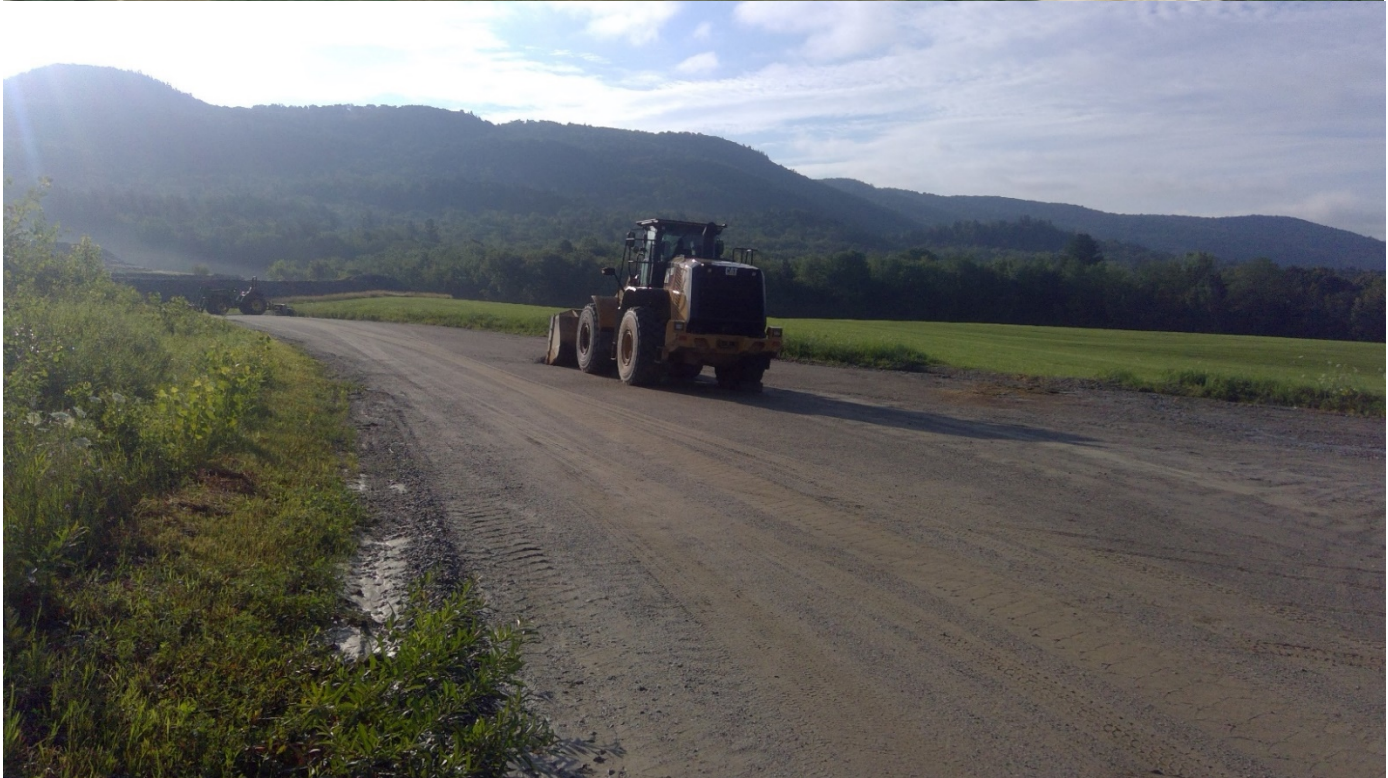
Appendix B

The accident occurred on the south side of the plant on Meadow Road between the scale house and the east pit (see Appendix B).

Location of the front-end loader at the time of accident

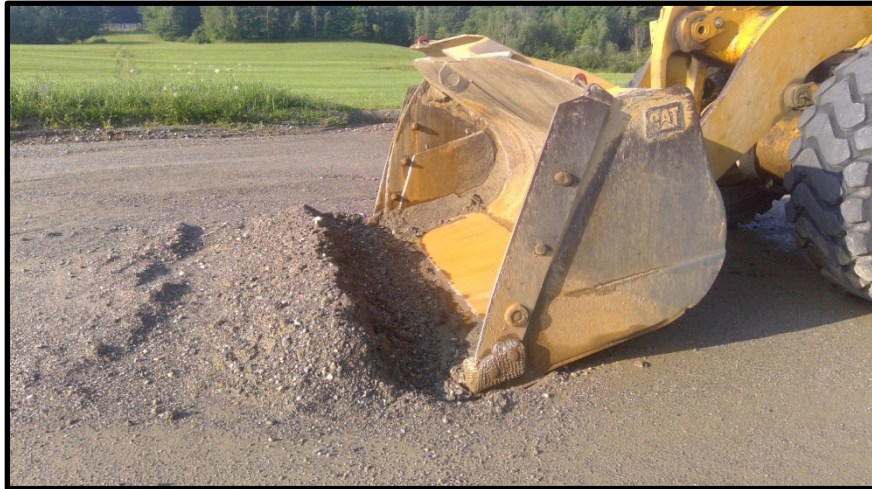
The location where the accident occurred on Meadow Road was wide with no visibility issues. Aside from where the bucket dug into the ground (see Appendix C), the roadway surface was a smooth, well-graded sand and gravel surface, and the slope measured approximately five degrees (see Appendix B). Investigators determined that road conditions were not a factor in the accident.

Root Cause: The accident occurred because the operator inadvertently struck ground with the front-end loader bucket causing the front-end loader to come to an abrupt stop.

Photo of bucket dug into ground

Corrective Action: Mine management reinstructed miners on the provisions of 30 CFR § 56.9101 including providing new instruction on not removing extraneous material from front-end loader buckets when the machine is in motion.

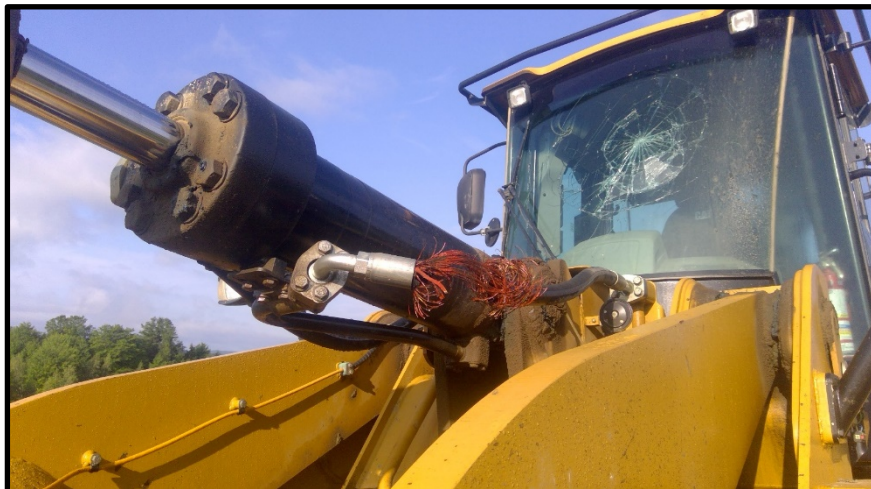
Damage to front window (outside) and hydraulics

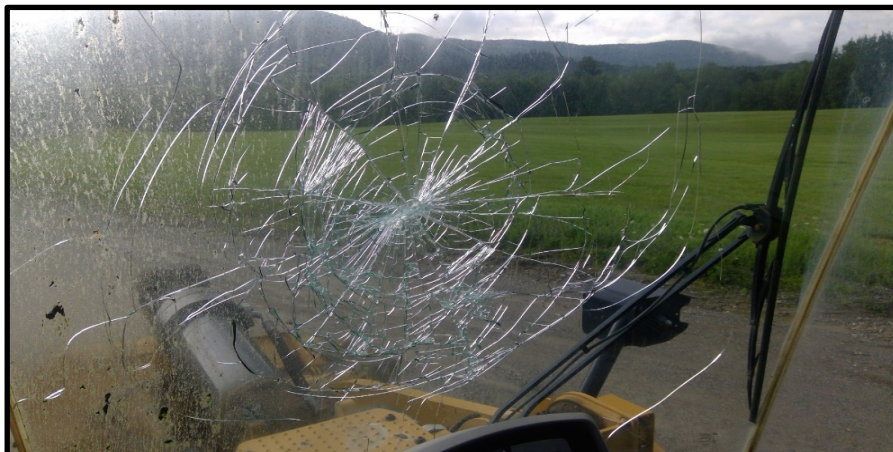
Root Cause: Fatal injuries occurred because the operator of the front-end loader did not wear the required seatbelt supplied in the Caterpillar 966K front-end loader.

Damage to front window (inside)

Corrective Action: Mine management reinstructed miners on their seat belt policy and the provisions of 30 CFR § 56.14130 (g) - Roll-over protective structures (ROPS) and seat belts, including the use of seat belts while operating mobile equipment.
