UNITED STATES
DEPARTMENT OF LABOR
MINE SAFETY AND HEALTH ADMINISTRATION

REPORT OF INVESTIGATION
Surface Nonmetal Mine
(Crushed Limestone)

Fatal Powered Haulage Accident
June 10, 2019

River Road Quarry
Vulcan Construction Materials, LLC
Nashville, Davidson County, TN
ID No. 40-00104

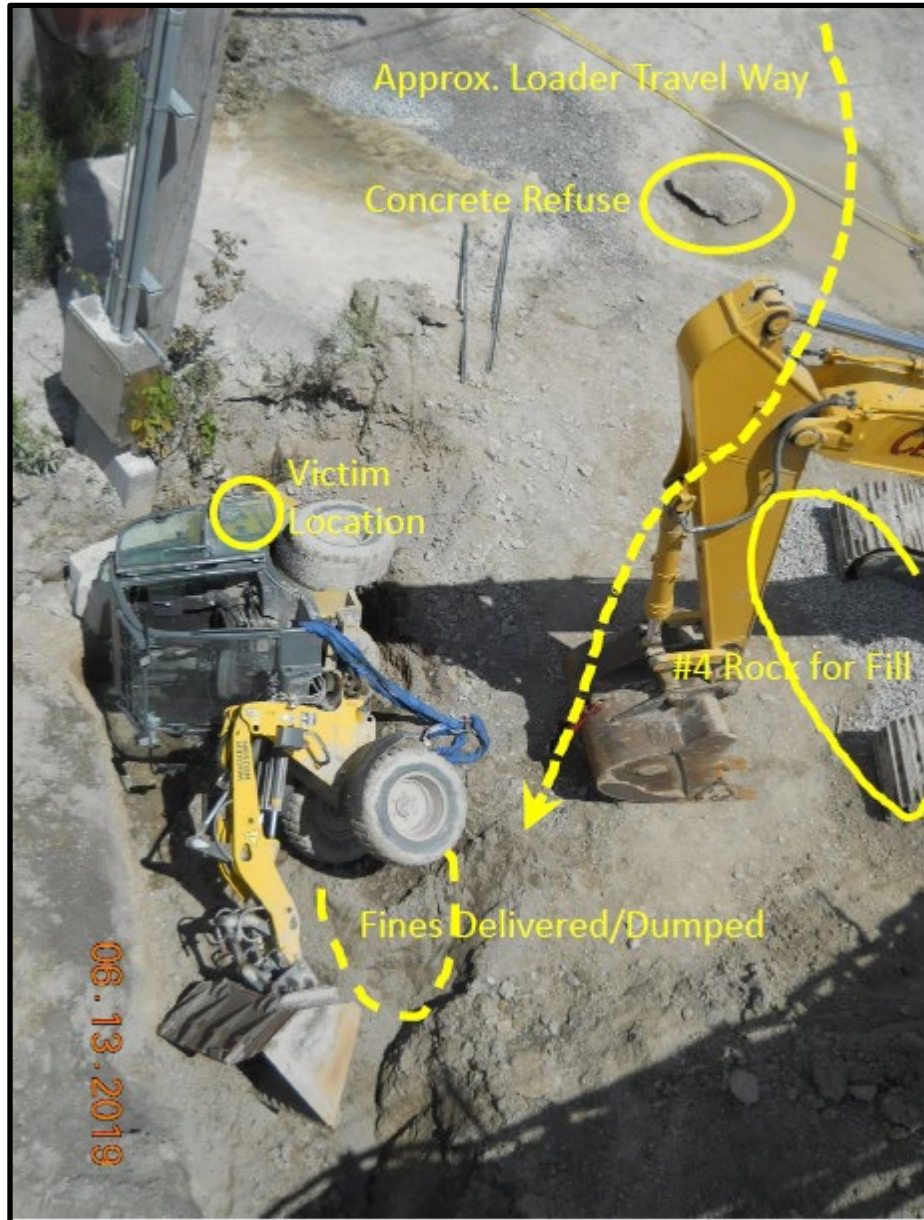
Appendix A – Overhead Photo

had to approach the trench at about a 30-degree angle and then turn to the right, which placed the bucket of the front-end loader parallel to the trench (see Appendix A).

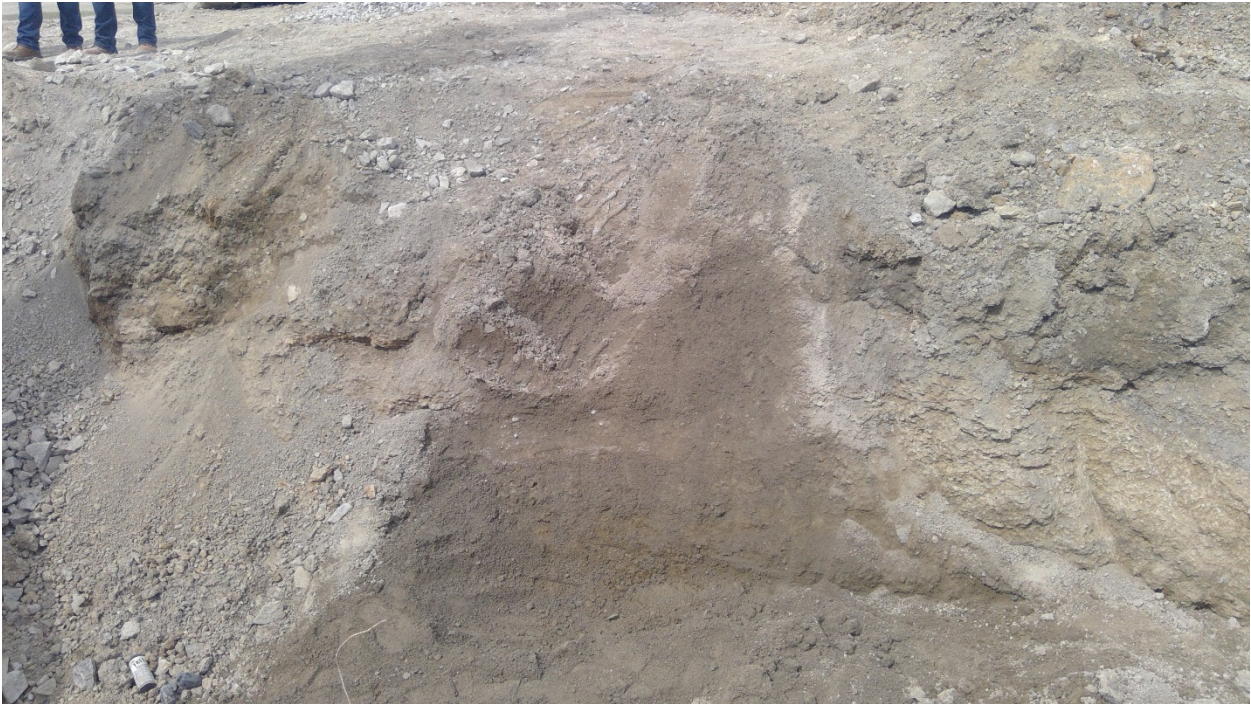
Appendix C – Wall detail

The accident occurred in an area where the operator was building a secondary processing plant. The electrical contractors were preparing to place electrical conduit and a junction box in a trench at the perimeter of the new plant site. The trench was approximately seven-feet wide and ranged from four to six feet deep. The walls were slightly sloped (see Appendix C), and there was a shallow ramp at the head of the trench for access.

Fines removed from wall after front-end loader extracted. No indication the trench wall collapsed. Note: front-end loader tracks indicate wheel was rolling into trench.

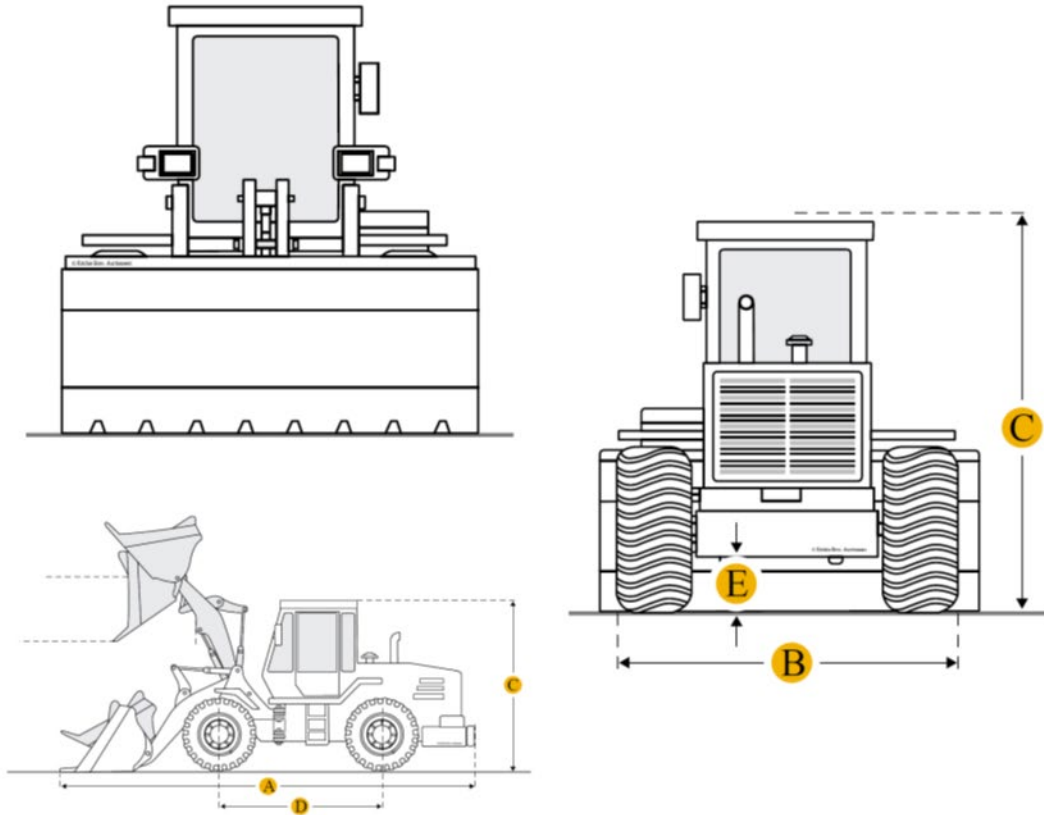
Appendix D – Wacker Neuson WL36 FEL

A Wacker Neuson WL36, front-end loader, Serial #3025335, with a bucket capacity of .8 cubic yards was involved in the accident (see Appendix D). River Road Quarry has only one front-end loader of this model and they have trained multiple miners to operate it. There were no documented mechanical issues with the front-end loader. Maintenance records did not indicate any current or recurring issues. After inspecting pre-operational examination records and conducting interviews, the accident investigators concluded that the mine operator was performing required examinations and there were no reported safety defects or concerns prior to the accident.
