UNITED STATES
DEPARTMENT OF LABOR
MINE SAFETY AND HEALTH ADMINISTRATION

REPORT OF INVESTIGATION

Powered Haulage
June 24, 2019

Northwest Crane Service, LLC. (D581)
at
Dolese Bros. Co.
East Sand Plant
Oklahoma City, Oklahoma
ID No. 34-02056

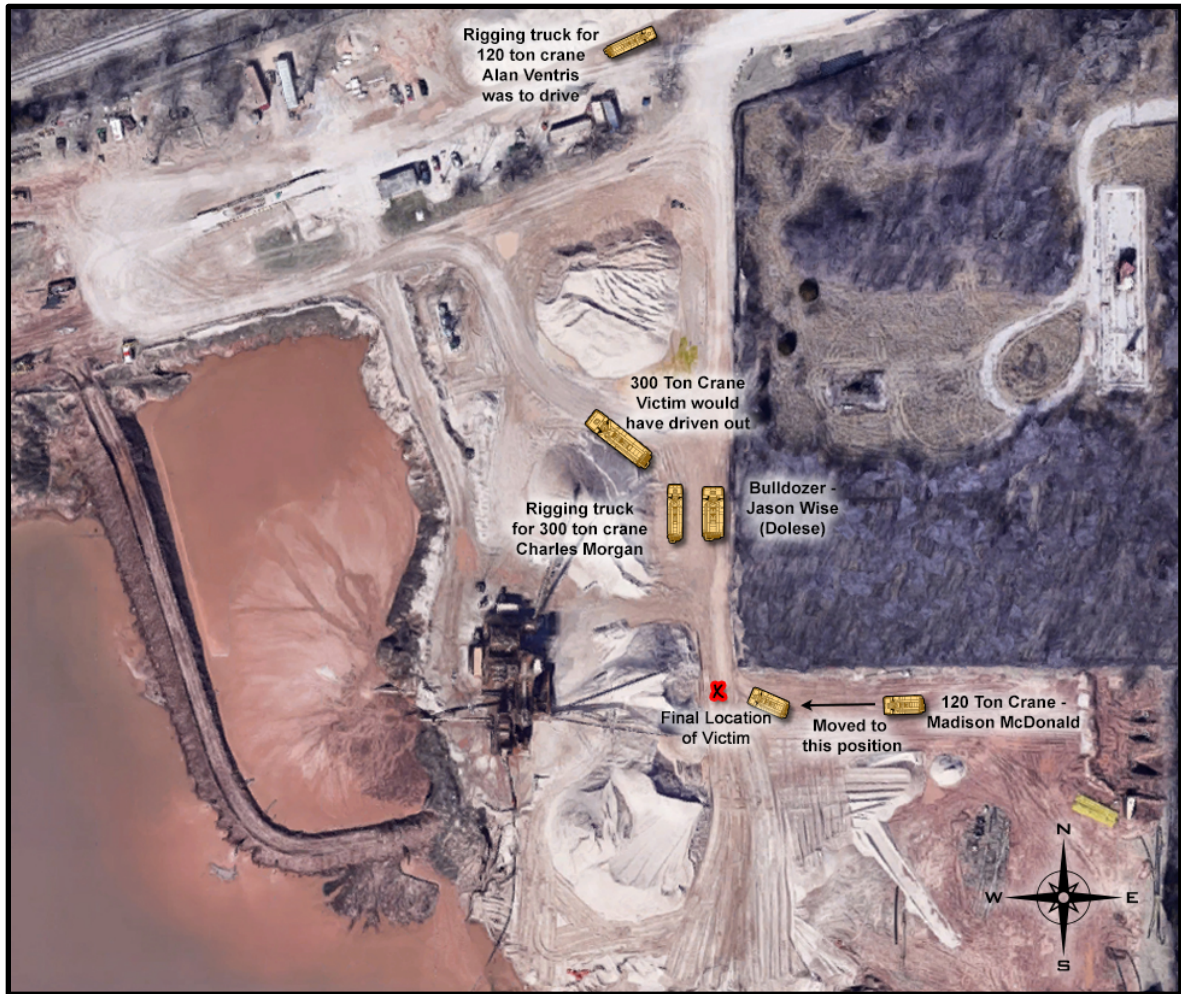
Appendix B Map of the Accident Site

The accident occurred on the East access road to the lake/dredge pond. See Appendix B for a map with the approximate location of the equipment involved in the accident.

(The map provided in the investigation was enhanced so as to provide more details in the approximate location the equipment involved in the accident)
