REPORT OF INVESTIGATION

**Surface Nonmetal Mine
(Dimensional Granite)**

**Fatal Machinery Accident
May 13, 2019**

**Millstone Quarry
Greene County Quarries, Inc.
Carlton, Oglethorpe County, Georgia
Mine ID No. 09-01109**

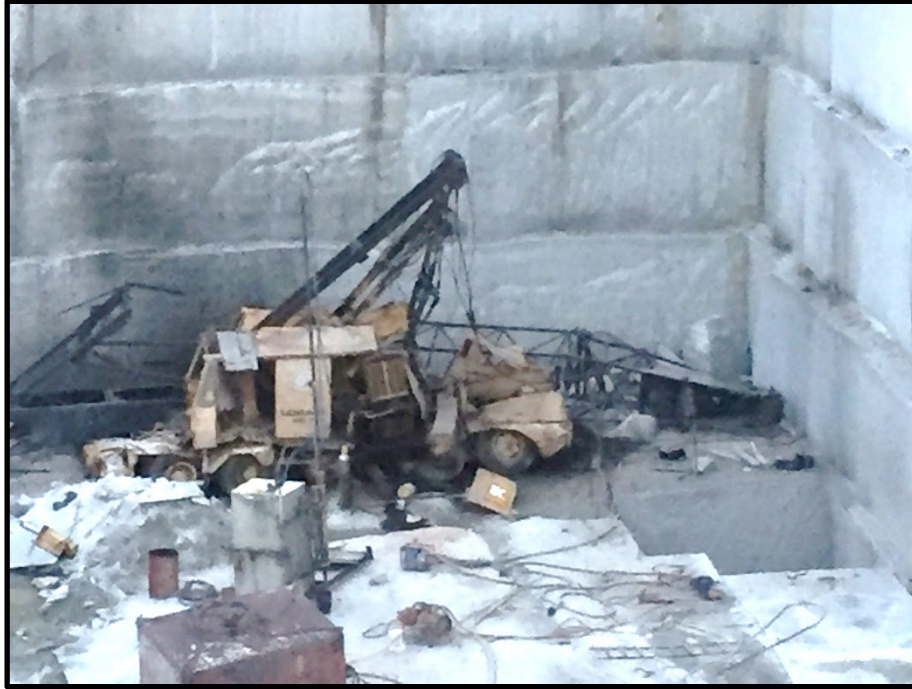
Danny Roth, a 59-year old superintendent with 40 years of mining experience, died on May 13, 2019, at approximately 11:30 a.m. when the 90-ton crane he was operating fell into the quarry. Roth was using the crane to lift a section of granite weighing approximately 15 tons from the quarry when the boom started lowering. This caused the crane to tip over and fall approximately 80 to 85 feet into the quarry.

The accident occurred because the boom pawl designed to prevent the boom from lowering was either not engaged or did not function properly.
