UNITED STATES
DEPARTMENT OF LABOR
MINE SAFETY AND HEALTH ADMINISTRATION

REPORT OF INVESTIGATION

Powered Haulage
May 18, 2019

Rogers Group Inc.
West Amarillo Sand & Gravel
Vega, Texas
ID No. 41-04358

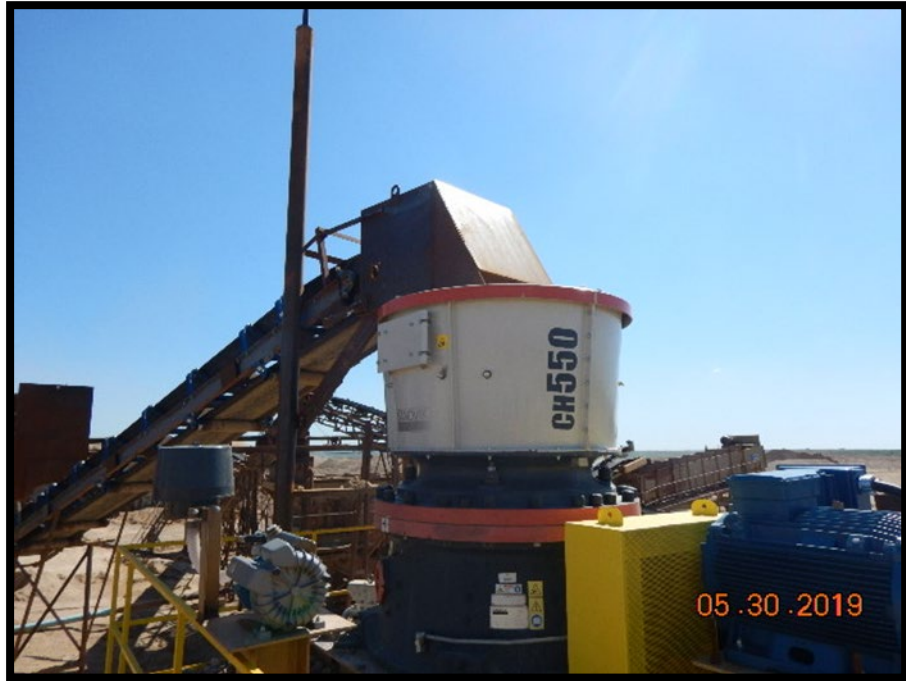
APPENDIX B
Cone Crusher
Sandvik CH550

The cone crusher is a Sandvik Model # CH550, Serial #0990S15216, with a fabricated feed box between the conveyor and the crusher. The cone crusher is the primary crusher at the main plant. (See Appendix B). West Amarillo installed the cone crusher and a new feed belt between May 2, 2019 and May 5, 2019, and started operating them on May 6, 2019. The mine encountered material flow problems with the feed belt and feed box from the beginning and made several modifications to try to resolve the issues. When a stoppage occurred, miners accessed the feed box from above by using a personnel lift, or from the crusher platform below, using a steel pry bar to break the stoppage loose.

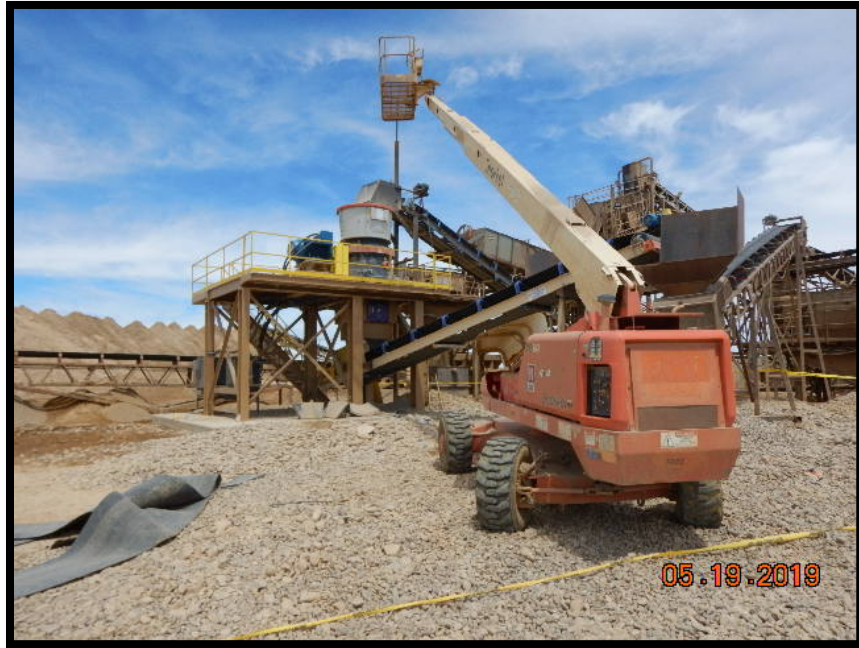
APPENDIX C
Personnel Lift
Snorkel Model # TB-60D7

The personnel lift is a Snorkel Model # TB-60D7, Serial # MY07112 (See Appendix C). At the time of the accident, the bottom of the basket was 28 feet above the ground. The boom was extended to a length of 37 feet, 2 inches, measured from the rear boom pin to the basket pin.

The basket’s torque plate was found to be damaged which caused the basket to move laterally, uncontrolled by the operator. The investigation team could not determine if the damage to the torque plate was the result of the bottom of the basket contacting a dowel pin on top of the cone crusher. Based on witness accounts, Ramirez was tramping the personnel lift away from the cone crusher structure just prior to the accident. Witnesses said the basket appeared to bounce up and down and the victim cartwheeled over the edge of the basket. The terrain, speed, damage

to the torque plate, and the boom arm extended 37 feet were factors causing the basket to move in an uncontrolled manner.

West Amarillo's policy states that fall protection must be used where required and the user must be properly tied off in all applicable situations. Ramirez had been trained on this policy. Although the policy did not specifically address tie off procedures in a personnel lift basket, the basket had a label warning equipment operators to wear fall protection at all times. The victim was wearing a fall protection harness and a six foot retractable lanyard, but the lanyard was not tied off at the time of the accident.

Corrective Action: The mine operator retrained plant operators and plant maintenance personnel on the requirement of wearing fall protection and their "working at heights policy" to include the requirement to tie off while using a personnel lift.
