UNITED STATES
DEPARTMENT OF LABOR
MINE SAFETY AND HEALTH ADMINISTRATION

REPORT OF INVESTIGATION

Fatal Machinery Accident
November 16, 2019

Caney Creek Limestone, LLC. (C0242)

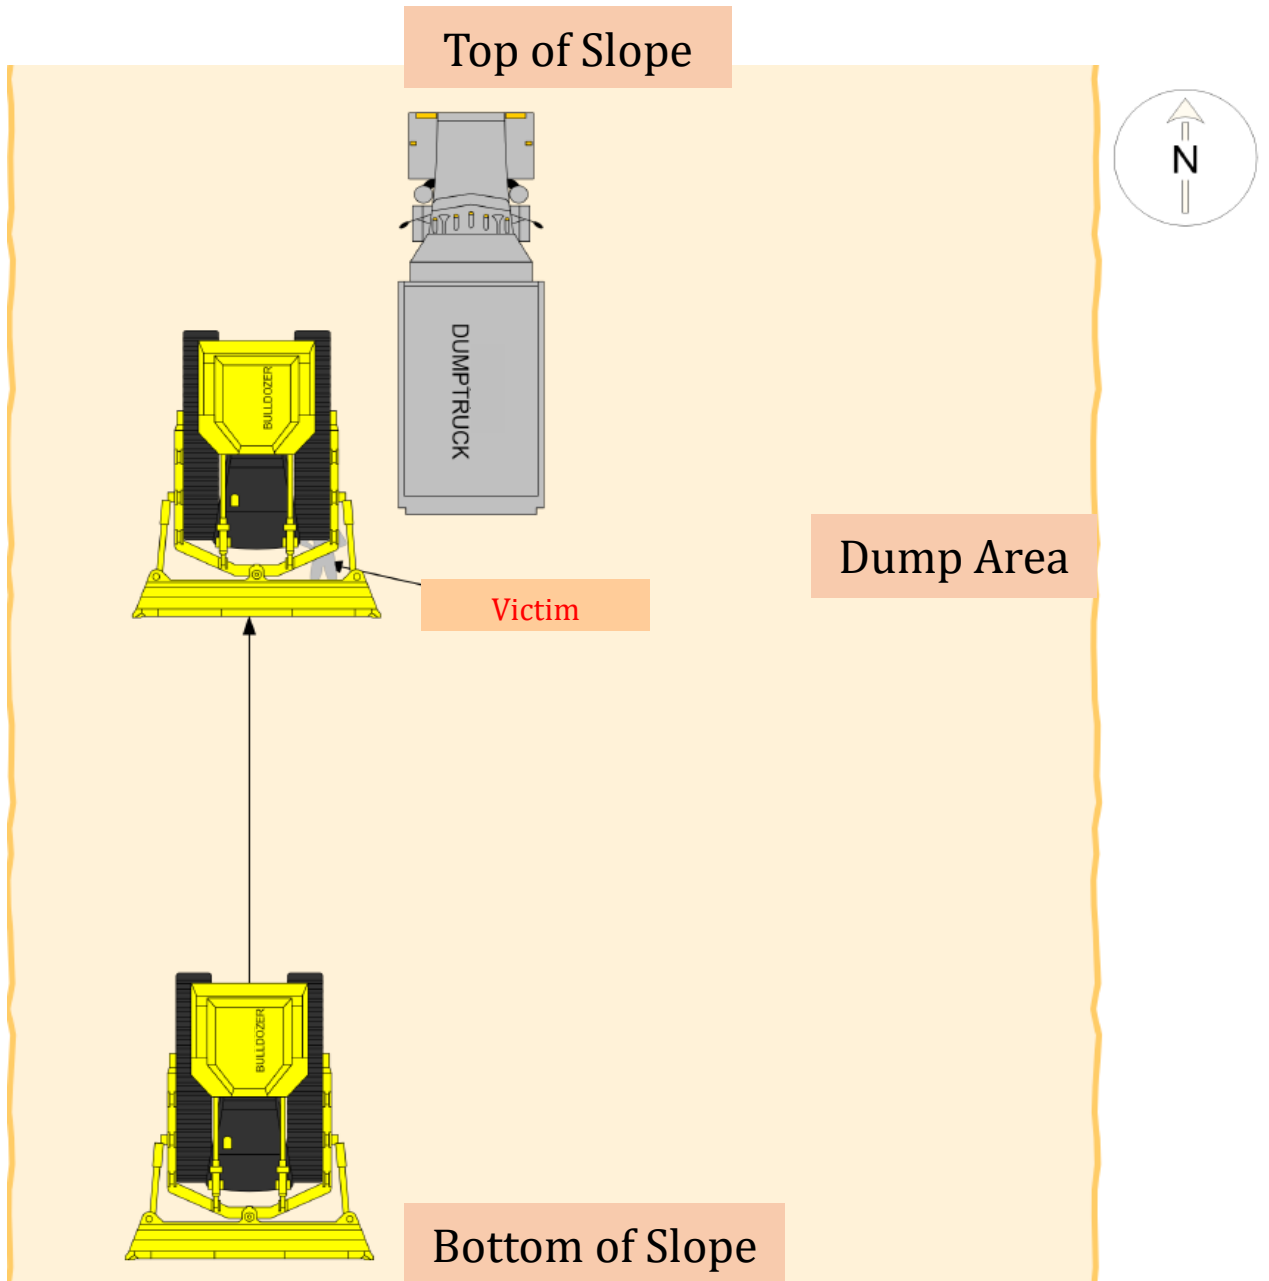
Appendix B
Map of the Accident Site
(Approximate location of the equipment involved in the accident)

The accident occurred on the South Slope of the #5 Impoundment. See Appendix B for a diagram with the approximate location of the equipment involved in the accident.

mechanical deficiencies or safety defects that would have caused the accident. Investigators determined that the slope of the impoundment limited the bulldozer operator's vision out the back window while backing up the slope. This would have attributed to the bulldozer operator's inability to see the victim.
