UNITED STATES
DEPARTMENT OF LABOR
MINE SAFETY AND HEALTH ADMINISTRATION

REPORT OF INVESTIGATION

Fatal Machinery
August 18, 2020

HJ Hove
Hi-Grade Materials Co.
Robar Enterprises Inc
Indio, Riverside County, California
I.D. No. 04-01854

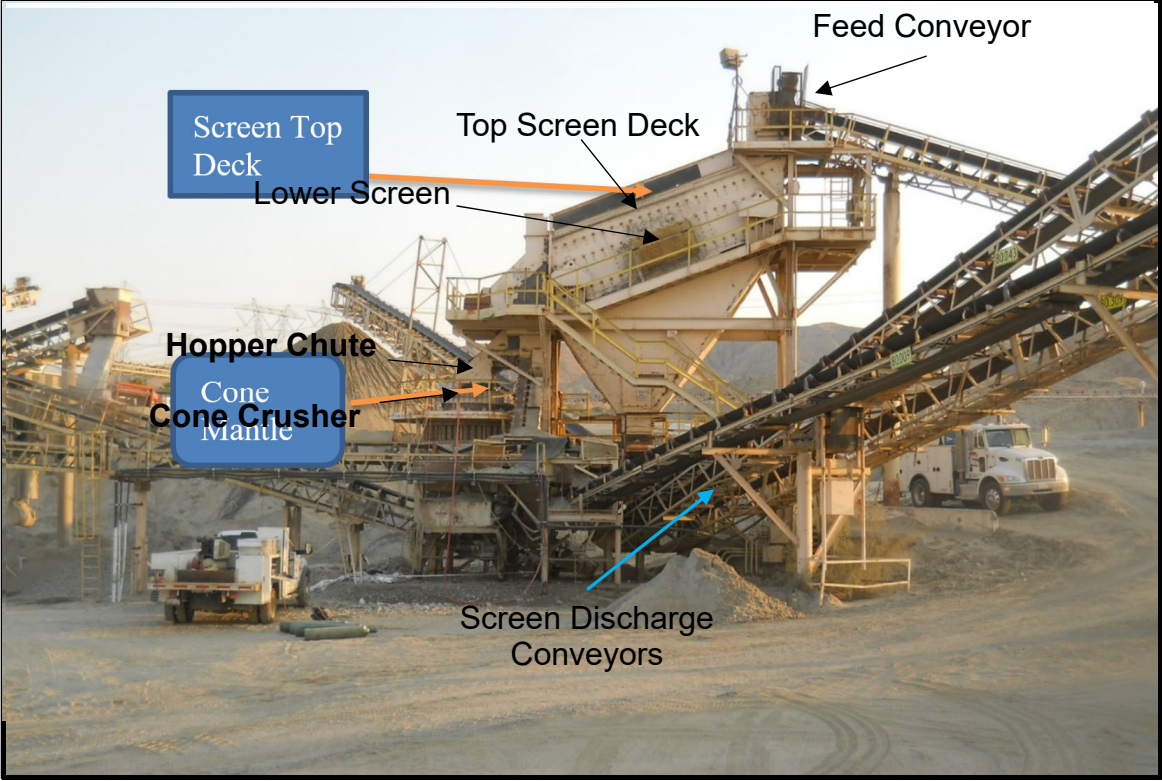
Appendix B
Side View of Plant

The accident occurred at the cone crusher, located roughly in the center of the plant near the stockpiles (see Appendix B).

Side view of the plant. The feed hopper had an estimated 12 ft. vertical drop from the top screen deck to cone crusher.

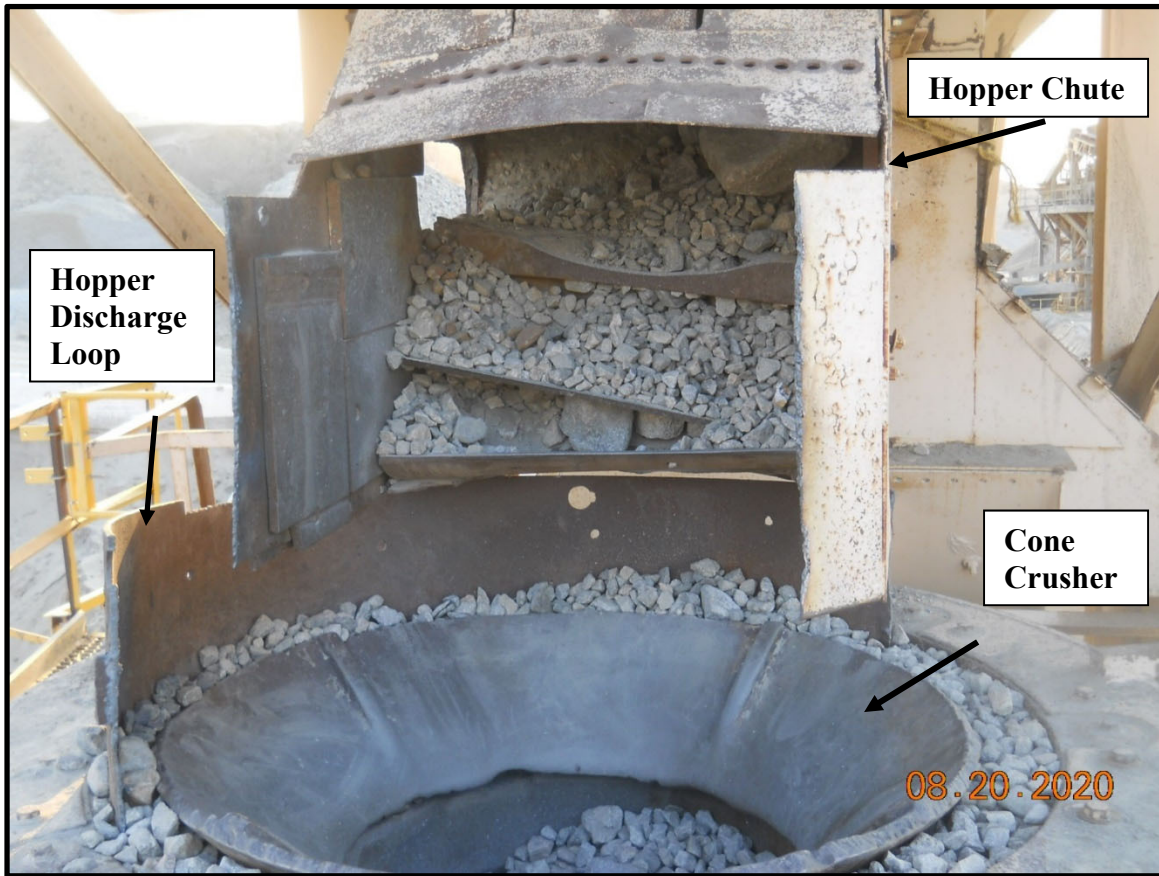
Appendix C
Scene of the Accident

A feed conveyor transports un-sized rock to a two-deck, TelSmith vibrating screen. The screen separates the rock into specific sizes. The top screen separates large rock, which moves through a hopper chute to the TelSmith D-style 66S cone crusher (see Appendix C). The bottom screen allows smaller sized rock to move through and drop onto conveyors for stockpiling. Prior blockages of material flow in the hopper chute and cone crusher had occurred frequently.

2. Root Cause: Mine management was aware of frequent material blockages in the hopper chute and cone crusher, and did not develop or implement measures to prevent blockages, nor did mine management provide safe points of access or safe procedures for clearing blockages when they occurred.

Part of the hopper discharge loop was removed during rescue operations.

Corrective Action: Hi-Grade Materials Co. analyzed the material flow through the hopper chute and cone crusher and made adjustments to allow the material to flow more freely. The company also modified access to the cone crusher to allow safe removal of blockages and has provided tools and PPE for use in such instances. The mine operator has trained all miners on the modified process, tools, and PPE.
