REPORT OF INVESTIGATION

Surface Mine
(Construction Sand and Gravel)

Fatal Machinery Accident
August 26, 2020

Portable 1
Chilton Logging Inc.
Woodland, Cowlitz County, Washington
Mine I.D. No. 45-03806

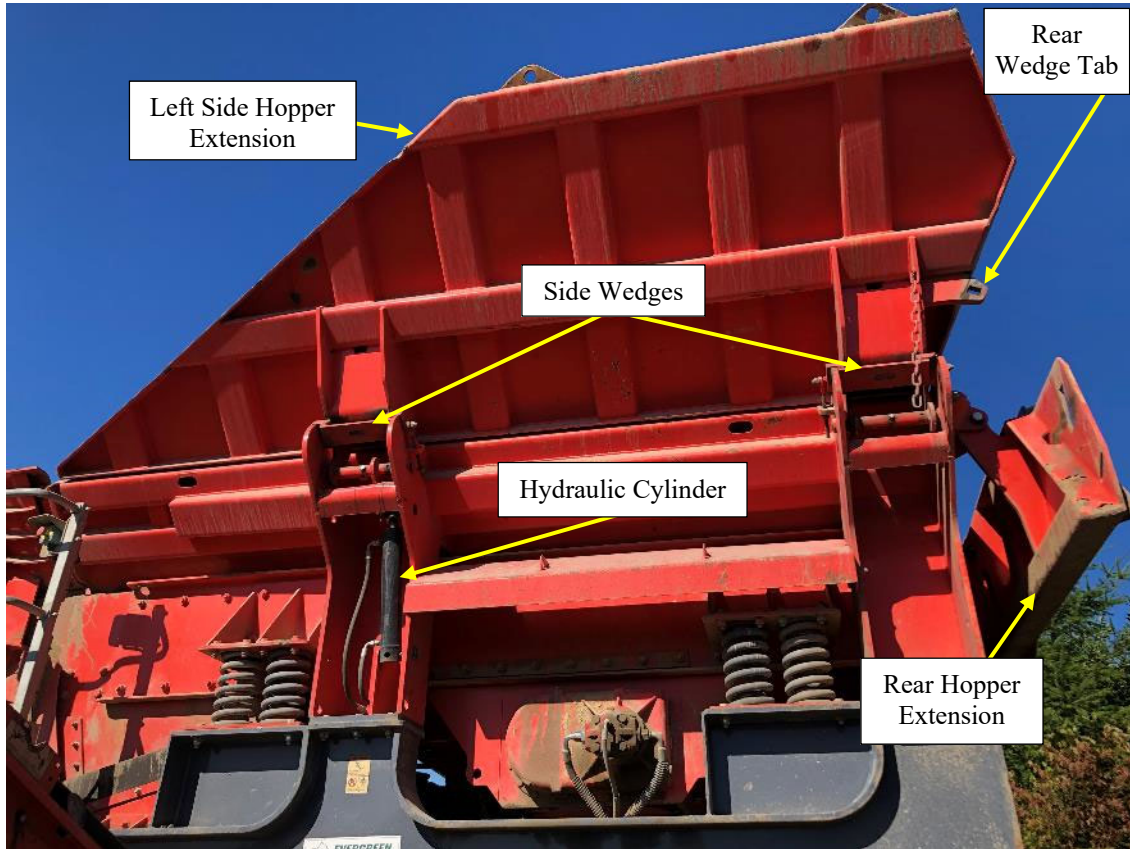
APPENDIX A
Photograph of Hydraulic Cylinder and Side Wedges

On August 26, 2020, Skillett and Craig Buck, Equipment Operator, arrived at the mine site at 5:00 a.m. and began the process of moving the Terex-Finlay jaw crusher and other equipment to another mine site. After some preparation and maintenance work, the miners were ready to lower the left side, right side, and rear hopper extensions on the jaw crusher. The miners removed both rear wedges that held the rear hopper extension in the raised position and used the hydraulic control levers to lower it. Next, the miners intended to lower the right side hopper extension, which was held in the raised position by two side wedges. These wedges were too high for the miners to reach, so Buck moved a Caterpillar hydraulic excavator adjacent to the jaw crusher for use as an access platform. Buck then positioned himself near the hydraulic control levers that raise and lower the right side hopper extension while Skillett positioned himself on top of the engine compartment of the hydraulic excavator. Skillett removed one side wedge from the right side hopper extension and used a 16-pound hammer to remove the second side wedge, when the right side hopper extension suddenly fell onto him (see Appendix A).

Photograph of the Left Side Hopper Extension in the Raised Position and the rear hopper extension in the lowered position. Note the location of the side wedges and hydraulic cylinder.

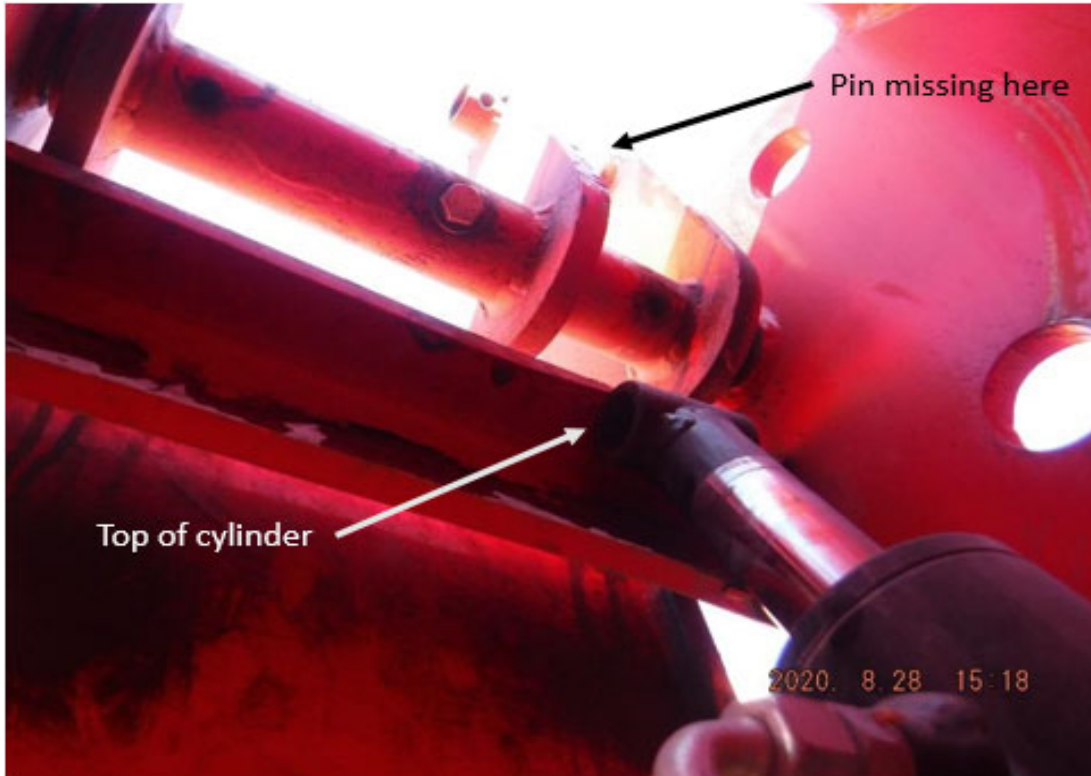
Photograph of Disconnected Hydraulic Cylinder

On the day of the accident, a hydraulic cylinder was not attached to the right side hopper extension. A metal wrist pin, which normally holds these components together, was missing (see Appendix C). Therefore, when Skillett removed the second of the two side wedges from the right side hopper extension, the hydraulic cylinder did not hold the hopper extension in the raised position. Instead, the right side hopper extension fell onto Skillett, crushing him against the top of the hydraulic excavator.

On August 26, 2020, a crusher foreman was attempting to lower the right side hopper extension to prepare the Terex-Finlay J-1175 mobile jaw crusher for transport. In part, because the metal wrist pin for the hydraulic cylinder on the right side hopper extension was not in place and because the right side hopper extension was not blocked to prevent accidental lowering, the hopper extension fell on the crusher foreman when he removed the last supporting side wedge, causing a fatal injury. The crusher foreman engaged in aggravated conduct constituting more than ordinary negligence in that he did not follow the operator's manual, which would have provided a means to block or mechanically secure the hopper extension to keep it from falling. This violation is an unwarrantable failure to comply with a mandatory standard.

Photograph of the hydraulic cylinder connection for the right side hopper extension. The metal wrist pin was missing and the top of the hydraulic cylinder was not connected to the right side hopper extension at the location labelled “Pin missing here.”

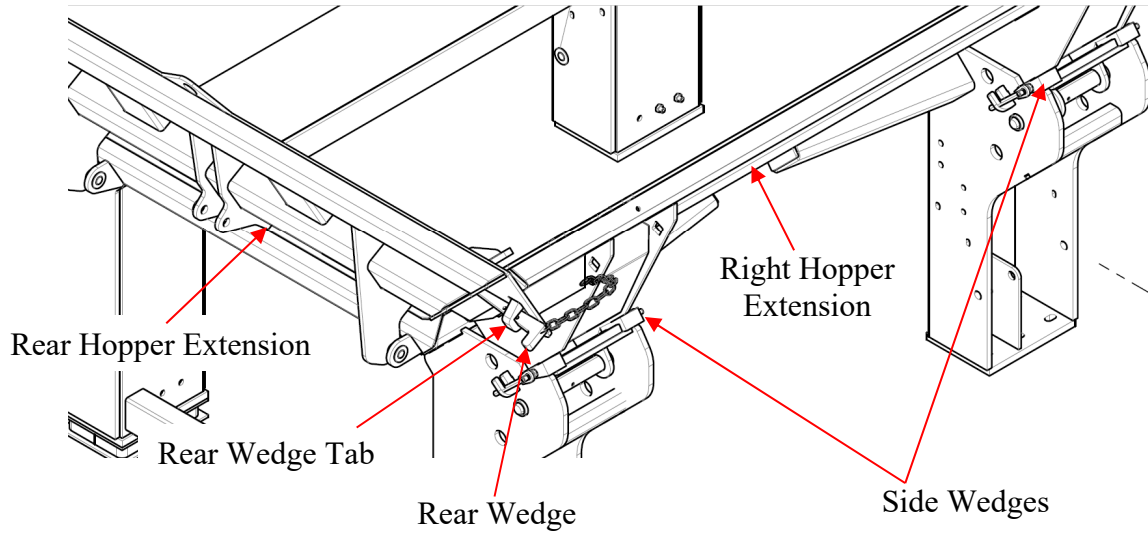
APPENDIX D
Rear and Side Wedge Locations

Diagram of the rear and side wedge locations. This view shows the rear and right side of the hopper. The rear wedges hold the rear and side hopper extensions together via the rear wedge tab. The side wedges secure the hopper extensions in the raised position during operation. If the rear wedge tabs are inserted through the openings in the rear hopper extension (right side shown), the left and right hopper extensions are mechanically locked in place and blocked against motion.
