REPORT OF INVESTIGATION

Surface
(Sand and Gravel)

Fatal Handling Material Accident
February 27, 2020

Patterson Road Mine
Michigan Materials and Aggregates Company
Middleville, Allegan County, Michigan
Mine ID No. 20-02995

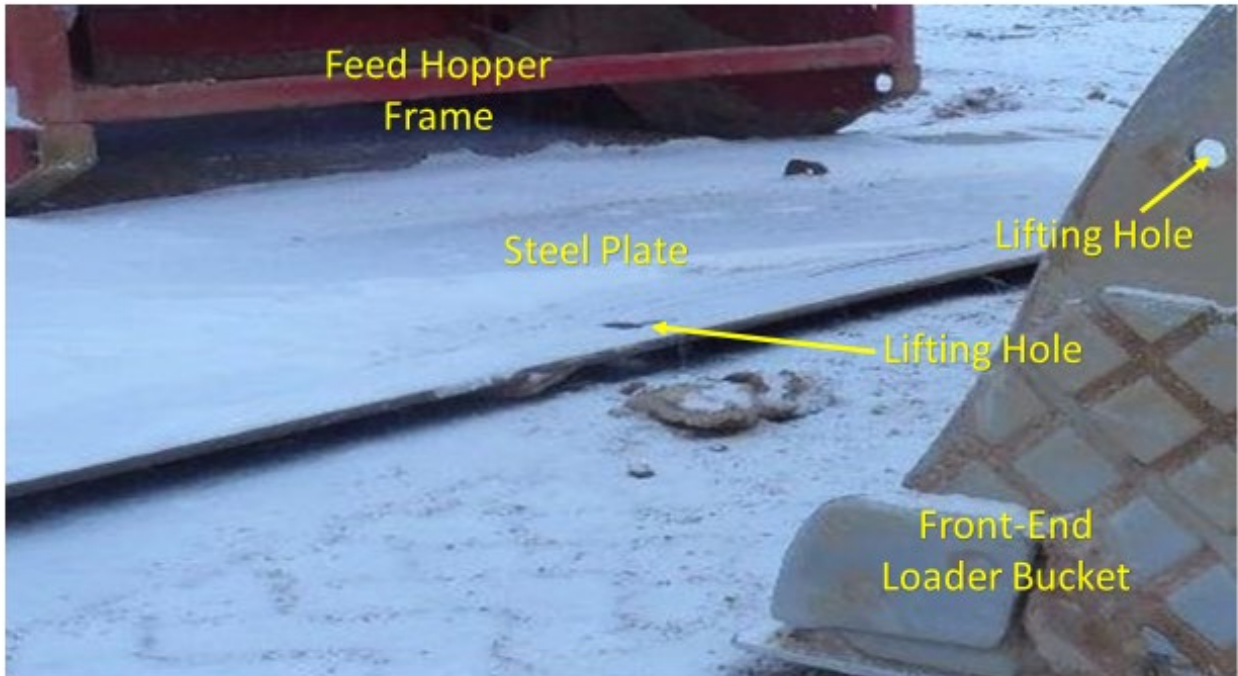
Appendix A
Photograph of Feed Hopper Frame and Lifting Holes

Miners used lift rigging to attach the steel plate to the bucket of the front-end loader. The lift rigging consisted of two double chain slings with grab hooks on each end and clevis anchor shackles. The miners installed the clevis anchor shackles through holes located in both sides of the front-end loader bucket (see Appendix A). Baughman and Branham inserted grab hooks through two three-inch diameter holes in the steel plate. The grab hooks were connected to chains that were shackled to clevis anchors.

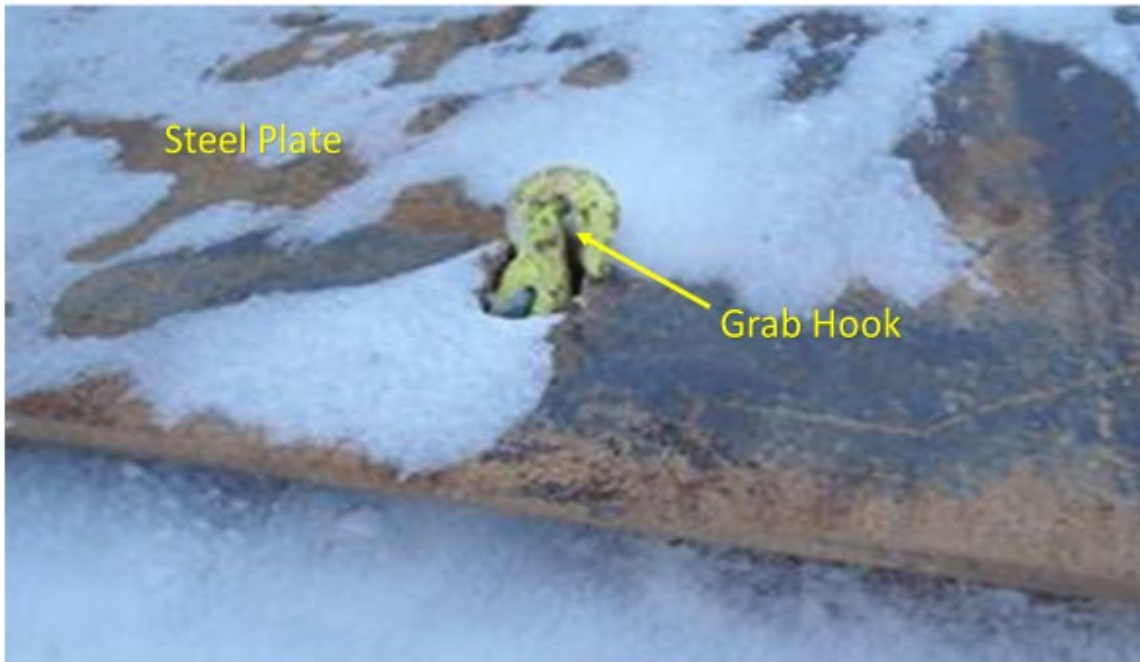
Appendix B
Photograph of Steel Plate and Grab Hook in the Lifting Hole

After the rigging was removed, Green drove the Caterpillar front-end loader from the area to load a customer's truck. Branham removed the grab hook and chain from the south side of the steel plate. The victim attempted to remove the rigging from the north side of the steel plate; however, the grab hook was stuck in the lifting hole (see Appendix B). The victim motioned to Wenger to lower the forks. Wenger lowered the forks and the victim stepped up onto the forks so he could reach and dislodge the grab hook from the lifting hole. The steel plate tipped over onto the victim pinning him between the fork and the plate.

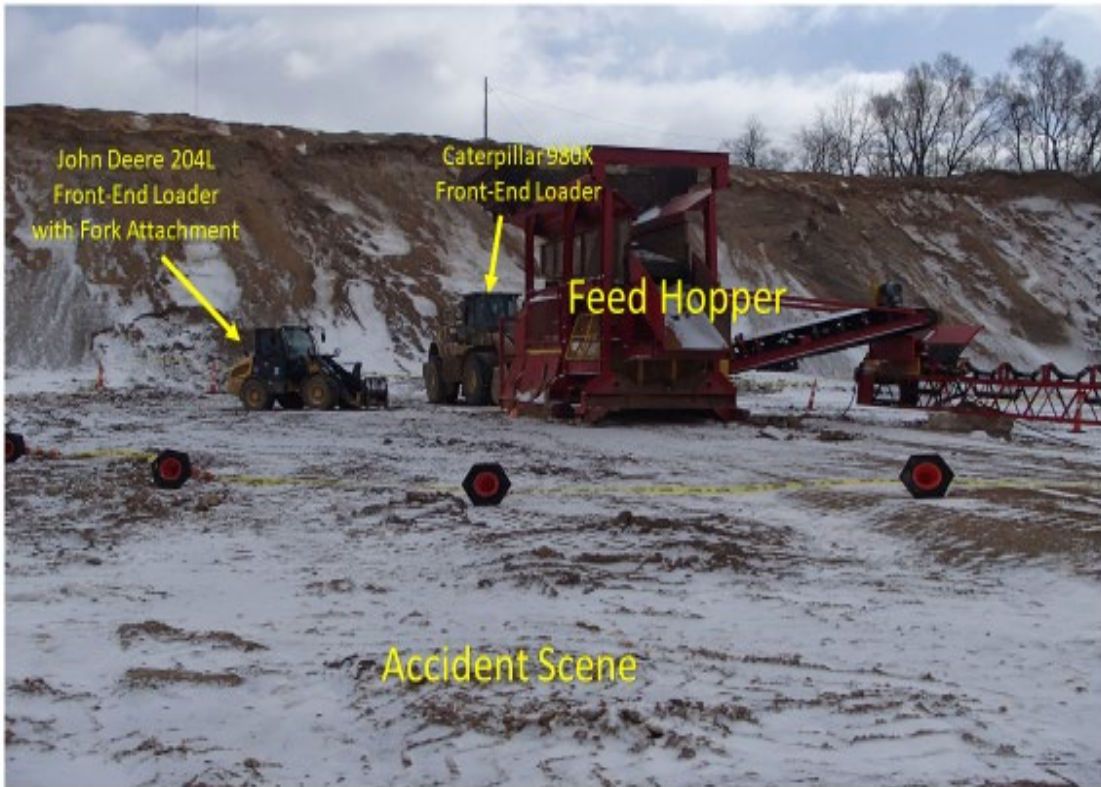
Appendix D
Photograph of Accident Scene

The accident occurred at the feed end (east side) of a Deister Machine Company feed hopper, which was located on the east side of the Patterson Road pit (see Appendix D). The steel plate measured 98 inches by 240 inches by 1-inch thick, and weighed approximately 6,800 pounds.

The weather at the time of the accident was 21 degrees with a 16 mph wind from the west. Cold, dry weather conditions created hard packed and frozen ground in the immediate area of the hopper at the time of the accident. Investigators believe that weather may have been one of the factors contributing to the accident as the wind was blowing in the same direction the steel plate tipped over.

Root Cause: The mine operator's feed ramp construction procedure did not explicitly require that the steel plate be securely fastened to the frame of the feed hopper prior to persons removing rigging, or prevent miners from working near an unsecured load.

Corrective Action: The mine operator revised the procedure and put it in writing. The written procedure ensures that the steel plate is fastened to the frame of the feed hopper before unhooking the rigging from the loader and steel plate. The mine operator trained miners on the new procedure.
