REPORT OF INVESTIGATION

Fatal Fall of Person Accident
January 23, 2020

Tehachapi Plant
Lehigh Southwest Cement
Tehachapi, Kern County, California
Mine ID No. 04-00196

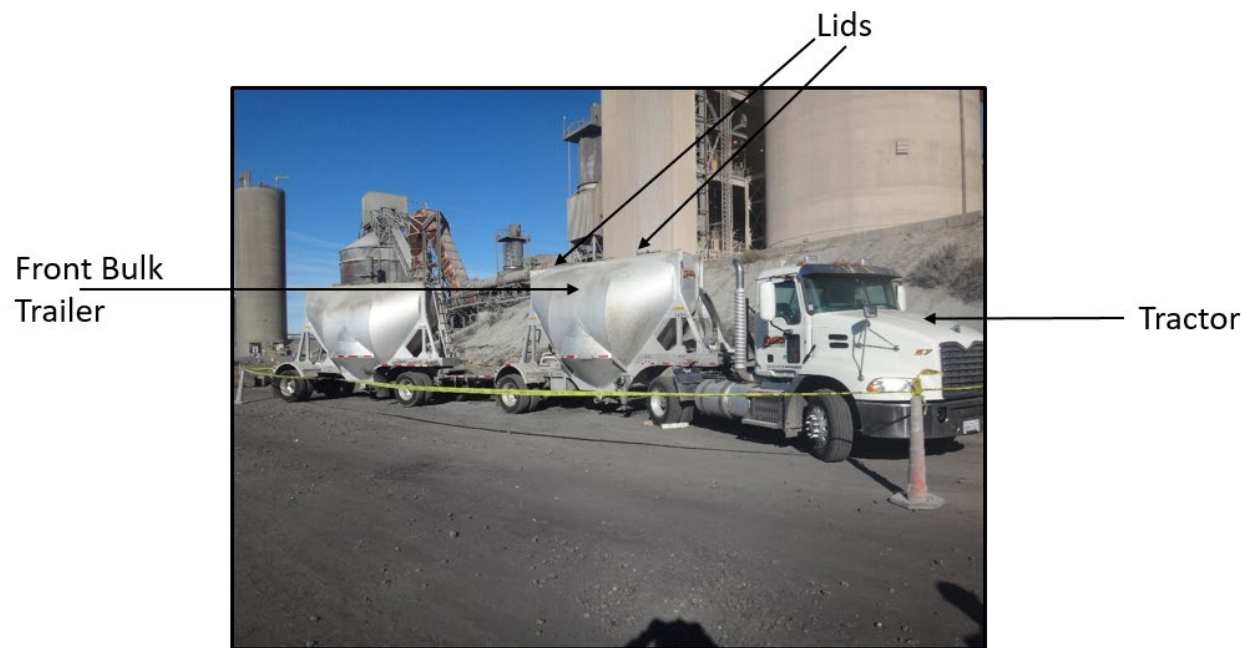
On January 23, 2020, Timothy A. Fortier started work at 5:04 a.m. driving his tractor-trailer, which comprised two bulk trailers (see Appendix A: Figure 1), to deliver a load of fly ash to South Valley Materials located in Hanford, California. After making the delivery, he drove to the Tehachapi Plant and arrived at 1:17 p.m. Fortier positioned his tractor-trailer on the south side of Tehachapi Plant's east truck racks. The truck drivers entering the Tehachapi Plant use the east truck racks to access and open the lids on top of the bulk trailers and then travel to cement silos for loading. After the bulk trailers are loaded with cement, the drivers move the vehicles to the south side truck racks to access and close the bulk trailer lids.

The victim's tractor was a model 2018 Mack. At the time of the accident, there were two J & L bulk trailers in tow. The bulk trailer immediately behind the tractor was a single axle semi-trailer with an unloaded weight of 4,920 pounds. The rear bulk trailer was a double axle full trailer with an unloaded weight of 6,500 pounds. Both trailers were model year 1999. The inspector examined the tractor-trailer and noted that two of the lid latches had been unscrewed

and there were scuffmarks on the driver's side of the front bulk trailer coming down from the lid. There were no apparent mechanical issues found on the tractor-trailer.

Figure 1: Bulk Trailer and Truck involved in accident

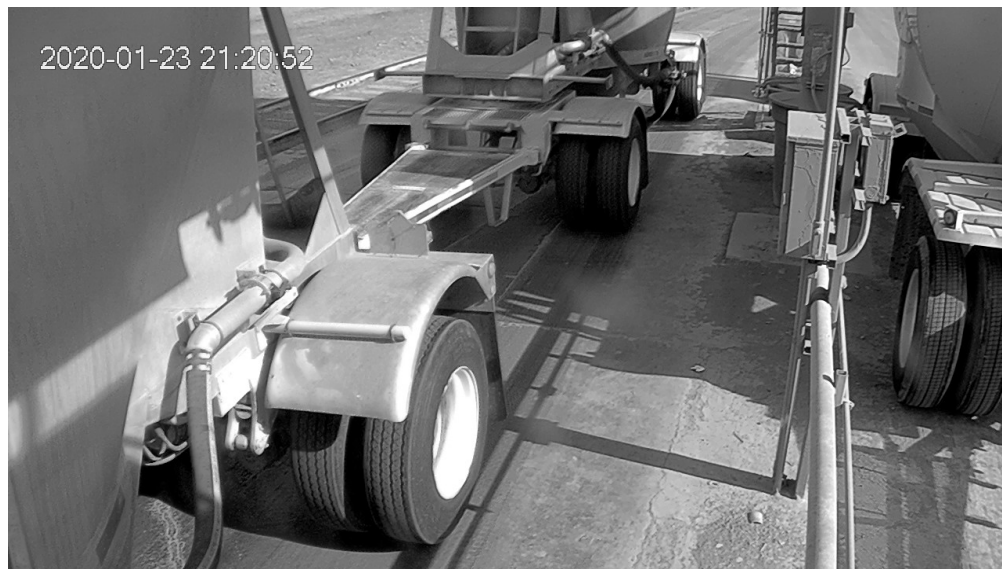
MSHA investigators determined through photographs and interviews with mine management, miners and customer truck drivers that when Fortier pulled into the east truck racks, he parked his truck so the rear bulk trailer's right front fender was within one foot of the truck rack (see Appendix A: Figure 2).

Based on photos, and substantiated by interviews with other drivers, the victim's tractor-trailer was too close to the truck rack frame for the gangway ramp and Safe-T Cage to properly align with the lid. The Safe-T Cage hit the passenger side of the bulk trailer and did not effectively seal the lid area on top of the bulk trailer, creating an approximate two to two-and-a-half-foot gap between the Safe T Cage railing and the bulk trailer, through which a person could fall. The victim fell approximately 12 feet from the top of the bulk trailer to the concrete pad below. The company did not institute adequate policies, procedures, or equipment to assure proper alignment of trucks when using the Safe-T Cages to open or close the lids. The only instruction was a manufacturer's instruction placard posted at the stairs to the truck rack (see Appendix E).

The gap was the result of the tractor-trailer not being correctly aligned with the center of the truck racks. The bulk trailer's location was noted from the under truck rack cameras view that shows the bulk trailer was approximately three (3) feet off center. With the bulk trailer three (3) feet too close to the racks, a gap between the gangway ramp with Safe-T Cage and the driver's side top surface of the bulk trailer is created where miners can fall through. While there is an operating diagram located at the steps leading up to the top of the truck racks, which describes how to align the bulk trailer with the gangway ramp with Safe-T Cage, there is no means for drivers to correctly align their units with the Safe-T Cage as they pull their units under the truck rack.

Figure 2: Victim's truck (right side) location at the time of the accident

Corrective Action: Management installed bumpers to help align the trucks as they entered the truck ramps. Management has developed and provided training to drivers on their new policies and procedures for proper alignment of bulk trailers with the gangway ramp and Safe-T Cage.

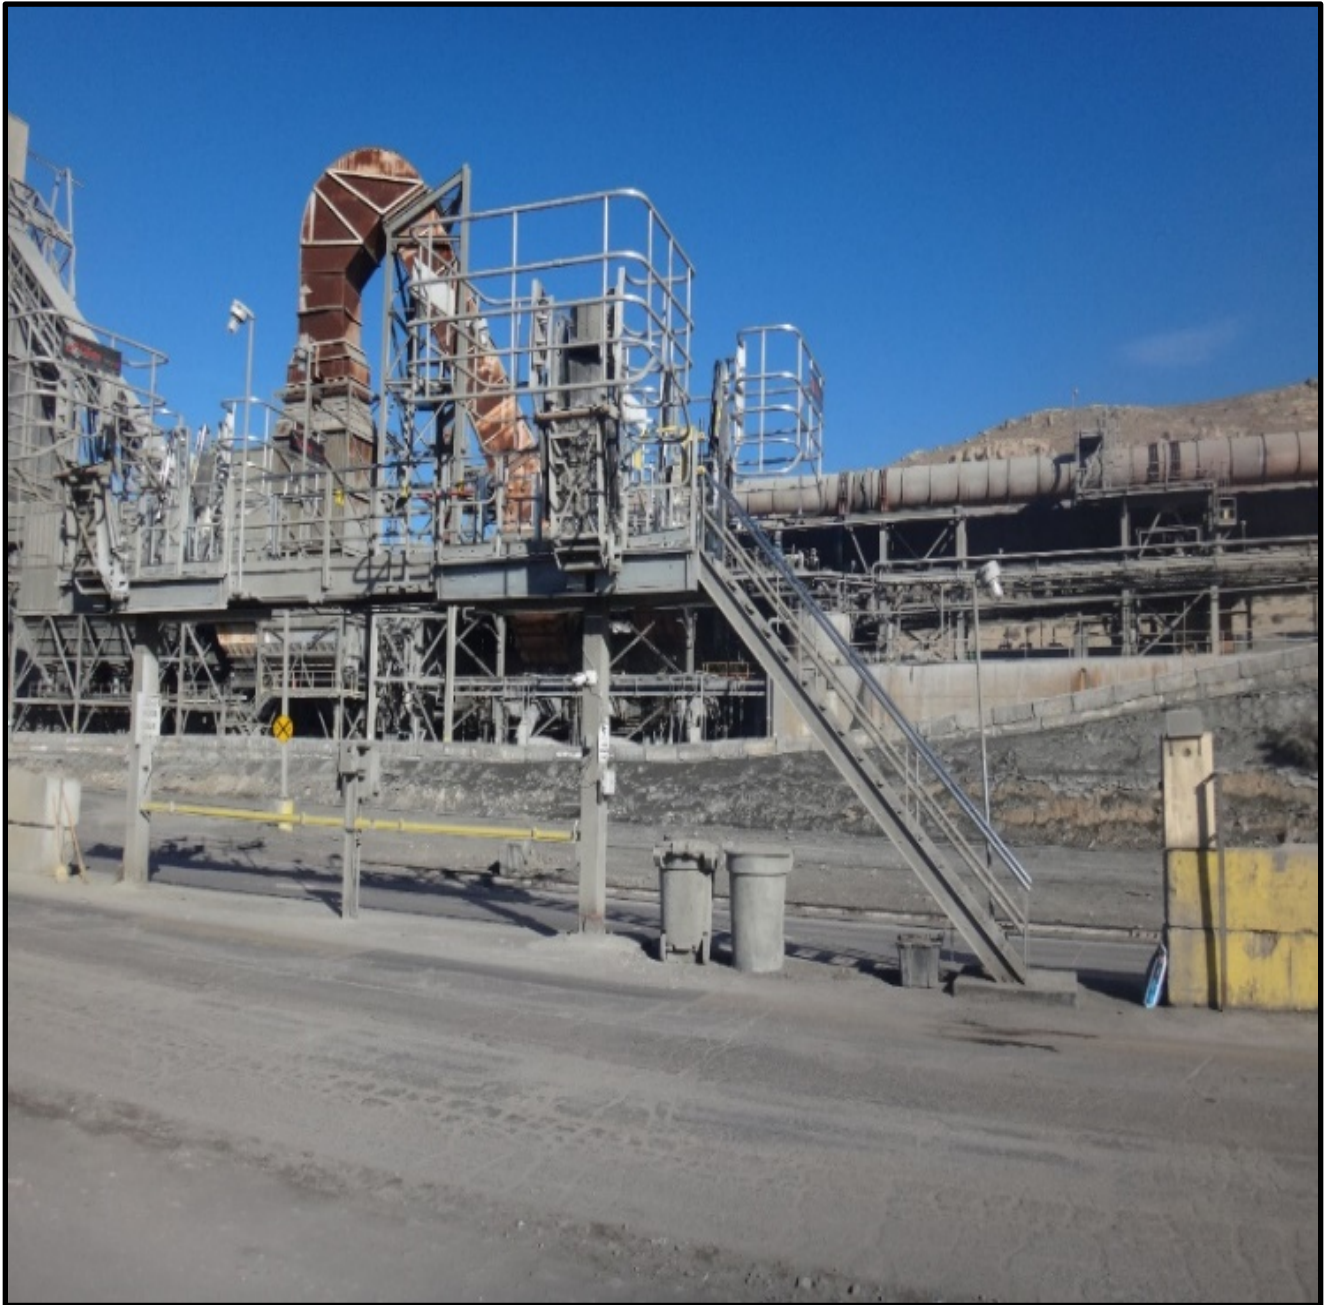
APPENDIX C
East-side truck racks with Carbis Gangway Ramps and Safe-T Cages

The accident occurred at the south entrance of Tehachapi Plant's east-side truck racks (see Appendix C).

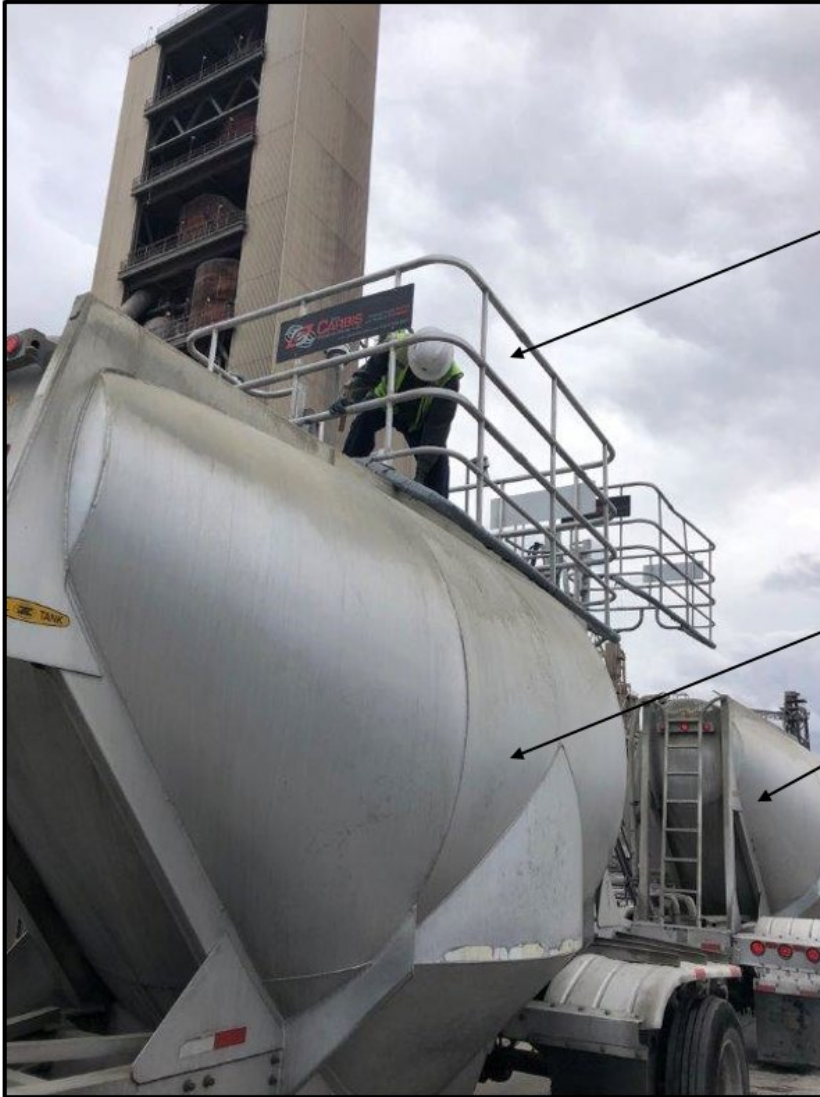
APPENDIX D
Proper Alignment of Safe-T Cage
(East Truck Racks)

The company installed Carbis model CI-TCG 2000 gangway ramps with Safe-T Cages (see Appendix D) to provide access to the top of bulk trailers. Truck drivers park their bulk trailers underneath a truck rack. Truck drivers then exit the truck, climb stairs to a platform, and lower a gangway ramp with an attached Safe-T Cage. A properly aligned Safe-T Cage sits on top of the bulk trailer around the lid, providing a secure work platform for the driver to access the lid. From this position, truck drivers open the lids so bulk trailers can be loaded. Also from this position, drivers close the lids after the bulk trailer is loaded. For proper alignment of the Safe-T Cage over the lid, a tractor-trailer must be approximately three feet away from the racks.
