REPORT OF INVESTIGATION

Surface Mine
(Construction Sand and Gravel)

Fatal Powered Haulage Accident
July 29, 2020

Gravel Pit
Fox Creek Aggregates
Mountain Grove, Wright County, Missouri
ID No. 23-02361

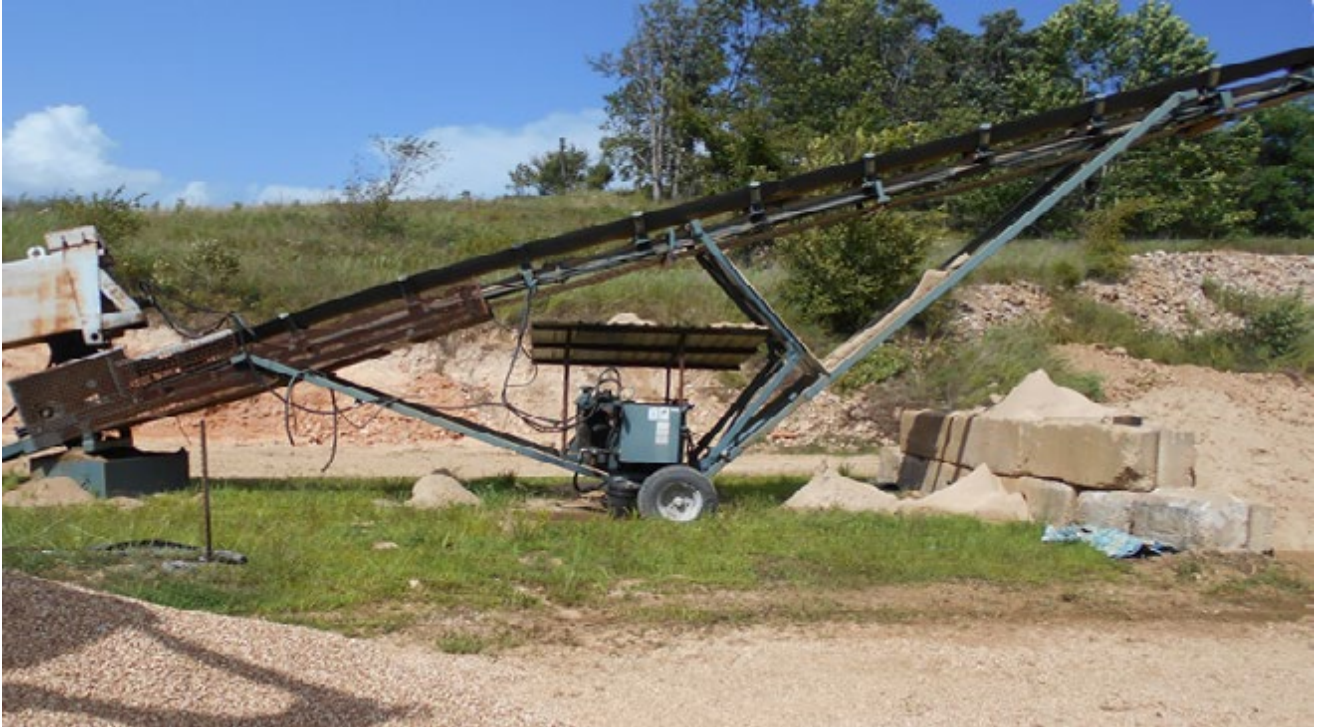
APPENDIX C
Photographs of the Sand Conveyor

The accident occurred at the tailpiece of the operating sand conveyor (see Appendix C). Shortly after the accident, Peterson instructed a miner to repair the sand conveyor belt because the sand conveyor belt had rolled into an o-shaped configuration, instead of the normal u-shaped configuration. During the nine-day period between when the accident occurred and when MSHA became aware of the accident, the mine operated the processing plant. All of these actions altered the accident site before MSHA could conduct an investigation of the accident. MSHA issued a non-contributory citation for a violation of 30 CFR 50.12 for failure to preserve the evidence of the accident.

The belt conveyor involved in this accident conveys sand-sized particles from the processing plant and stacks them into a pile. The belt consists of a 3/8-inch cleated rubber-covered fabric, is 45 feet long by 30 inches wide, and is positioned on a 30-degree angle from horizontal. The tail pulley is 34 inches wide and ten inches in diameter and is located three feet above ground level. The discharge end of the belt conveyor is 15 feet above ground level. A diesel engine-powered hydraulic pump drives the belt

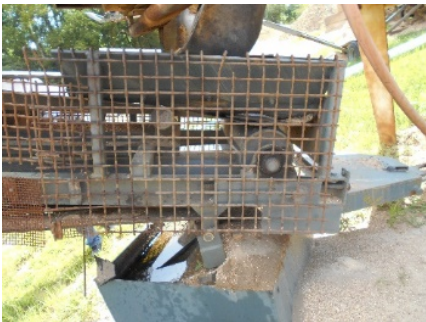
The protective guard (see Appendix C) used to cover the tail pulley is made of two-inch mesh sizing screen. The wires of the screen guard are ¼-inch in diameter and bent at a 90-degree angle to serve as hooks to hang on the side of the tail pulley and cover the pulley. According to Besson, Hammett, and Peterson Ranch Foreman Kleveland Gastineau, the tail pulley guard was on the ground leaning against the tail pulley at the time of the accident.

An accident occurred at this site on July 29, 2020. A miner got his arm caught in the sand conveyor and received serious injuries that resulted in his death. The guard had been removed from the conveyor and was sitting on the ground leaning against the tail pulley at the time of the accident. This created an entanglement hazard on the lower (tailpiece) end of the conveyor, which was approximately three feet above the ground. The conveyor was operating at the time of the accident, and the miner's injuries were the result of his contact with the moving equipment. The accident investigation revealed it was a common practice for the guard to be removed while the conveyor was running to facilitate cleaning that was required due to frequent material accumulations. Failure of the mine operator to maintain the guard securely in place while machinery is being operated constitutes more than ordinary negligence and is an unwarrantable failure to comply with a mandatory standard.

The guard that was removed from the tailpiece at the time of the accident.

Corrective Action: The mine operator developed and implemented a written action plan to prevent similar occurrences. This plan includes: 1) a provision that all moving machine parts will be guarded; 2) training for all miners on the importance of guarding moving equipment and the hazards of working near a moving belt conveyor; 3) additional management oversight to ensure guarding is installed and maintained; and 4) a redesign of the guard involved in the accident to simplify the process of replacing it. The mine operator incorporated this action plan into the mine's training program, and trained all miners at this mine in the action plan.

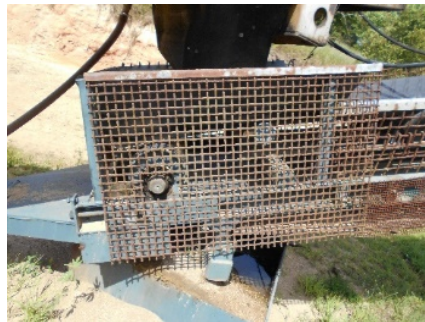
The opposite side of the tailpiece.

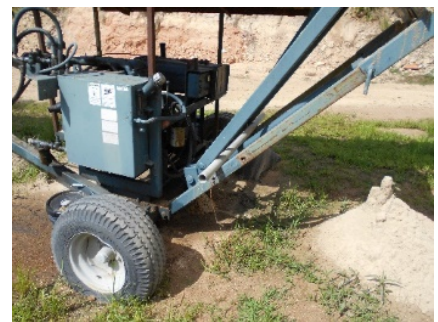
conveyor, and the start/stop switch is located beneath the conveyor. The belt conveyor has been in service at this mine for at least seven years. A coat of paint obscures the belt conveyor model and serial numbers.

The hydraulic and diesel components of the sand conveyor.
