UNITED STATES
DEPARTMENT OF LABOR
MINE SAFETY AND HEALTH ADMINISTRATION

REPORT OF INVESTIGATION

Fatal Electrocution
July 9, 2020

Hudson Sand Mine
Atlanta Sand and Supply Co.
Byron, Peach County, Georgia
ID No. 09-01219

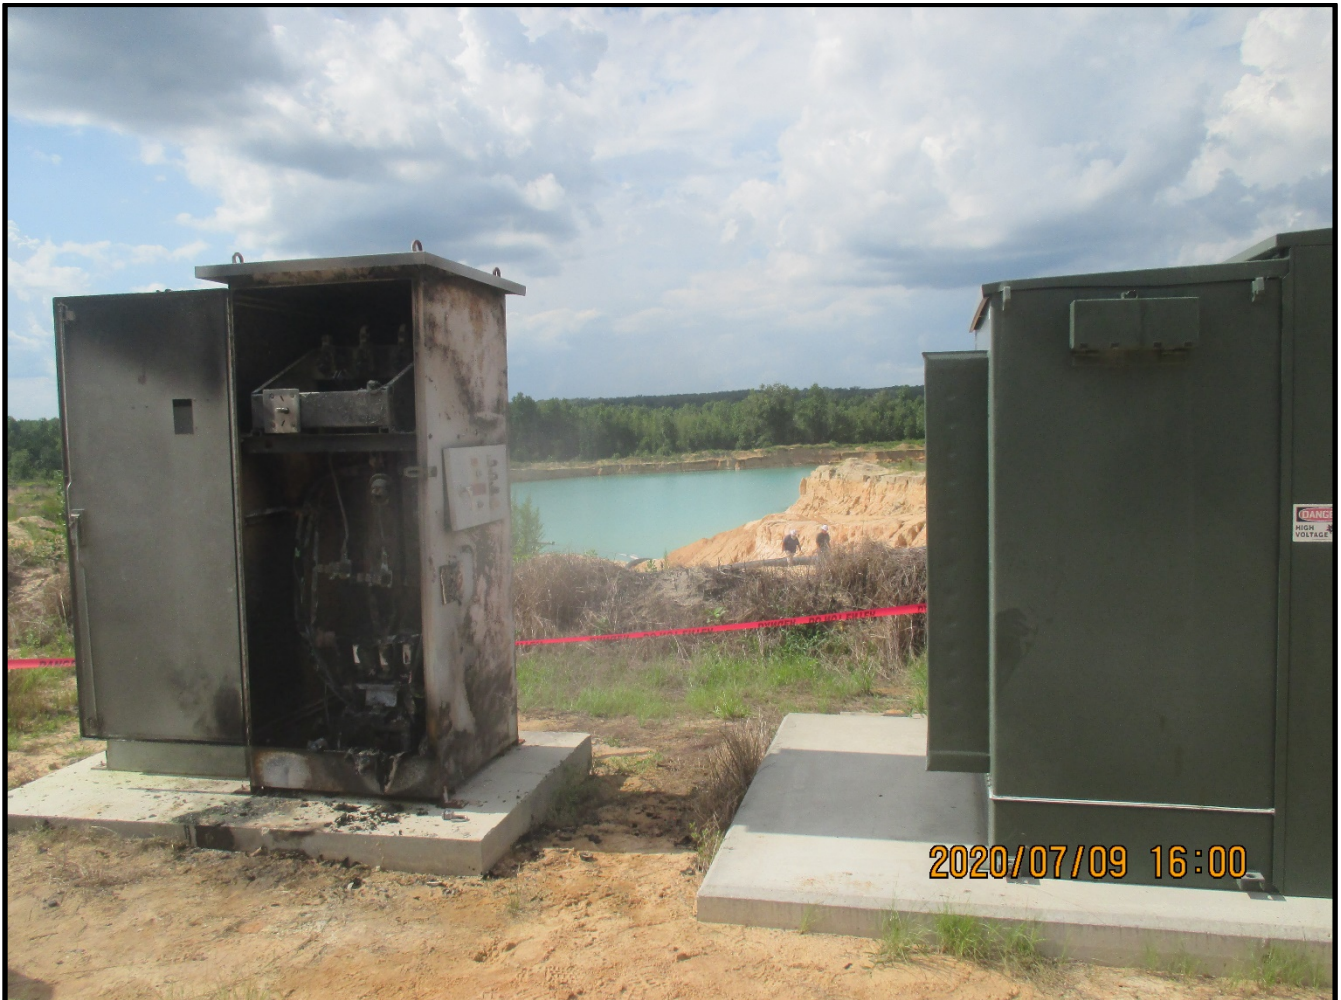
APPENDIX B
Photograph of the Accident Scene

The accident occurred at the 4,160 VAC electrical enclosure that provides electrical power to the dredge trailing cable. The electrical enclosure is located on the shore approximately 500 feet from the dredge pond bank (see Appendices Band C).

At the scene of the accident, investigators observed damage in the electrical enclosure that was caused by the accident. The most severe physical damage was on the right side of the electrical enclosure where one phase (phase 3) was located.

On the disconnect switch, the metal support for the phase 3 flicker blade arc chute showed signs of arcing damage and was considerably shorter than the other two supports. The three blades and flicker blades of the disconnect switch were intact, but the fiberglass connector links between the blade crank shaft and the blades were destroyed in the accident.

The high voltage fuse installed in phase 3 was completely destroyed. The shell of the vacuum bottle from the vacuum contactor installed in phase 3 was broken to the extent that the internal contacts were visible. The control transformer, mounted inside on the right side of the electrical enclosure, suffered extensive damage as well.

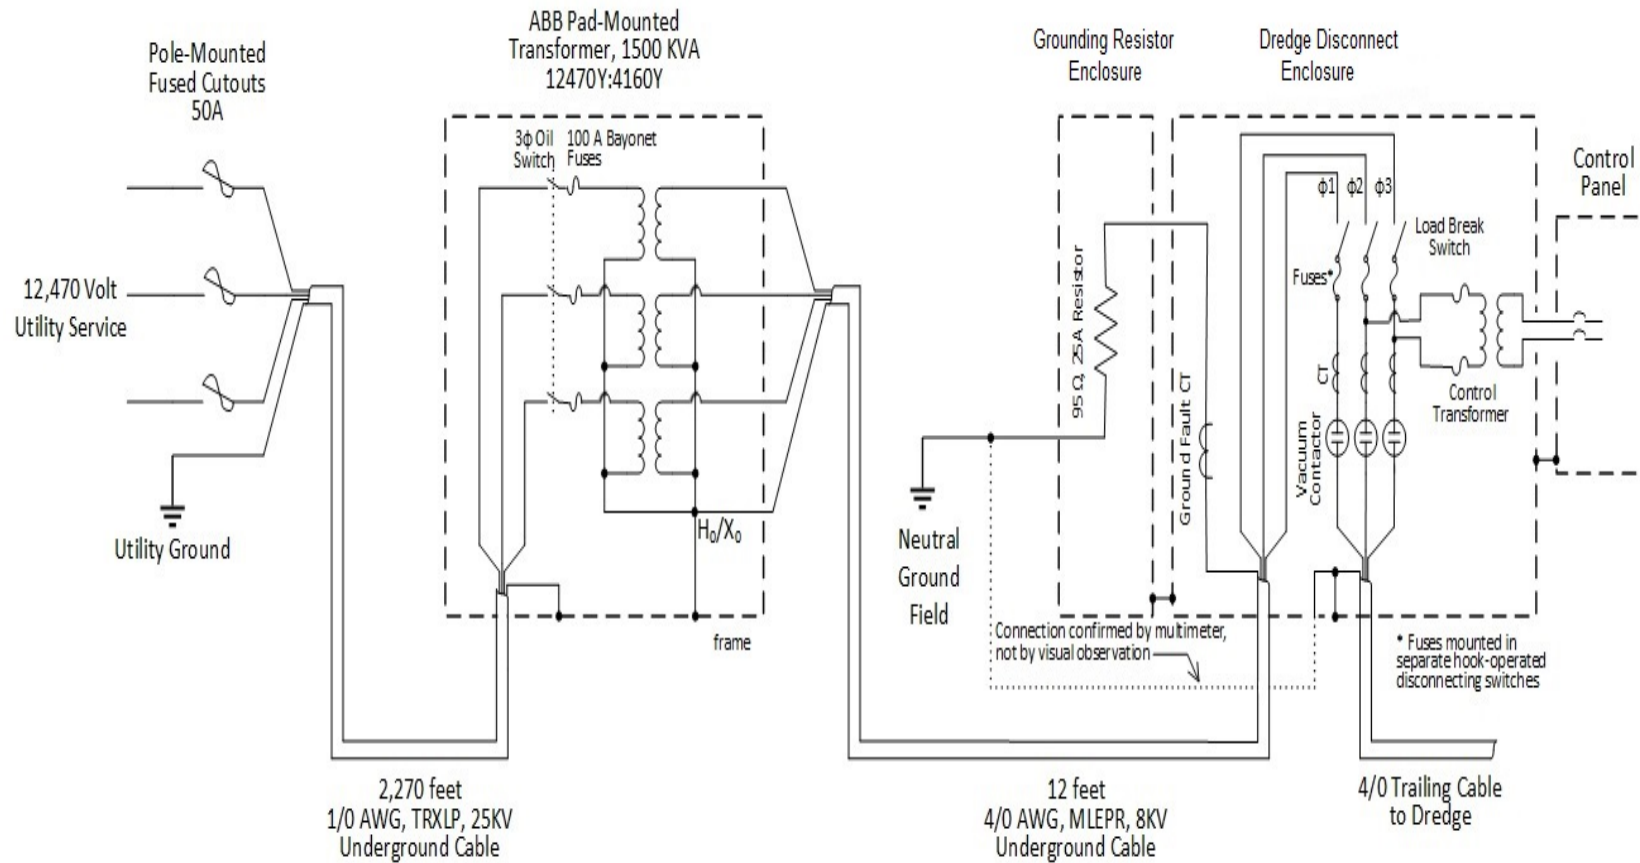
Appendix D Electrical Schematic of the Dredge Circuit

The electrical enclosure received 4,160 VAC electrical power from a transformer that was approximately seven feet away on another concrete pad. The electrical circuit for the dredge was equipped with a 95 ohm grounding resistor. The transformer secondary was properly connected to the grounding resistor, but was incorrectly connected to the frame of the transformer. This increased the amount of electrical current during the accident (see Appendix D).

Based on observations at the mine and analysis of the physical evidence, it is likely that the phase 3 blade or flicker blade failed to open when the victim moved the handle of the disconnect switch to the open position. This failure would have energized circuit elements in phase 3 all the way down to the line side of the vacuum contactor. Connections through the primary winding of the control transformer would have energized the phase 2 line side of the vacuum contactor as well (see Appendix D).
