UNITED STATES
DEPARTMENT OF LABOR
MINE SAFETY AND HEALTH ADMINISTRATION

REPORT OF INVESTIGATION

Fatal Electrocution
July 9, 2020

Hudson Sand Mine
Atlanta Sand and Supply Co.
Byron, Peach County, Georgia
ID No. 09-01219

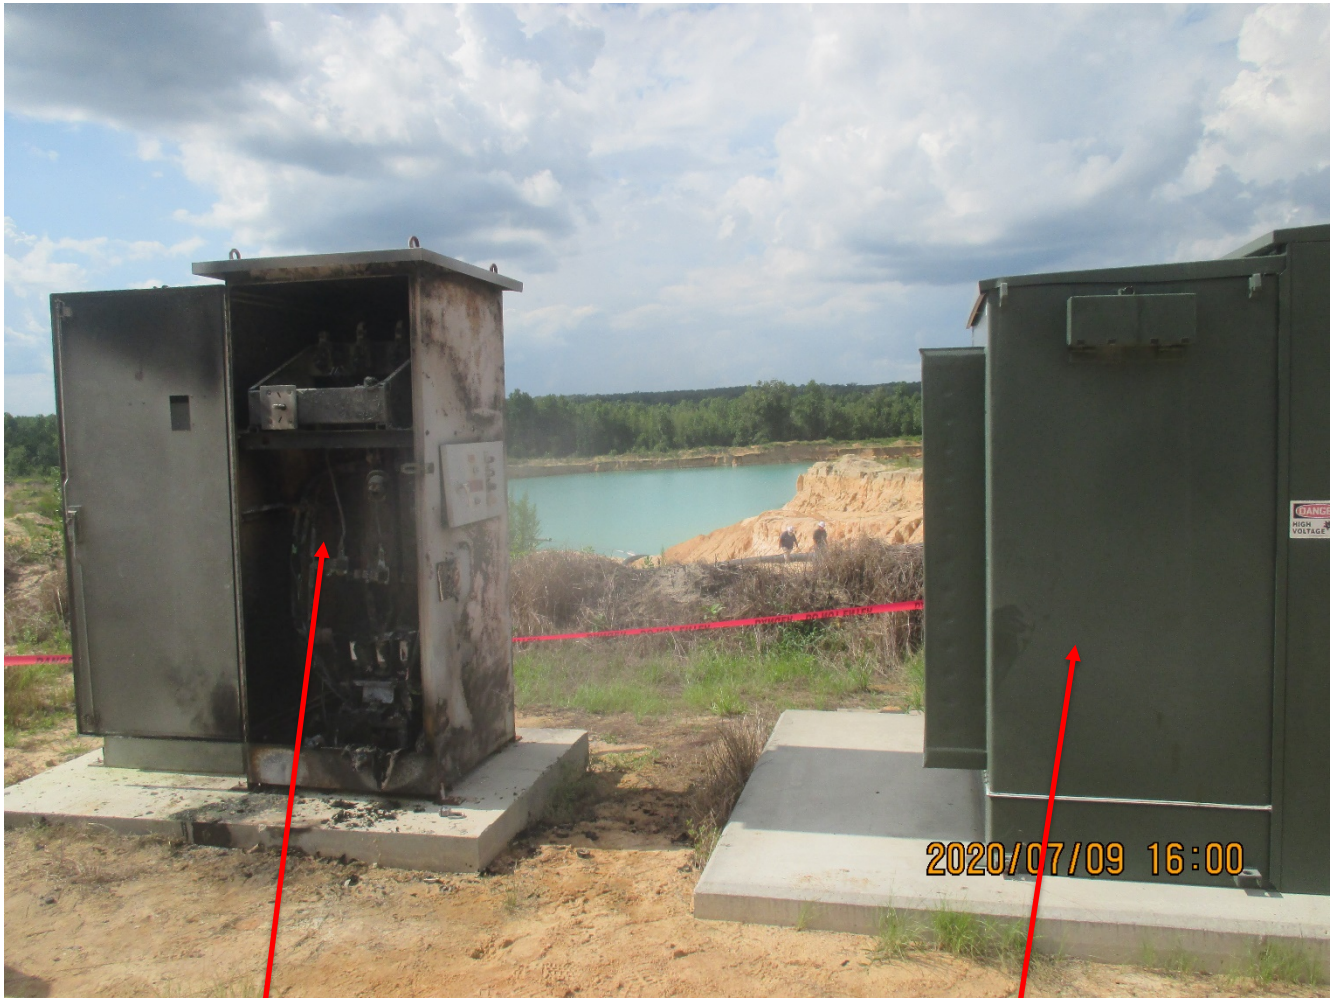
APPENDIX B
Photograph of the Accident Scene

The accident occurred at the 4,160 VAC electrical enclosure that provides electrical power to the dredge trailing cable. The electrical enclosure is located on the shore approximately 500 feet from the dredge pond bank (see Appendices B and C).

Electrical Enclosure

Transformer supplying power to
the electrical enclosure

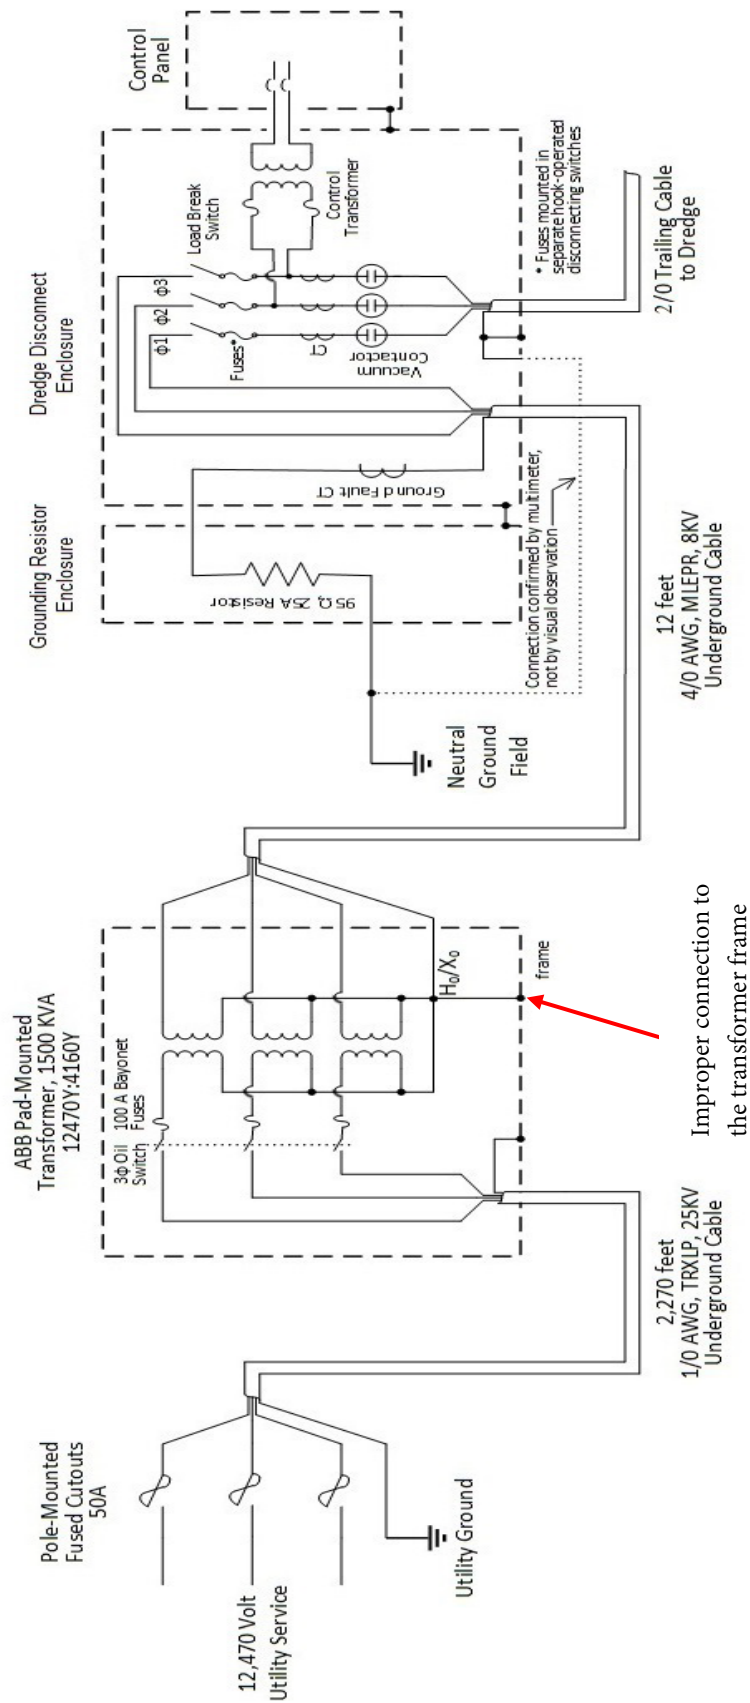
Appendix D Electrical Schematic of the Dredge Circuit

The electrical enclosure received 4,160 VAC electrical power from a transformer that was approximately seven feet away on another concrete pad. The electrical circuit for the dredge was equipped with a 95 ohm grounding resistor. The transformer secondary was properly connected to the grounding resistor, but was incorrectly connected to the frame of the transformer. This increased the amount of electrical current during the accident (see Appendix D).

Based on observations at the mine and analysis of the physical evidence, it is likely that the phase 3 blade or flicker blade failed to open when the victim moved the handle of the disconnect switch to the open position. This failure would have energized circuit elements in phase 3 all the way down to the line side of the vacuum contactor. Connections through the primary winding of the control transformer would have energized the phase 2 line side of the vacuum contactor as well (see Appendix D).
