REPORT OF INVESTIGATION

Fatal Fall of Material Accident  
June 19, 2020

Plant 2  
Harshman Construction LLC  
Cedar Point, Osage County, Kansas  
ID No. 14-01537

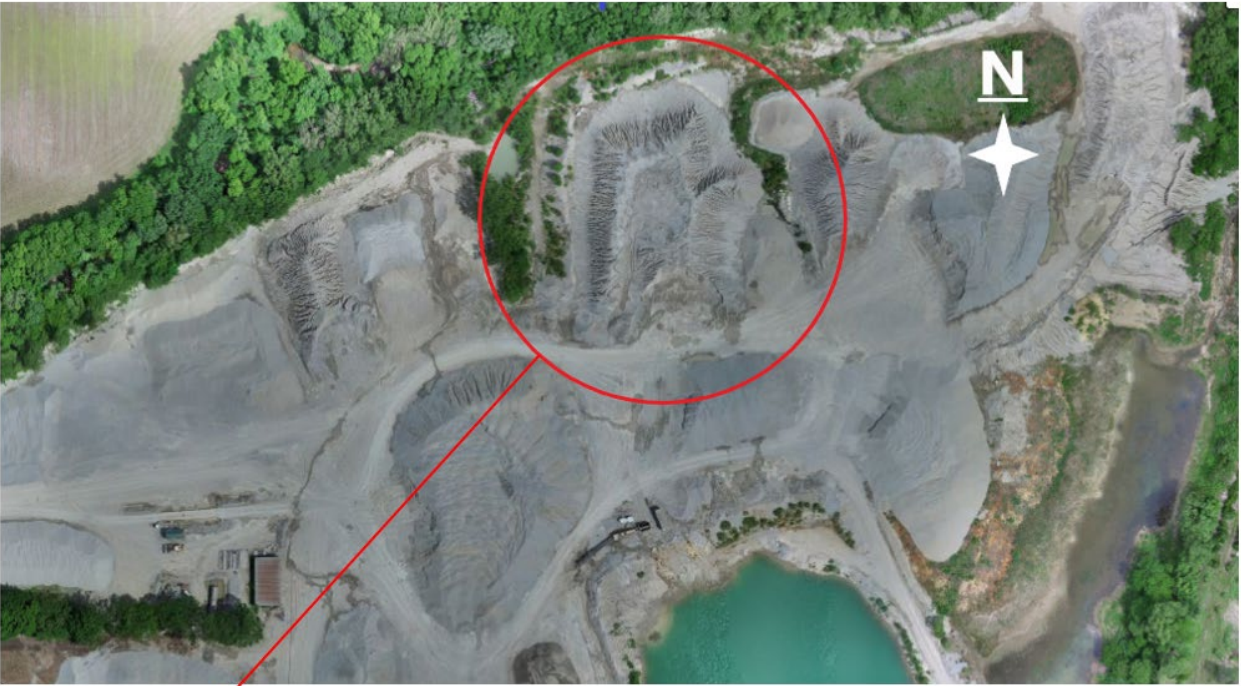
APPENDIX B  
Aerial Photograph

The accident occurred at the 7/16-inch minus (screenings) stockpile (see Appendix B). The stockpile is 25 to 30 feet high and 100 feet wide. During normal working conditions, miners regularly undercut the face of the stockpile, which causes material to fall to its natural angle of repose. At the time of the accident, because the material did not fall as normal, eventually a large amount of material fell because the stockpile could not support its own weight.

Overhead photo of the 7/16-inch minus stockpile. May 2020.

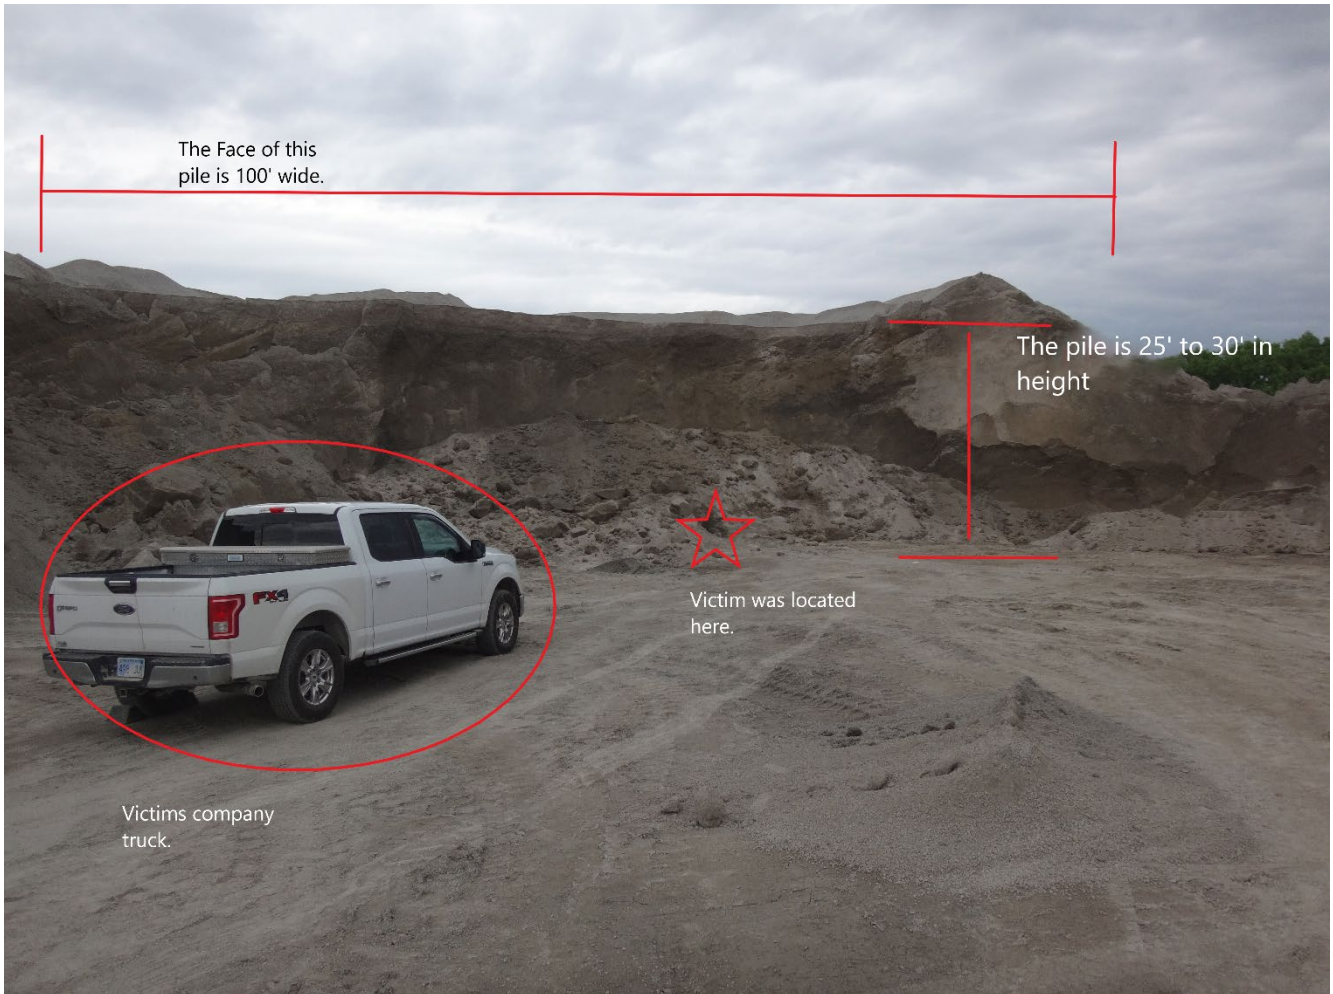
APPENDIX C  
Accident Scene Photograph  
June 19, 2020

Jenkins and Burright stated the stockpile regularly had been falling to its natural angle of repose as they removed material from the face. They would remove material in one area until the face of the pile started falling, and then they would move a short distance away from that area and repeat the process. Miners followed this practice since they initially began removing material from the stockpile on May 18, 2020. Investigators determined that this was a common practice at this mine. See Appendices C and D.

The operator did not maintain the 7/16-inch minus (screenings) stockpile in a safe manner. The face of the stockpile was 25 to 30 feet high and 100 feet wide. Miners regularly undercut the face of the stockpile causing the stockpile to become unstable and preventing support otherwise associated with material in its natural angle of repose. A miner was fatally injured when a portion of the stockpile collapsed while he was kneeling at the toe of the stockpile and visually scanning the face of the stockpile for oversized material. The stockpile regularly had been falling to the angle of repose as the two front-end loaders removed material from the face. On the day of the accident, the face did not fall to the angle of repose and miners did not trim the face to prevent a hazard to persons. The two front-end loader operators were aware of the hazardous condition of the stockpile. This condition exposed miners to injury and material engulfment.

1. The operator will construct stockpiles in a manner to eliminate vertical heights that require undercutting, which can cause a sudden rush of material into areas where foot traffic or mobile equipment are present;
2. The operator will barricade areas identified as hazardous to prevent entry until corrective measures are taken.
  - A. Operator will immediately remove all personnel exposed to the hazard.
  - B. Operator will promptly correct all unsafe conditions from a safe location (if possible)
3. The operator will provide specific training on examinations and will emphasize aspects of stockpile safety including hazard recognition and safe work practices around stockpiles to all employees.
