REPORT OF INVESTIGATION

Fatal Handling Material Accident  
May 2, 2020

Enon Sand & Gravel  
Enon Sand & Gravel LLC  
Enon, Clark County, Ohio  
Mine ID No. 33-01466

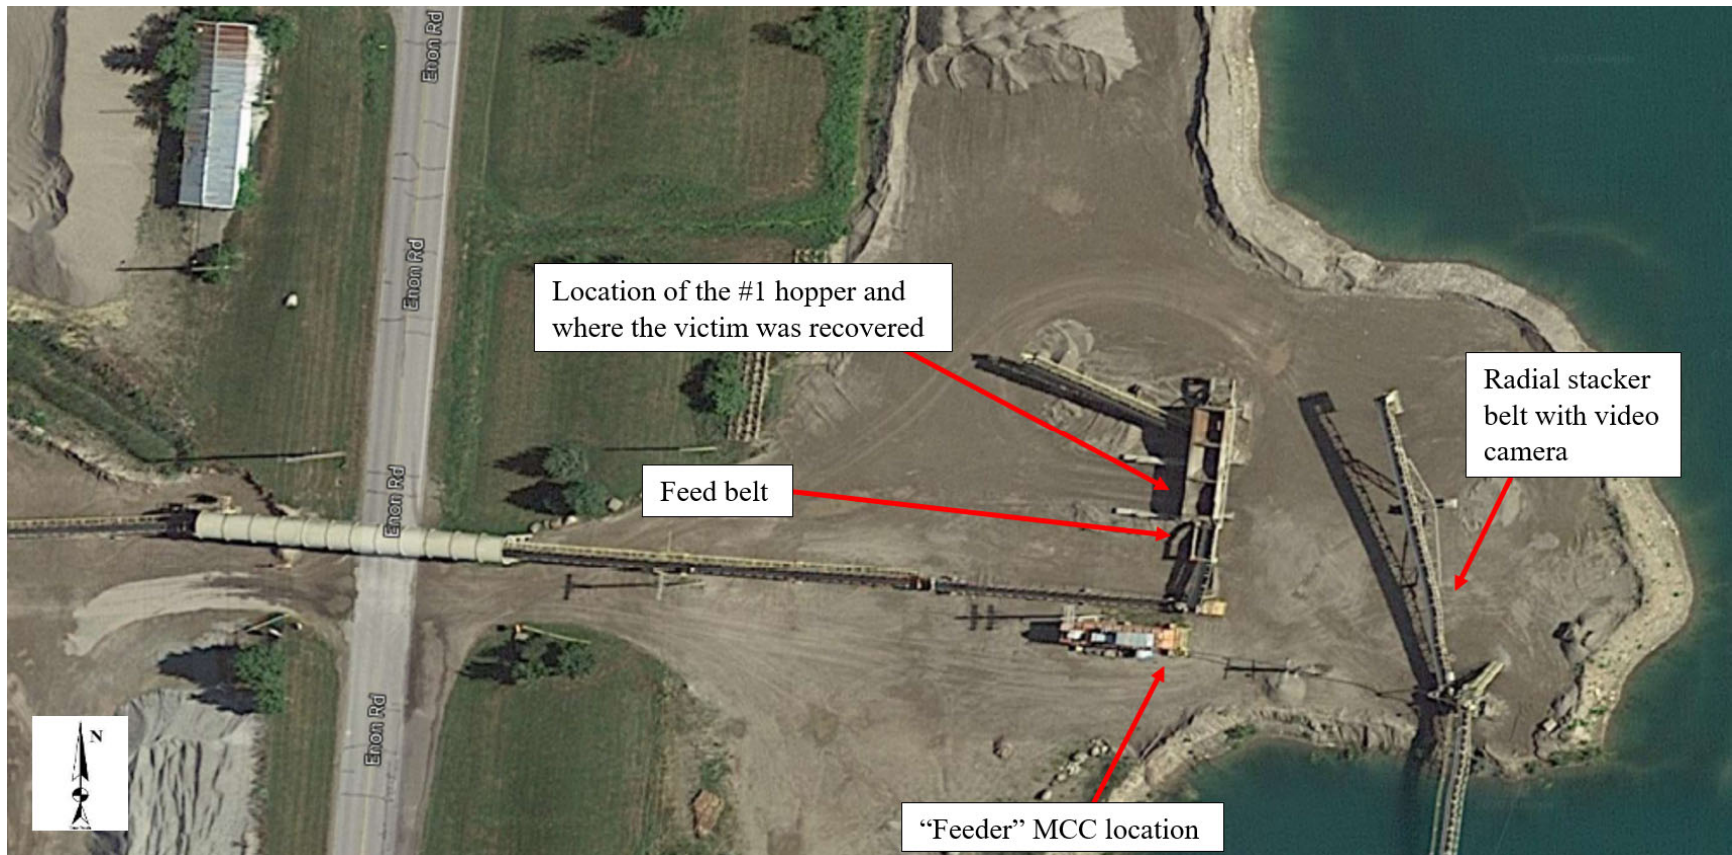
Appendix A  
Location of #1 Hopper and Victim at the Time of Accident

On May 2, 2020, at 6:00 a.m., Zimmerman began work performing his normally assigned task, operating a Caterpillar 972K front-end loader. At 6:24 a.m., Zimmerman began loading raw material, which had been transported from another mine site, into the hopper to be processed (see Appendix A). At 6:35 a.m., Zimmerman positioned a radial stacker to begin feeding material from the dredge into the hopper. At 8:30 a.m., Zimmerman observed the flow of material from the hopper had stopped and determined there was a blockage in the hopper. Zimmerman parked the front-end loader, walked over to the radial stacker controls, and repositioned the radial stacker away from the hopper.

The accident occurred at the hopper on the east side of Enon Road, between the hopper dump ramp and the dredging pond.

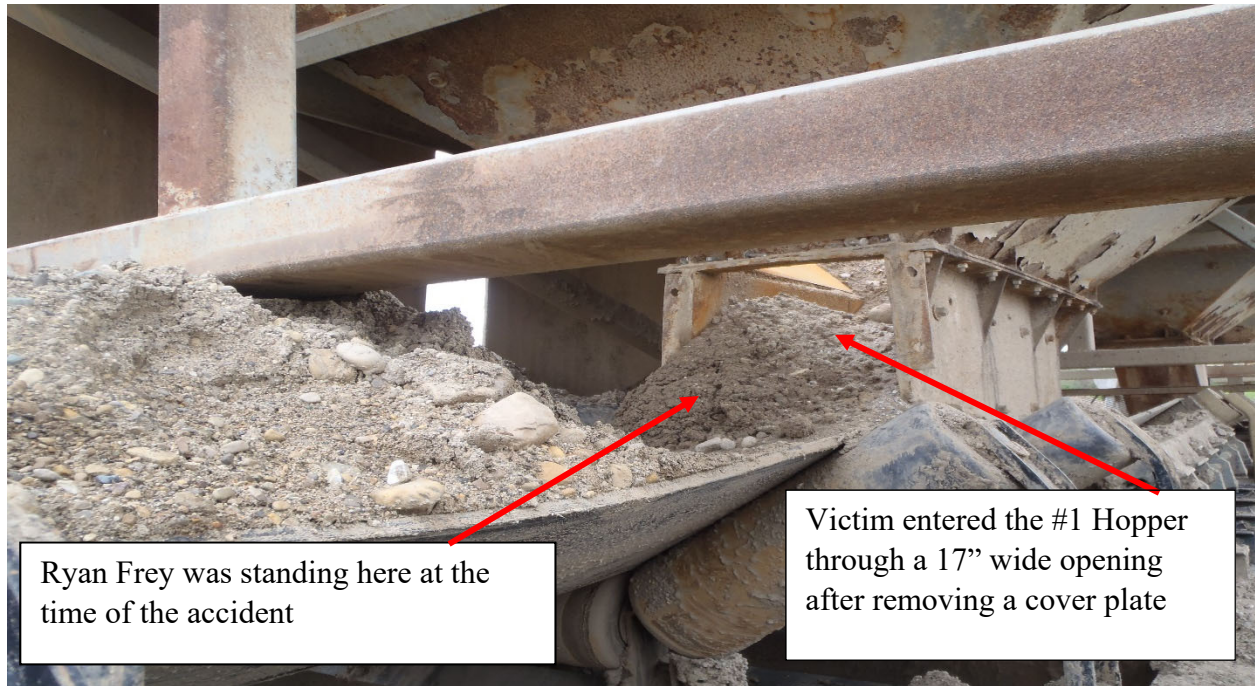
Appendix B  
Photo of #1 Hopper and Feed Belt

At 8:31 a.m., Ryan Frey, Equipment Operator, arrived at the radial stacker in a maintenance truck. At 8:35 a.m., Frey climbed onto the belt conveyor that runs underneath the hopper (see Appendix B). The belt conveyor was not de-energized, locked out, or otherwise blocked against hazardous motion. Frey began striking the side of the hopper with a hammer in an effort to free the blockage. At 8:46 a.m., Zimmerman climbed onto the conveyor support structure to assist Frey. At 8:47 a.m., Zimmerman climbed off the structure, retrieved a tool, and climbed back onto the structure with Frey. At 8:49 a.m., Zimmerman began striking the outer walls of the hopper with a hammer, attempting to dislodge the material inside.

The equipment involved in the accident was a Harman Fabco Feed Hopper which discharged onto a 48-inch-wide belt conveyor. The hopper was not equipped with mechanical devices or other effective means to size the material or to break up agglomerations of material that had a propensity to cause blockages in the hopper.

Root Cause: Mine management did not task train any of their miners on how to safely clear blockages in the hopper. The miner entered the bottom of the hopper when loose unconsolidated material, which ultimately engulfed him, was present inside the hopper.

Corrective Action: Mine management permanently removed the #1 hopper and belt conveyor from service. The mine operator acquired a portable crusher and placed it into service. Mine management developed and implemented written procedures for safe entry, operation, and maintenance of hoppers in accordance with 30 CFR § 56.16002.

Corrective Action: Mine management established written procedures for the maintenance of the new portable crusher and any hoppers. All miners who operate this equipment were trained in the written procedures in accordance with 30 CFR § 46.7(b), and this training was documented in accordance with 30 CFR § 46.9.
