REPORT OF INVESTIGATION

Fatal Powered Haulage Accident
June 4, 2018

Morgan Camp Mine
Carter Roag Coal Company
Mill Creek, Randolph County, West Virginia
ID No. 46-08656

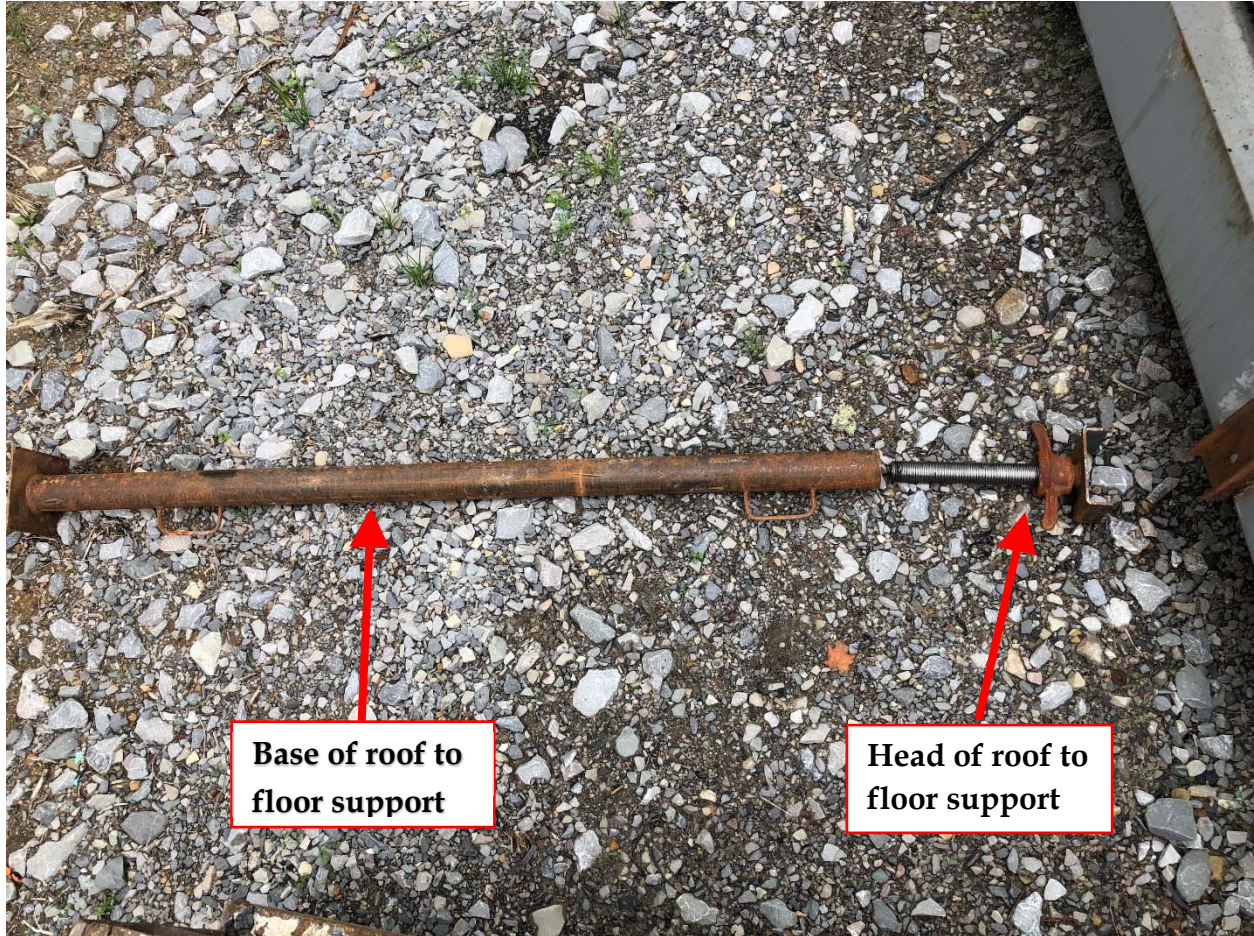
APPENDIX B
Photograph of a Roof-to-Floor Support

At approximately 11:40 p.m., the diesel personnel carrier contacted a roof-to-floor support (see Appendix B) lying in the South Mains haulage roadway at 3 block. The support base was propelled into the passenger compartment and struck Taylor in the head. Taylor was sitting in the right front passenger seat when he was struck. After striking Taylor, the support base struck Wright on the arm and then landed on the mine floor (see Appendix C). Wright was sitting in the driver's seat when he was struck.

**Base of roof to
floor support**

**Head of roof to
floor support**

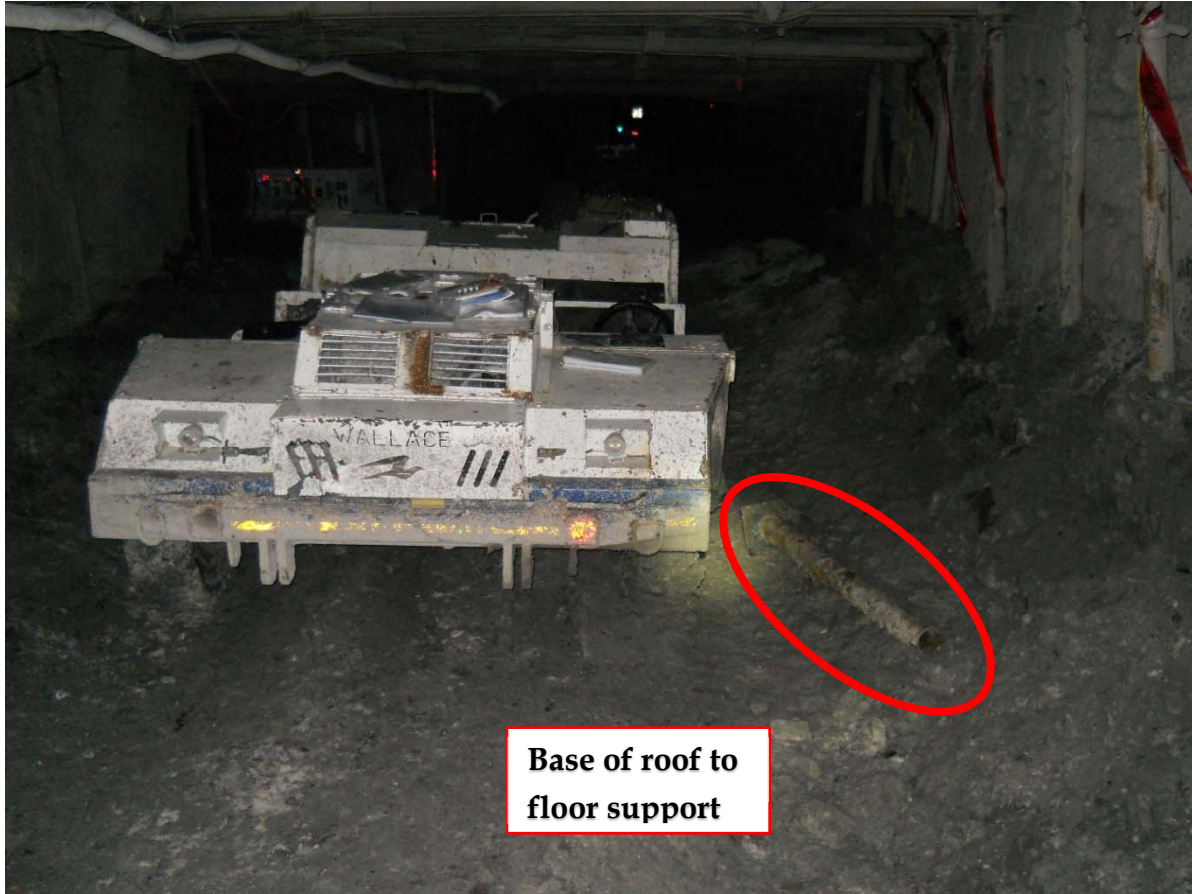
APPENDIX C

Accident Scene Photograph - Diesel Personnel Carrier and the Roof to Floor Support.

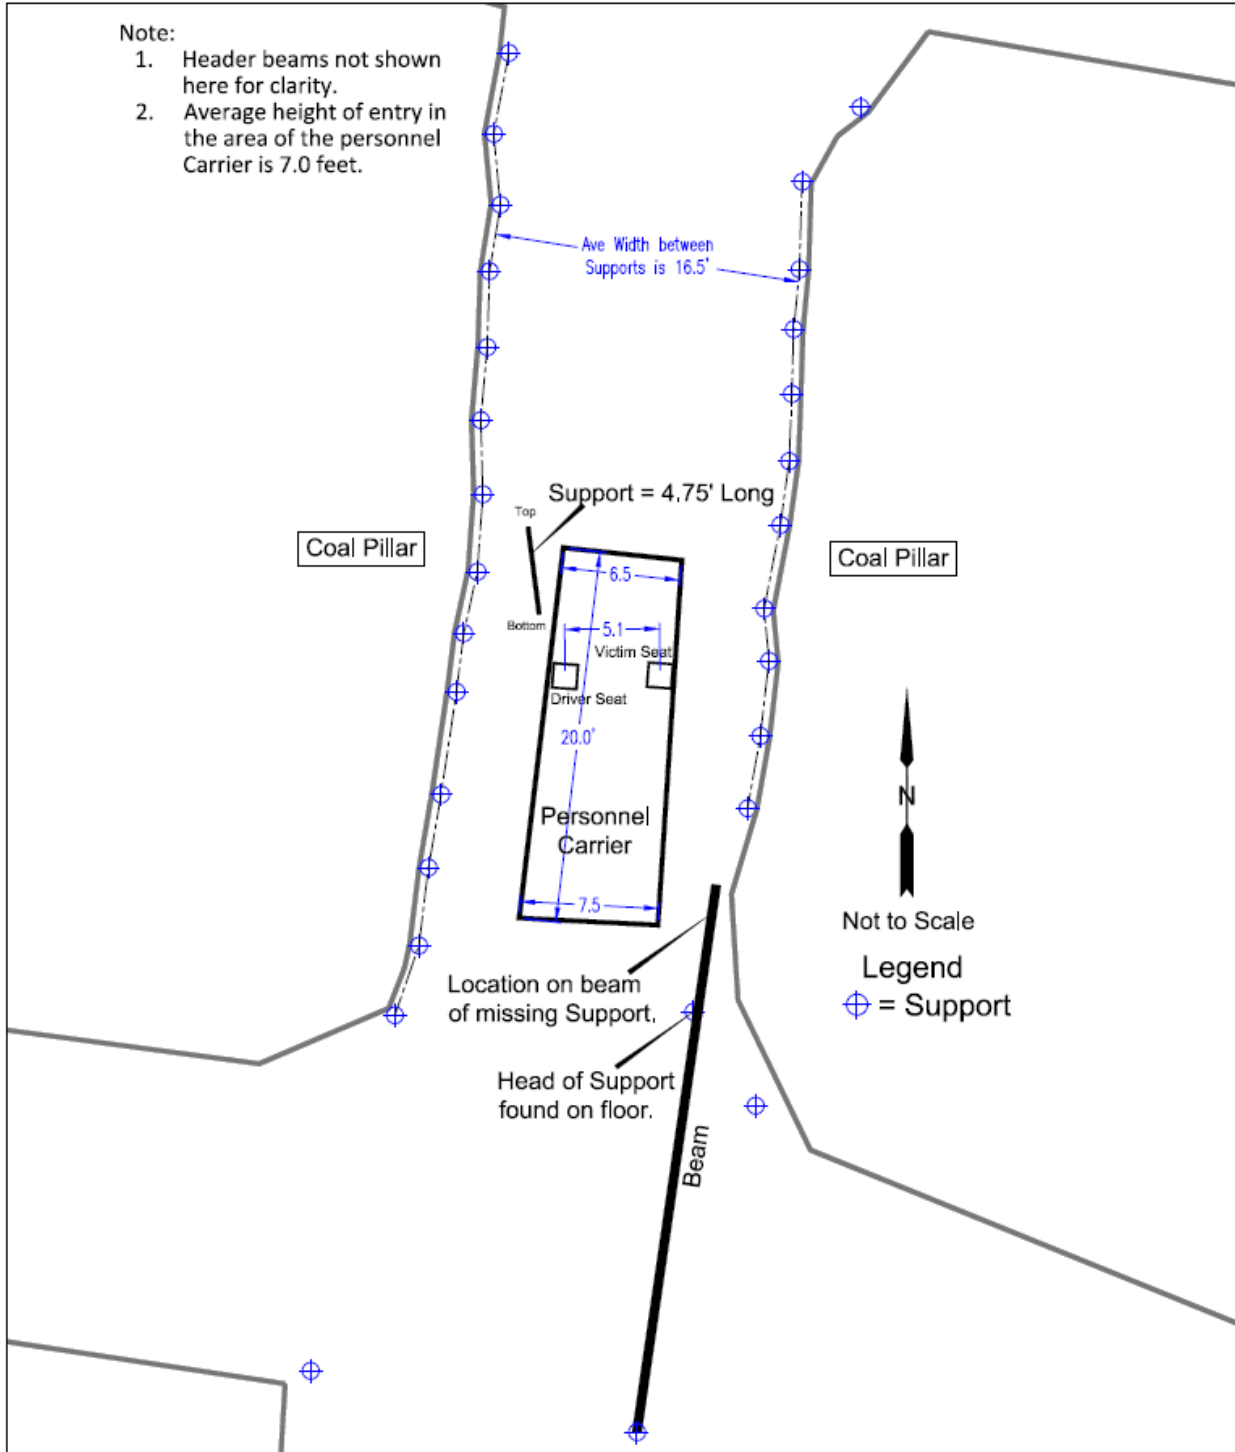
APPENDIX D

The accident investigation was conducted by Mine Safety and Health Administration (MSHA) personnel in conjunction with the West Virginia Office of Miners Health Safety and Training (WVOMHST) and mine management. The investigation team traveled underground and took pictures and measurements of the scene. The mine operator asked their surveyors to create a drawing of the accident scene (see Appendix D).

Drawing of the Accident Scene.

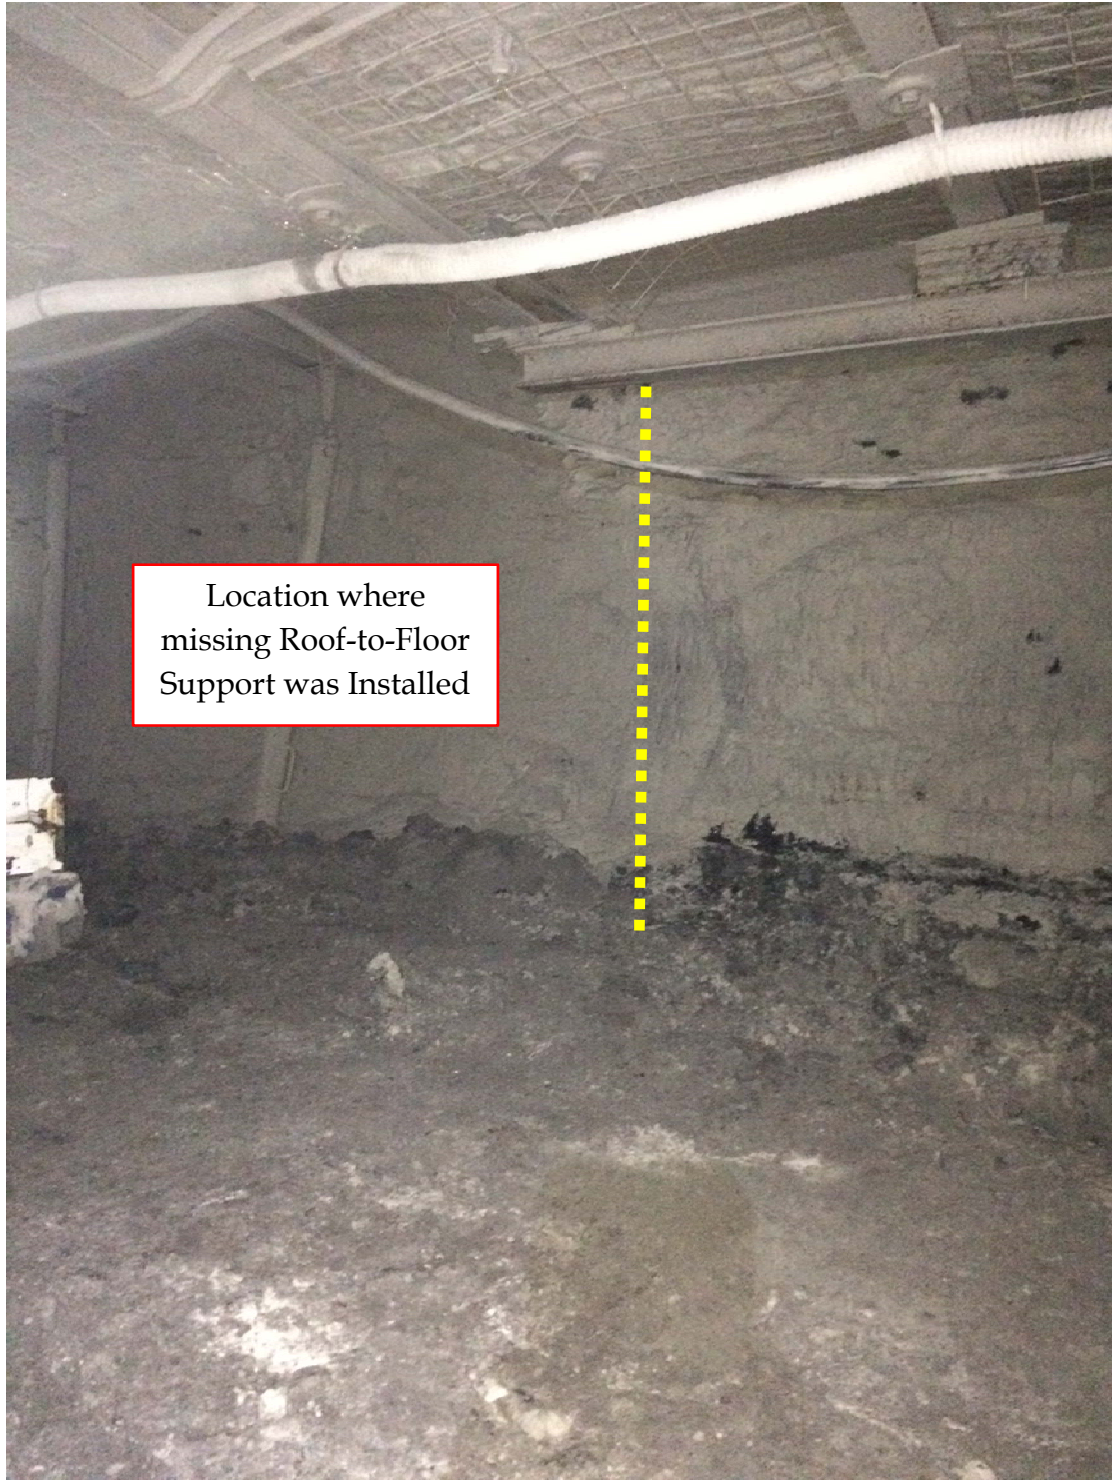
APPENDIX E

When investigators arrived at the accident scene, they found that the haulage roadway repair work had been completed. However, the roof-to-floor support installed under the outby end of a beam at 3 block was missing. The top of this support was found approximately 7 feet from where it had been installed and the base was located next to the personnel carrier. The roadway condition at the time of the accident and original location of the roof-to-floor support are shown in Appendix E. Investigators were not able to determine what caused the roof-to-floor support to fall into the roadway.

Photograph of Accident Scene

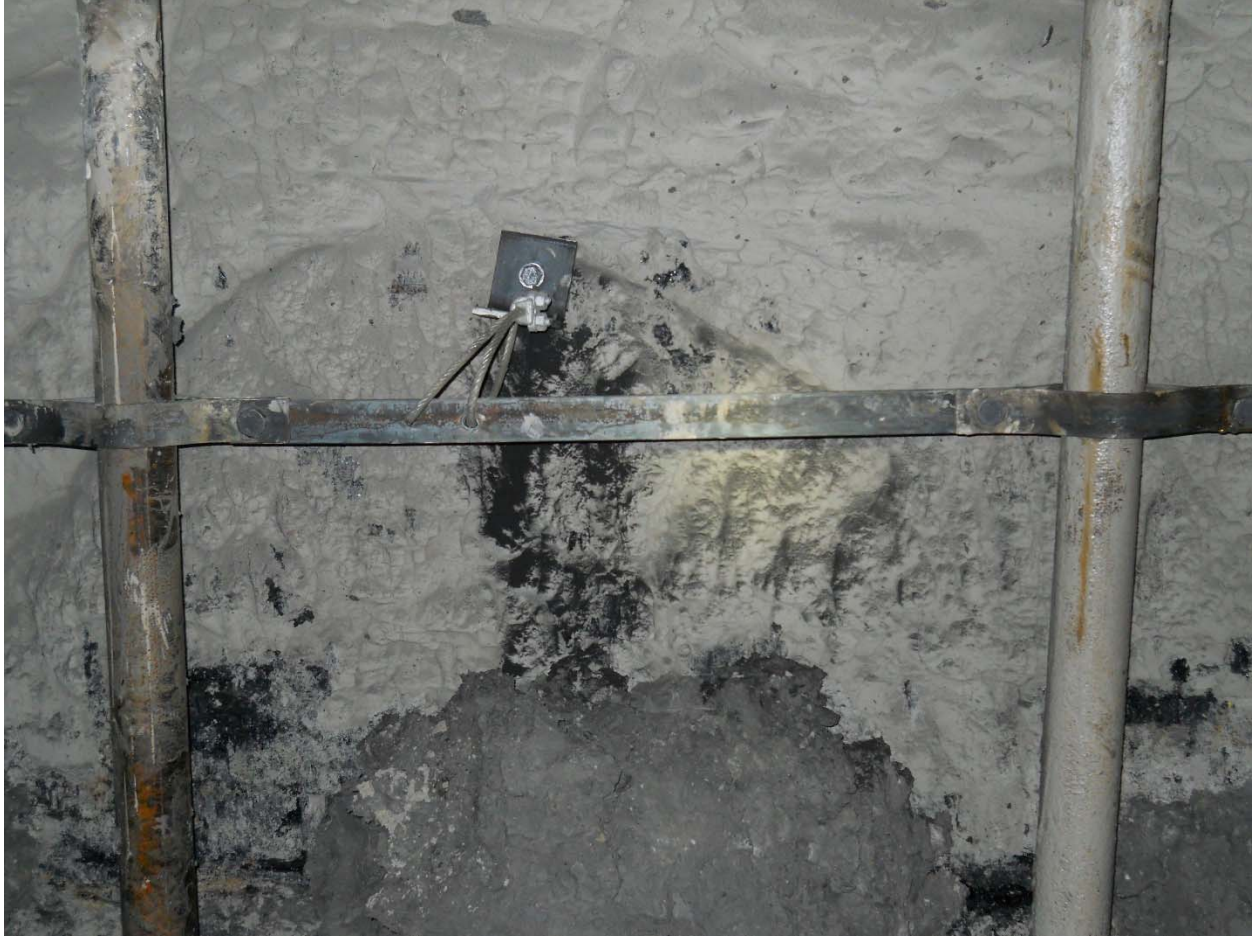
APPENDIX F

Photo of Supports that were Secured after the Accident

Corrective Actions: All extraneous material was removed from the haulage roadway. The mine operator developed and implemented a policy to secure roof-to-floor supports, located in haulage roadways, to the ribs. This is designed to prevent the supports from becoming dislodged and lying in the haulage roadway (see Appendix F). The miners were trained in this new policy.
