REPORT OF INVESTIGATION

Fatal Machinery Accident
January 23, 2023

Meikle Mine
Nevada Gold Mines, LLC
Carlin, Eureka County, Nevada
ID No. 26-02246

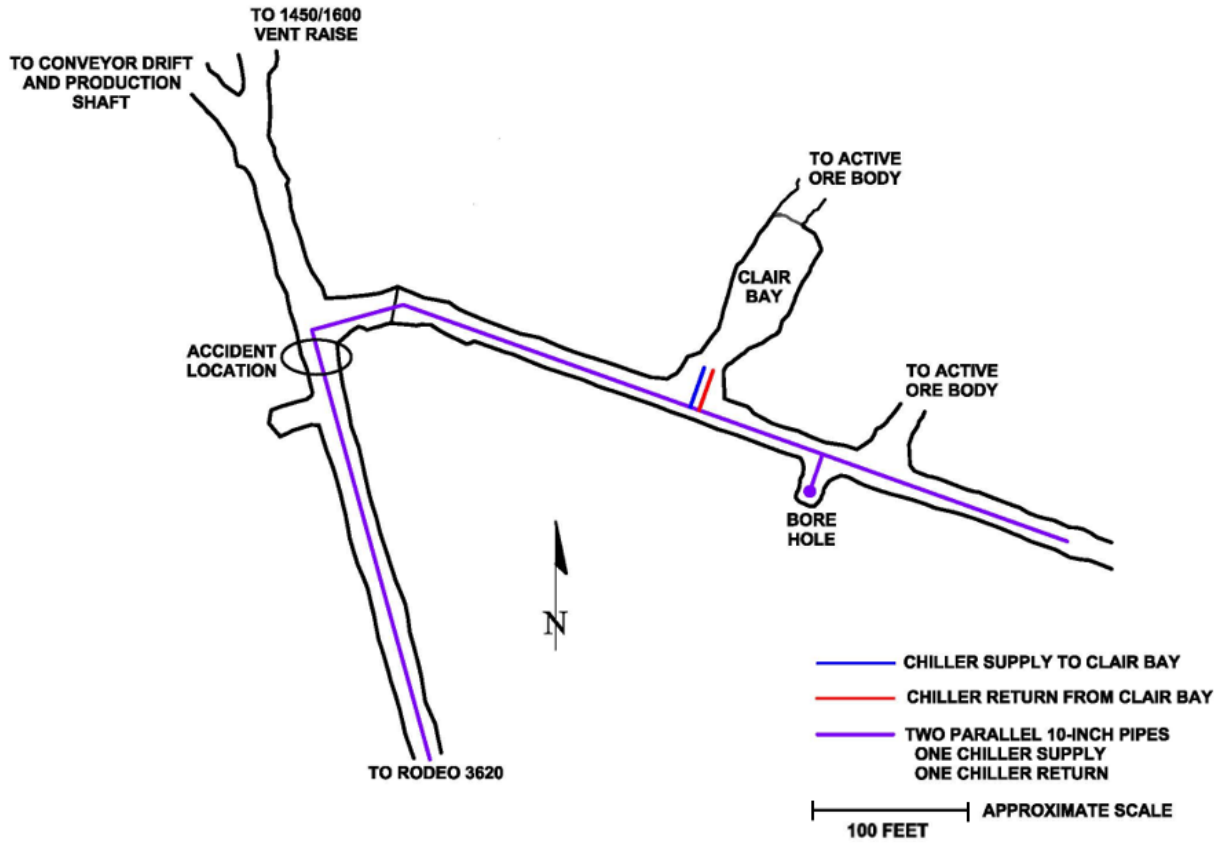
APPENDIX B – Location of the Accident Scene

The accident occurred just below the intersection of the 1600 Rodeo haulage travelway and the 3830 intersection (see Appendix B).

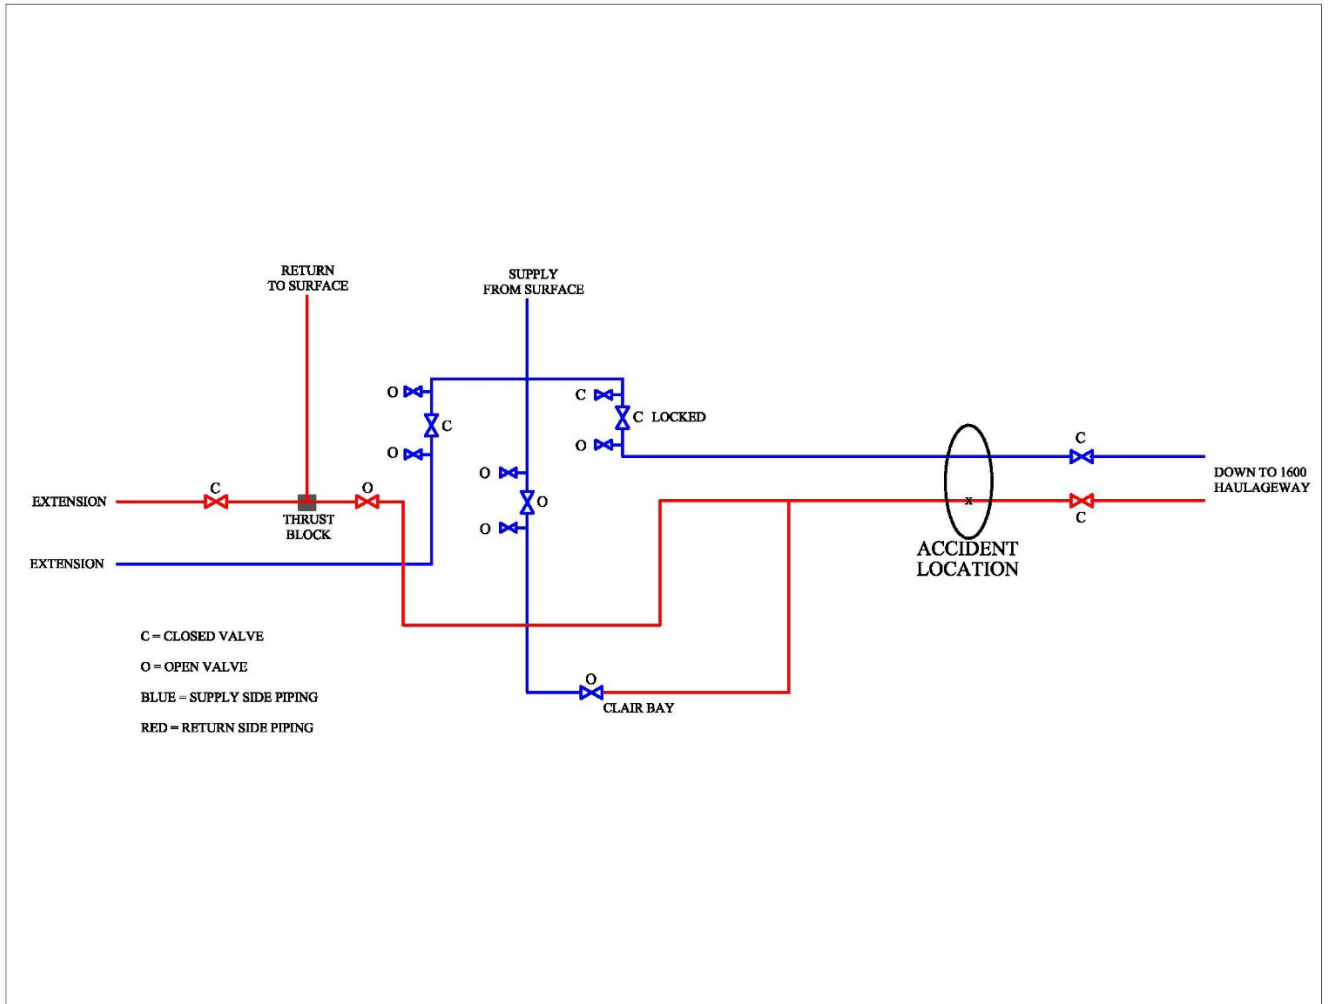
APPENDIX C – Schematic of Chiller Pipes

The two ten-inch metal pipes being removed were part of a closed loop chiller system that had been abandoned (see Appendix C). One pipe supplied chilled water underground (supply) and the other pipe returned water to the surface (return). The chiller pipe system ran from the chiller buildings on the surface to the 1600 foot underground level. At the bottom, the return line was anchored with a concrete thrust block and the supply line was anchored using mechanical supports.

Both the supply and return pipes had isolation valves. One set of isolation valves on the supply and return sides was located approximately sixty feet away from the accident location and was only reachable by a lift or ladder. The investigators found these valves closed. The closed valves on the return pipe near the thrust block, along with the closed isolation valve on the return line 60 feet away from the accident location, left water trapped in the return chiller pipe and pressurized by up to 1,600 feet of water column all the way back to the surface. If full, this entrapped water column pressurized the return chiller pipe with an estimated 700 pounds per square inch of water pressure due to gravity. The investigator was unable to determine how much water was in the pipe at the time of the accident.

The mine operator had an established procedure for hazardous energy isolation of air, water, and discharge lines. The procedure required miners to identify and isolate all energy sources, turn off and lock the main feed valves, and open relief valves to release stored energy. On the day of the accident, the miners did not follow these steps before removing the pipe. The accident investigator determined this contributed to the accident.

Corrective Action: The mine operator retrained miners in their existing procedure to check for all forms of stored energy in systems and equipment prior to beginning work and to ensure that proper lock out/tag out procedures are implemented before conducting any task.

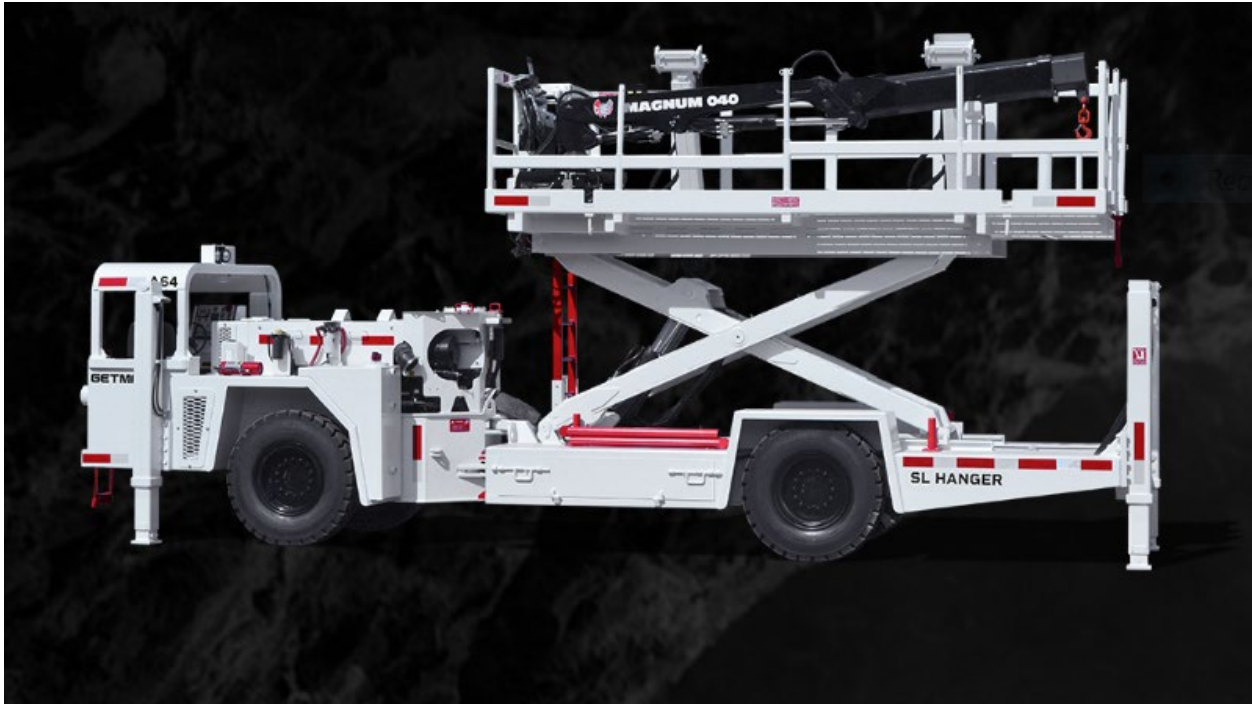
APPENDIX D – Getman A-64 Scissor Lift

The scissor lift in use was a Getman A-64, Company No. 12 (see Appendix D). The scissor lift was equipped with two hydraulic pipe handlers. Examination of the scissor lift did not reveal mechanical deficiencies or defects that contributed to the accident. The battery powered impact wrench Morquecho used was found lying in the middle of the deck. The socket had been washed down the travelway.

The mine operator's training guide for the scissor lift states that miners should "know and use fall protection procedures." Multiple tie-off posts for D-rings are located on the deck. The mine operator's job hazard analysis for Pipe Installation/Removal and Utility work at heights is rated as a medium level hazard when using a body harness and fall protection as standard personal protective equipment.

Castaneda had a fall protection harness on but was not tied off to anything. The investigator determined that this contributed to the accident.

Corrective Action: The mine operator retrained miners in their existing policy to know and use fall protection procedures while working from the scissor lift.
