REPORT OF INVESTIGATION

Fatal Slip or Fall of Person Accident
July 26, 2021

G & R Mineral Services Inc.
Contractor ID No. (ACR)

Hercules Cement LP
Stockertown, Northampton County, Pennsylvania
ID No. 36-00006

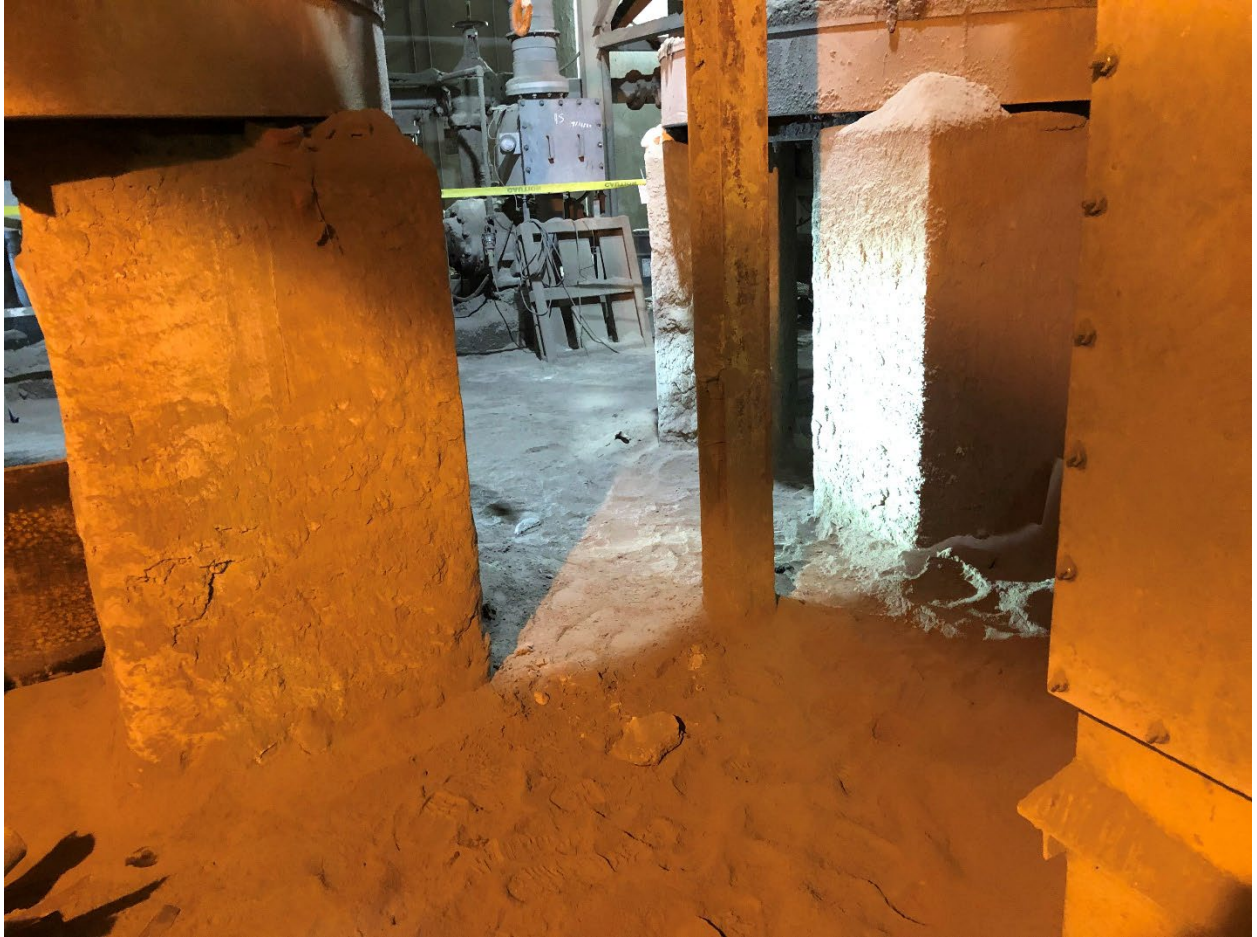
APPENDIX B – Photograph of the Accident Scene

The accident occurred between the top of #5 and #6 Cement Coolers, which are located inside the Mill Building, east of the Mills and west of the Storage Hall (see Appendix B). The G & R crew had removed the section of catwalk between the #5 and #6 Cement Coolers and placed it to the side, on top of the handrails to the south of the #6 Cement Cooler. G & R did not place barricades around the 74 inch wide by 90 inch long opening, or provide any sort of warnings of the dangerous opening.

Investigators found two pieces of a wooden plank, measuring nine inches wide, 80 inches long and one and a half inches thick when re-assembled, on the floor near Pittman. An additional unbroken wooden plank was located on the catwalk along the east side of the #5 Cement Cooler.

Neither of the wooden planks was adequate for use as a scaffold platform. A narrow section of catwalk, measuring 15 inches wide by 72 inches long, was in place between the #5 and #6 Cement Coolers to the east of the opening and adjacent to where the removable section of catwalk was previously located. This narrow section of catwalk had no handrails along the west side where the 74 inches wide by 90 inches long opening existed.

Corrective Action: The mine operator developed and implemented a written plan to assure safe access for personnel working at the top of the coolers during gearbox changes. The plan includes extending the overhead monorail across the top of all the coolers and past the end of the catwalk. This monorail extension will allow the overhead electric-powered hoist to raise the components up, trolley across, and lower them to the floor. The mine operator trained all miners on the use of the monorail extension.

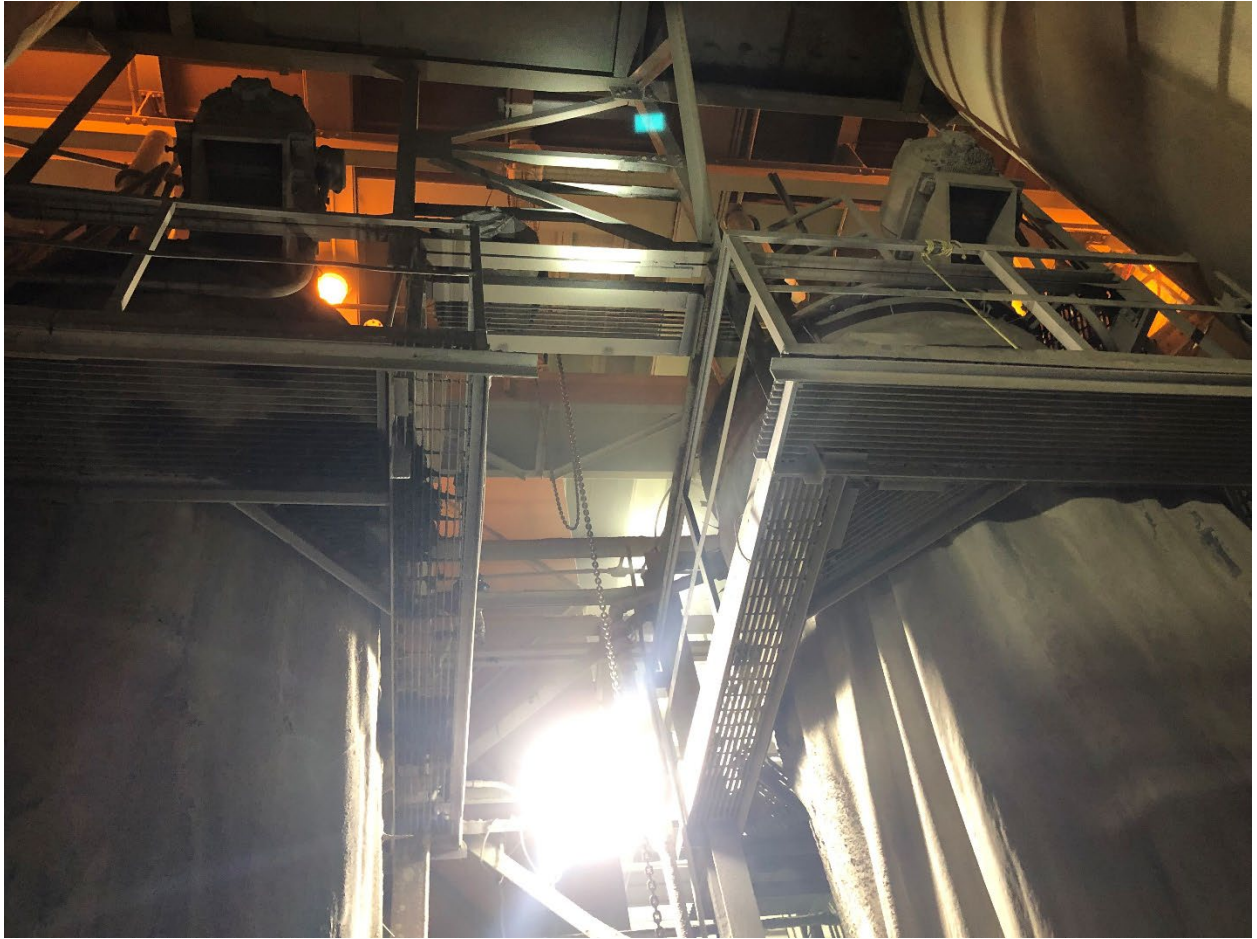
APPENDIX C – Photograph of the Equipment Involved

F.L. Smidth manufactured the #6 Cement Cooler (Cooler). The Cooler is a six foot six-inch diameter cylindrical cooler (see Appendix C). Investigators determined that the top of the Cooler had grease, dust, and structural obstacles, which contributed to hazardous conditions, including the potential for slipping and tripping.
