**United States  
Department of Labor  
Mine Safety and Health Administration  
Coal Mine Safety and Health**

**Report of Investigation  
Underground Coal Mine Explosion  
Dutch Creek No. 1 Mine – I.D. No. 05-00301  
Mid-Continent Resources, Inc.  
Redstone, Pitkin County, Colorado  
April 15, 1981**

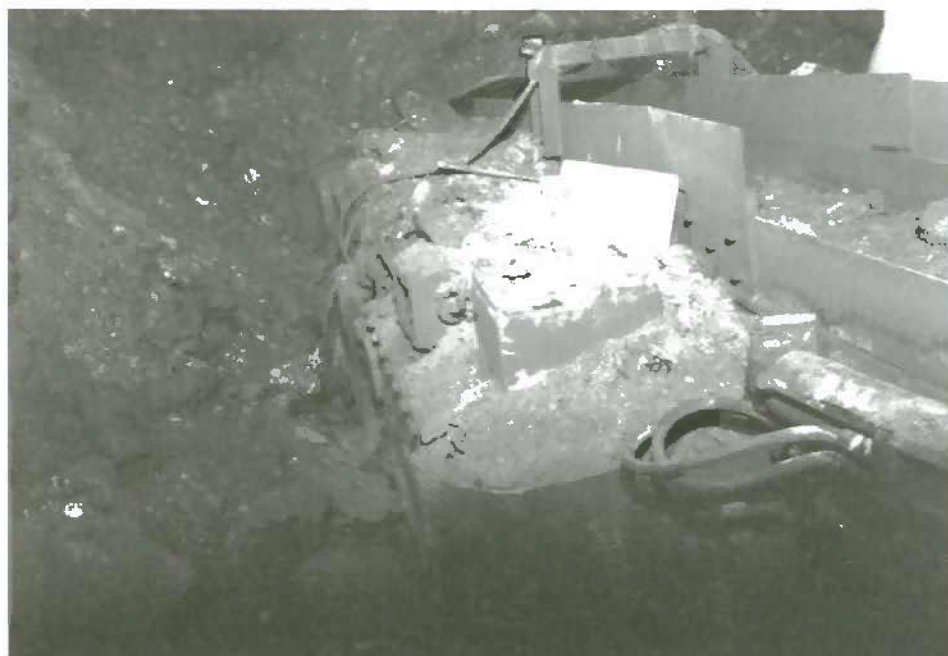
MSHA investigators concluded that the explosion originated in the face area of the No. 1 entry in the 102 Section, when a methane-air mixture within an explosion-proof compartment on a continuous mining machine was ignited by an electric arc. The compartment, containing electrical components of the mining machine, had not been maintained in a permissible condition. Flame and major forces of the explosion propagated from the face area of the 102 Section, and split in the main slope entries at the mouth of the 102 Section. Flame and forces traveled inby in the Nos. 7, 6 and 5 entries of the slopes to the Slope Section, and then moved outby in the slope entries. The flame extended as far as the No. 56 crosscut, and the major forces traveled further outby to the No. 48 crosscut.

FIGURE 1. - Lighting system box on left side of Joy 12 CM continuous mining machine in face of No. 1 entry 102 section.

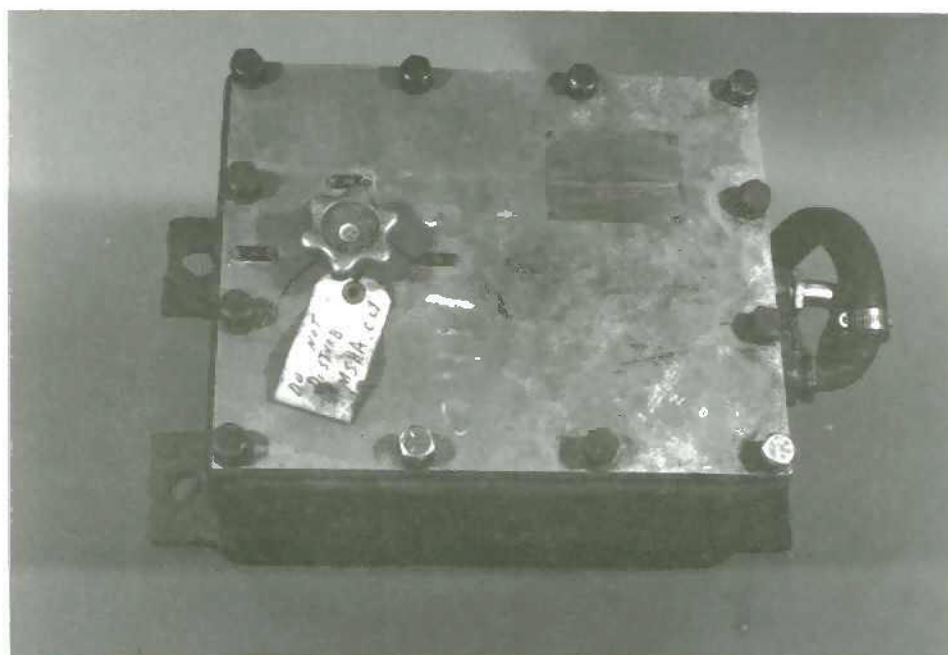
FIGURE 2. - McJunkin Corp. lighting system box.

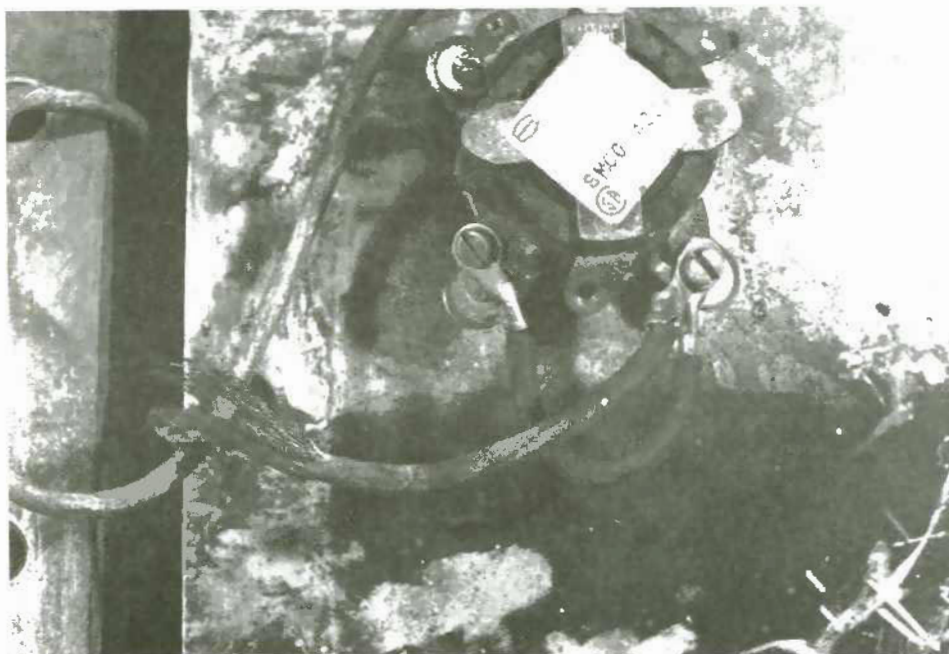
mining machine was in operation, however, the light switch was found in the "off" position.

FIGURE 3. - Light switch and No. 14 wire inside McJunkin Corp. lighting system box.

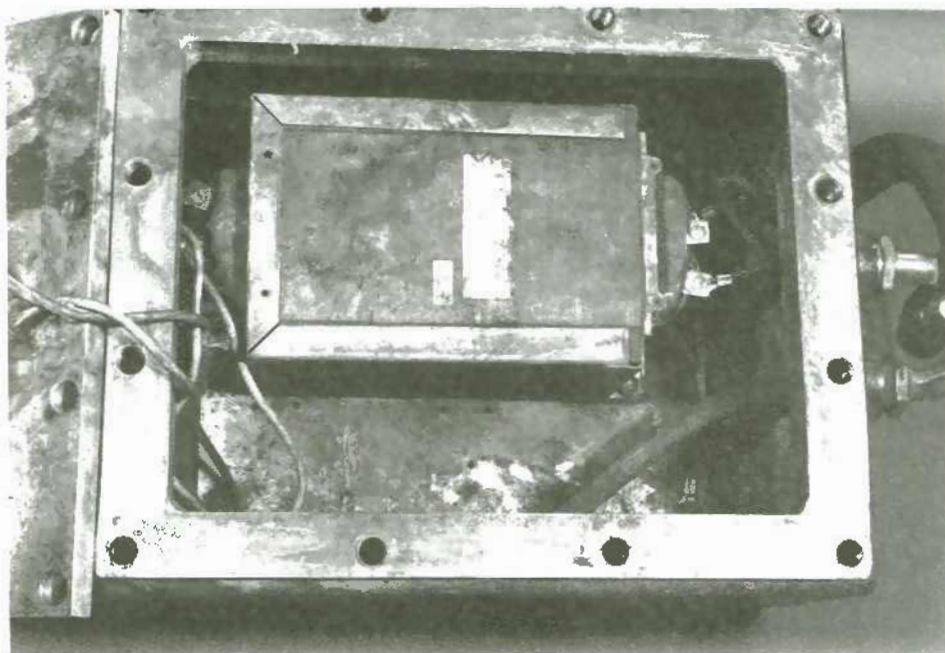
FIGURE 4. - Transformer inside the McJunkin Corp. lighting system box.

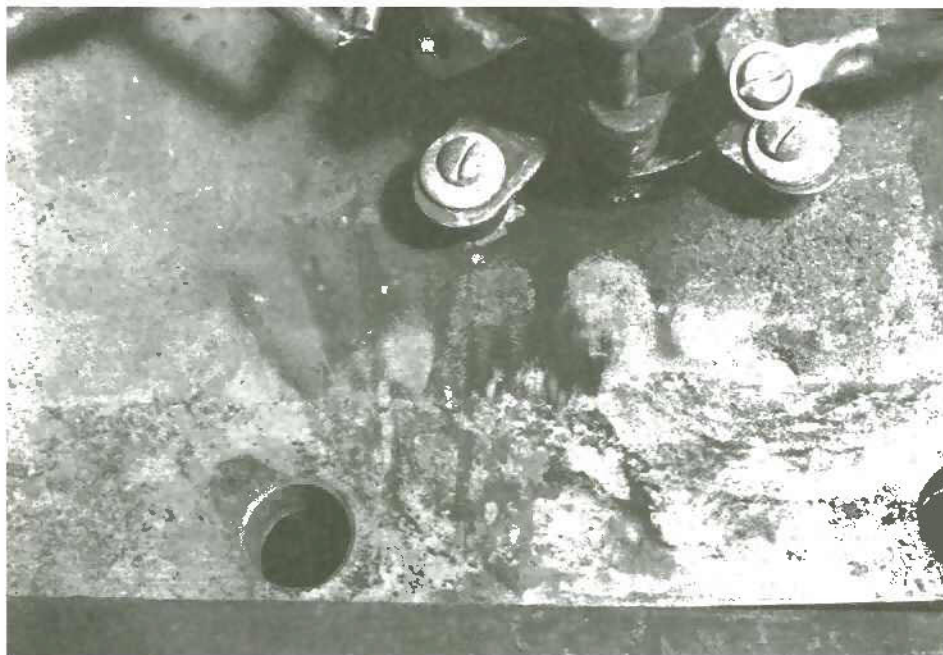
FIGURE 5. - Dust inside the McJunkin Corp. lighting system box.

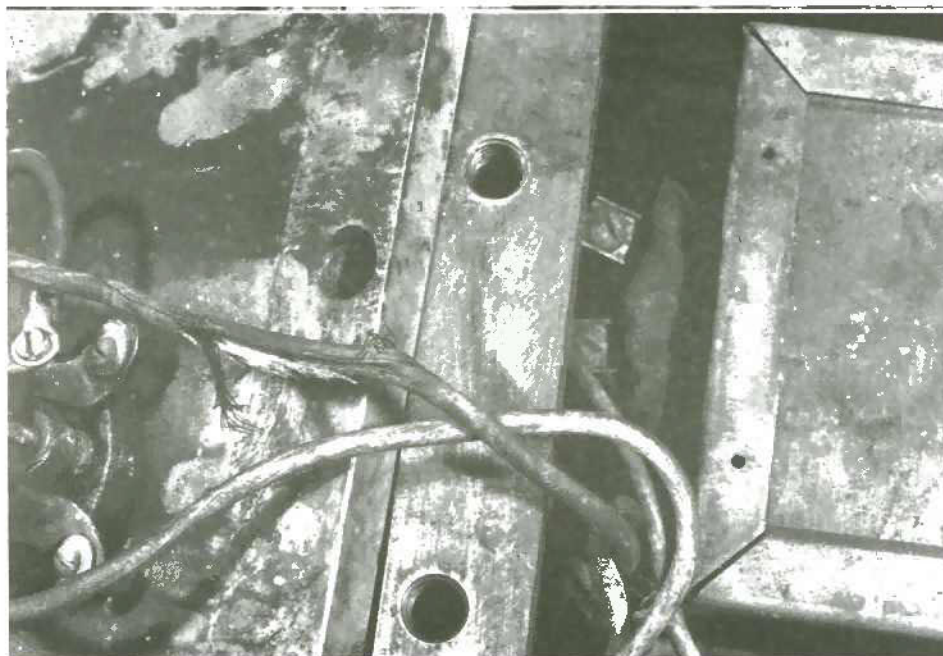
FIGURE 6. - No. 14 wire inside the McJunkin Corp. lighting system box.

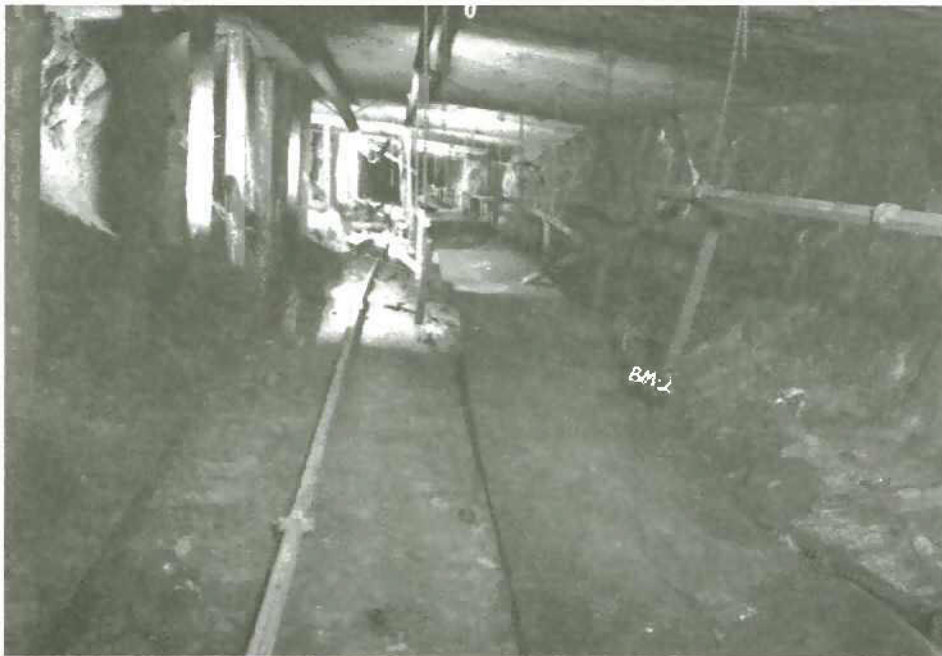
torn apart. Cap lamps and self-rescuers were torn away from the victims. Posts were dislodged and scattered, and the shuttle car canopy was lifted off the car parked at the belt feeder, and moved 50 feet outby in the No. 1 conveyor belt entry. The conveyor belt was blown completely out of the belt tailpiece, and the conveyor belt and belt structure and pipelines were extensively damaged and blown into a pile along the rib. A section of the conveyor belt and belt structure starting 650 feet from the belt tailpiece and running 275 feet outby remained intact. Three prefabricated metal overcasts at the mouth of the 102 Section were dislodged and destroyed. Figures 7-11 in Appendix L are photographs of this damage.

FIGURE 7. - Belt destruction 102 section.

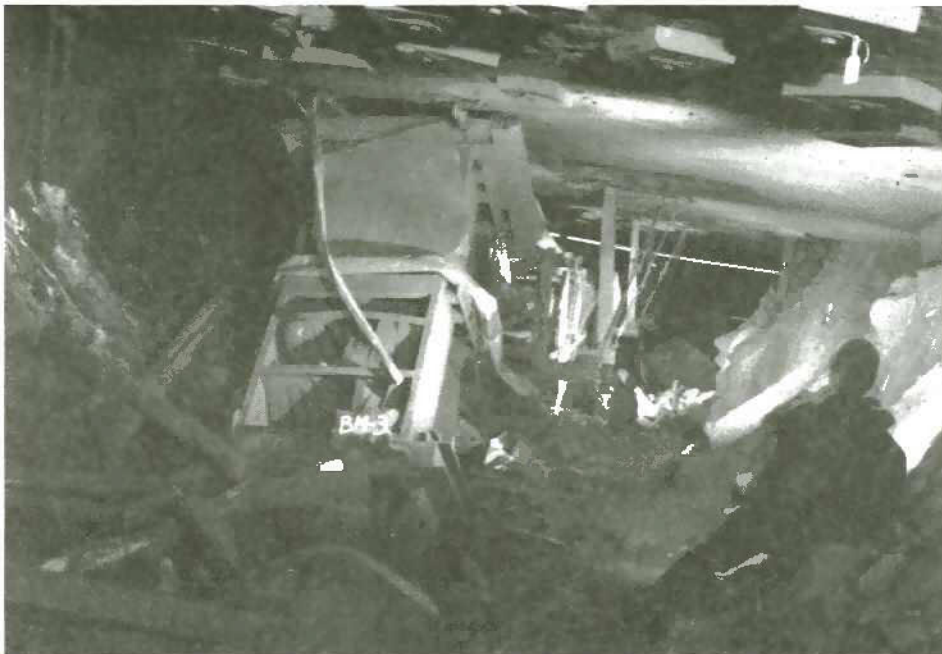
FIGURE 8. - Belt air lock 63rd x cut No. 7 slope.

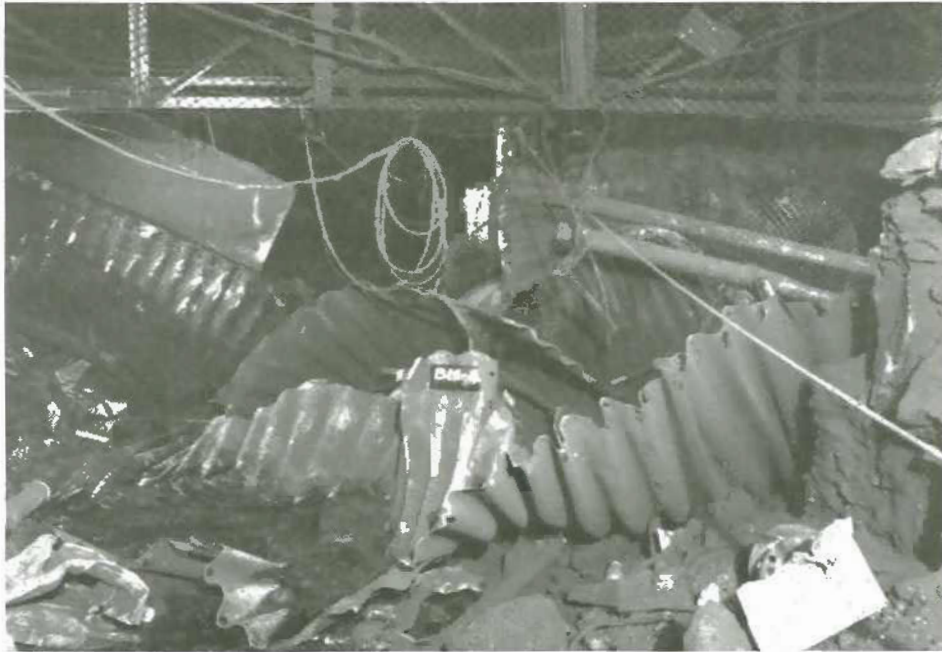
FIGURE 9. - Overcast destruction No. 6 slope 63 x cut.

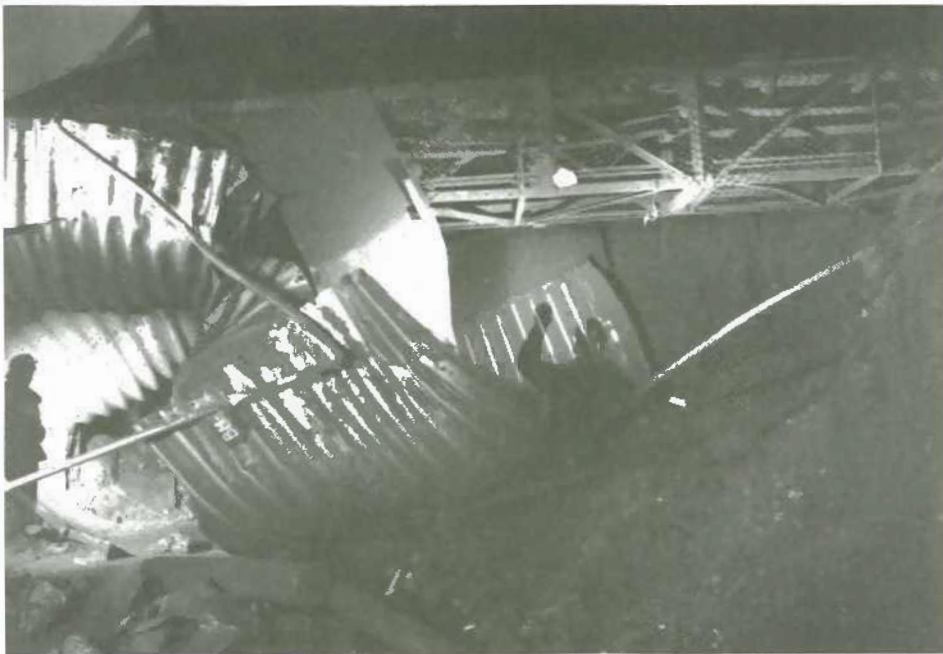
FIGURE 10. - Overcast destruction No. 5 slope No. 63 x cut.

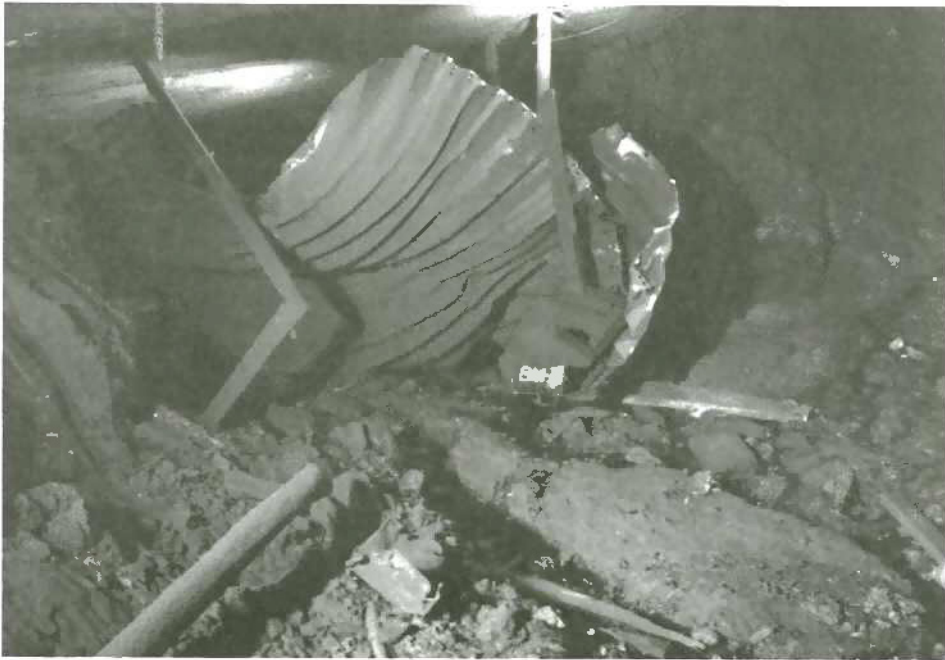
FIGURE 11. - Overcast destruction No. 64 x cut No. 7 slope.

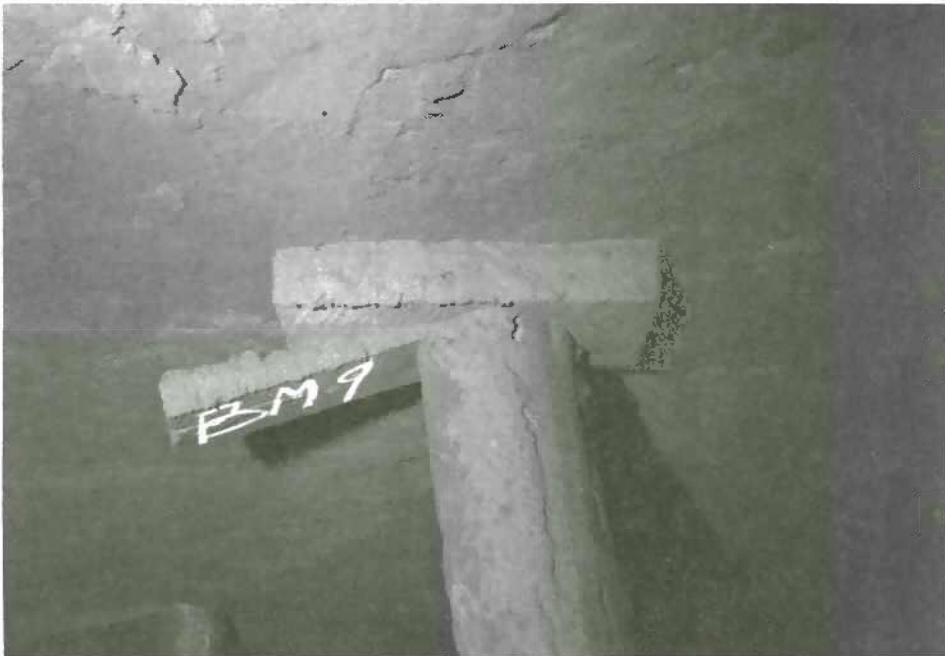
Flame: Partly burned paper, melted plastic brattice material, soot deposits and coke on the roof, on one or both sides of posts, on mining equipment, and in other places was visibly evident in the 102 Section and in the slope entries from the faces as far outby as No. 56 crosscut in No. 6 entry. Severely charred posts were found in the Slope Section. In the 102 Section, soot and some coking was evident throughout the length of the No. 2 entry, but only sporadically in the No. 1 entry. The slower moving flame in the No. 2 entry lent itself to coke formations while higher flame speeds in the belt entry inhibited coke formation. Inby the last open crosscut of No. 1 entry, coke was observed as if splattered on the mine roof above the continuous mining machine and on the only post in the face area remaining intact, 12 feet outby the cutting head of the continuous mining machine.

FIGURE 12. - Heavy coke on post about 20 ft outby last open  
x cut No. 2 entry 102 section.

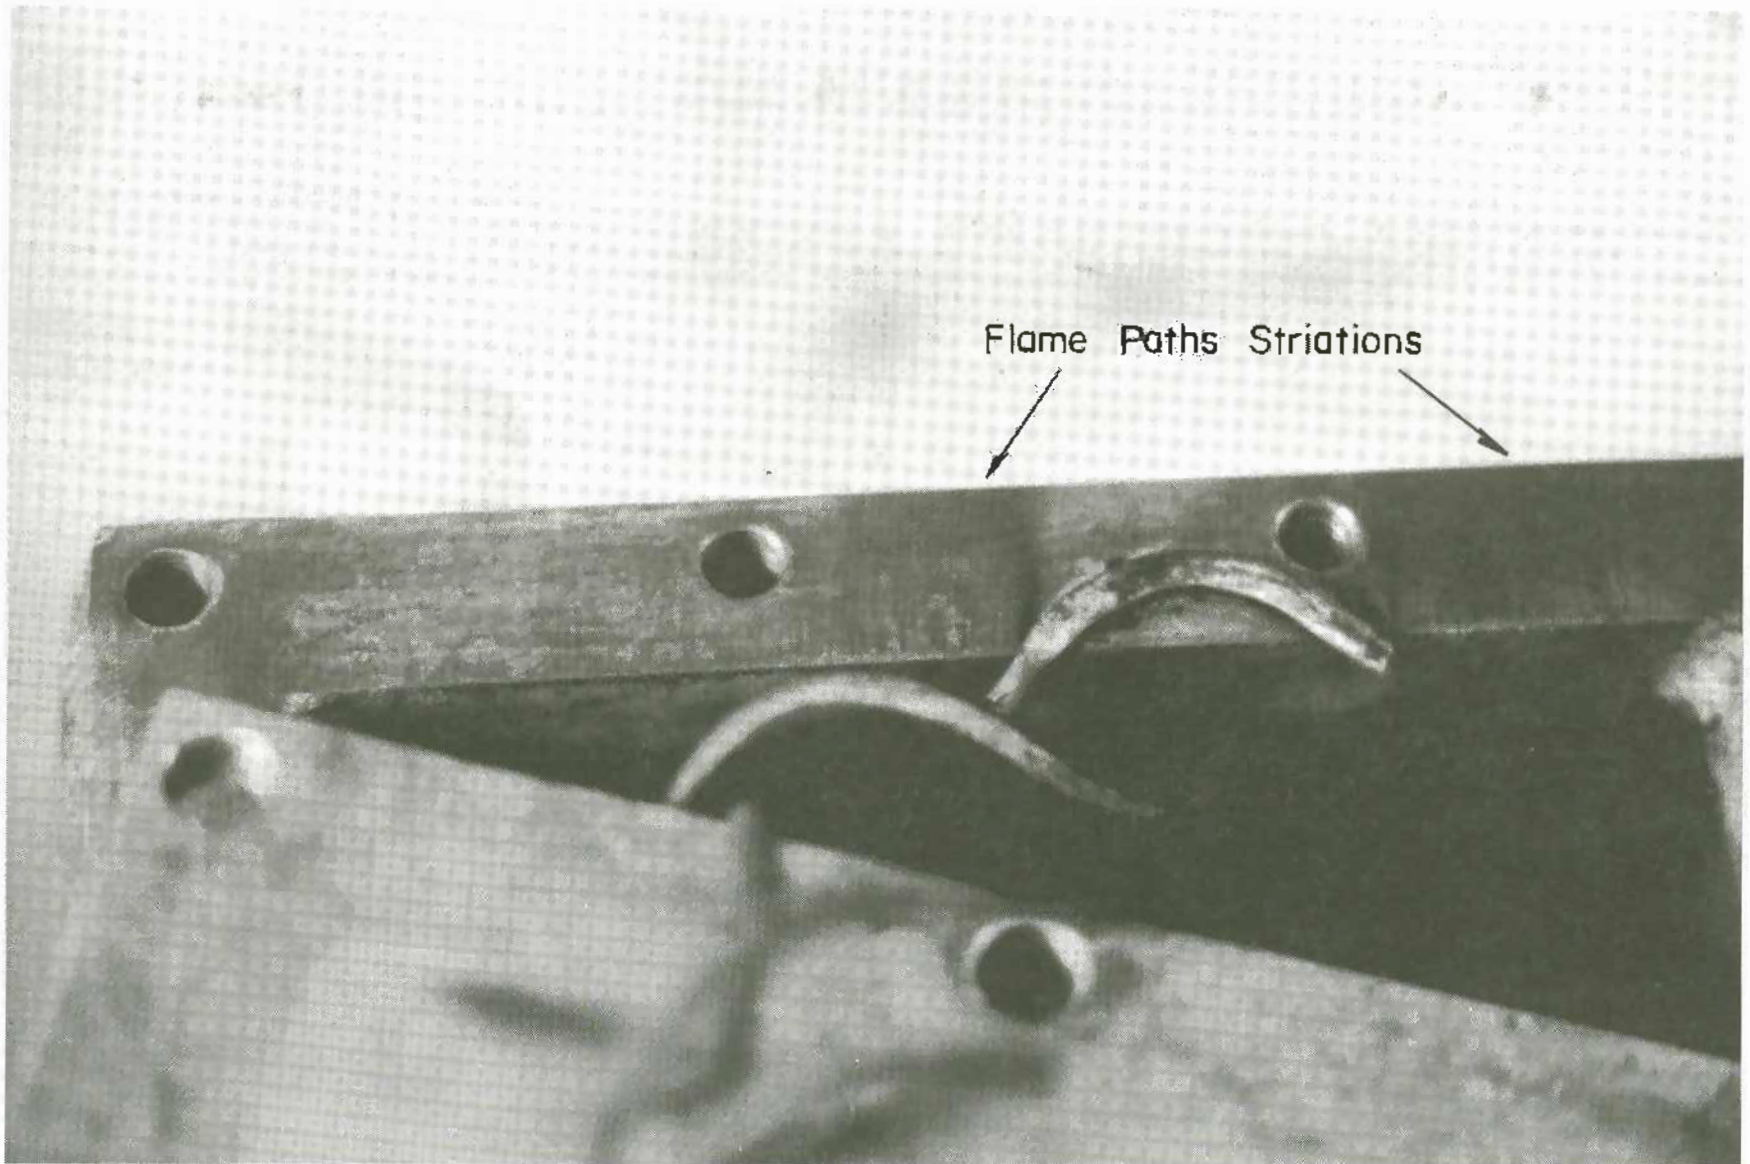
FIGURE 2 - Original Box showing fingers in dust on both sides of pinched wire.
