# **Quarterly Training Summit**

## **October 2016**

**U.S. Department of Labor**  
**Mine Safety & Health Administration**

**10/18/2016**

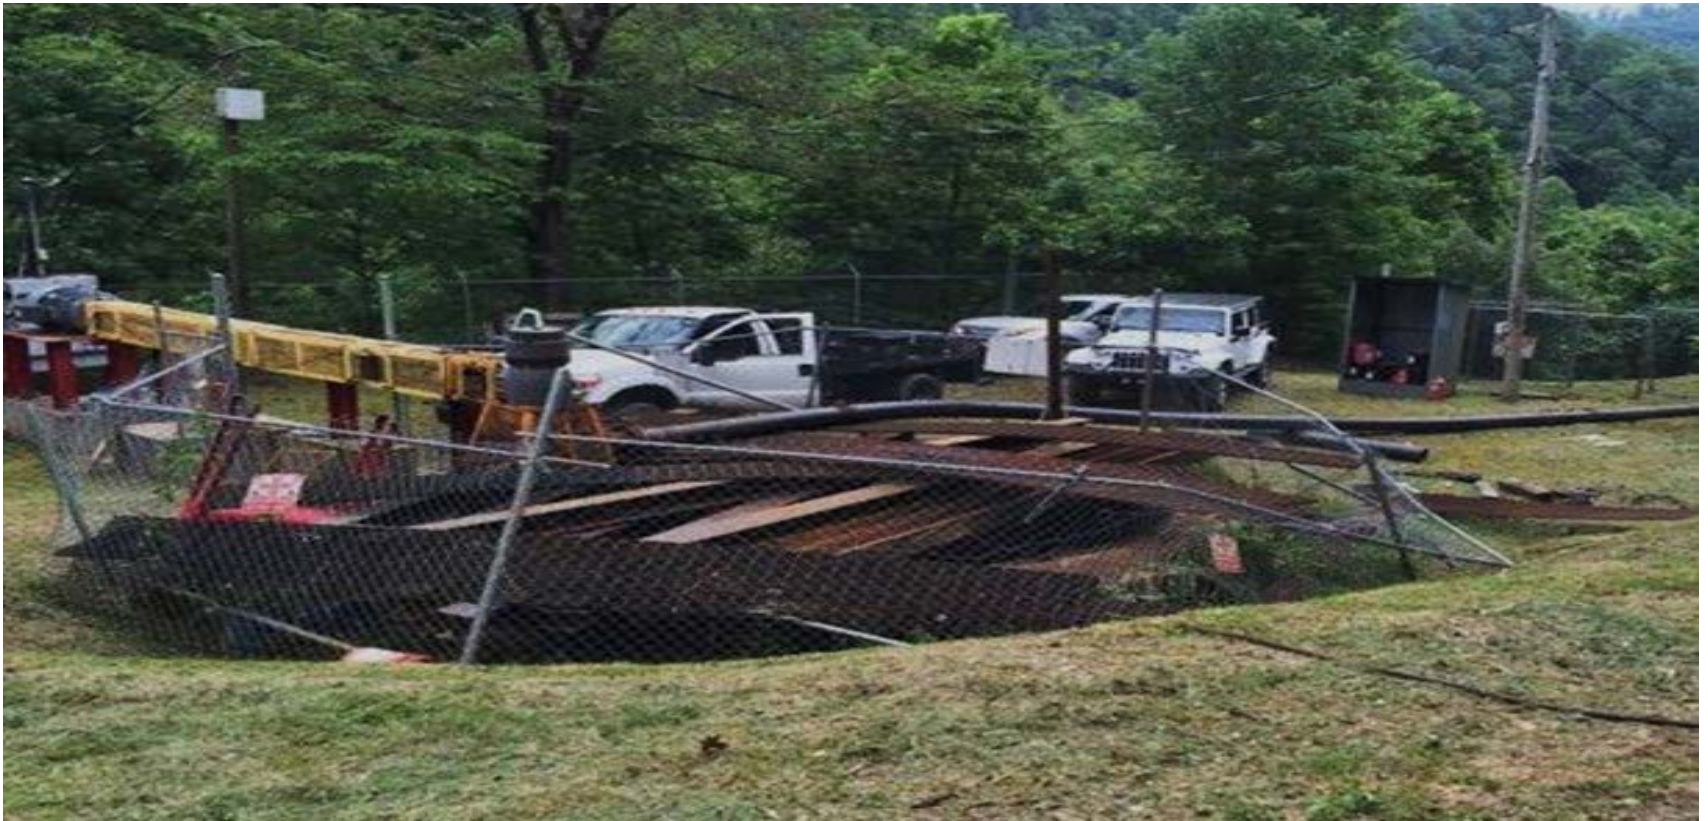
Fatal No. 7 - On Friday July 29, 2016, a 58-year-old miner with 40 years of mining experience sustained fatal injuries when an ignition occurred in the shaft he and another miner were working above. Two miners were welding threaded blocks to secure guarding around the drive-shaft between a motor and dewatering pump. Methane ignited within the shaft, and the victim was in the direct line of the ignition force. On August 4, 2016, the victim died from the injuries received during the accident.

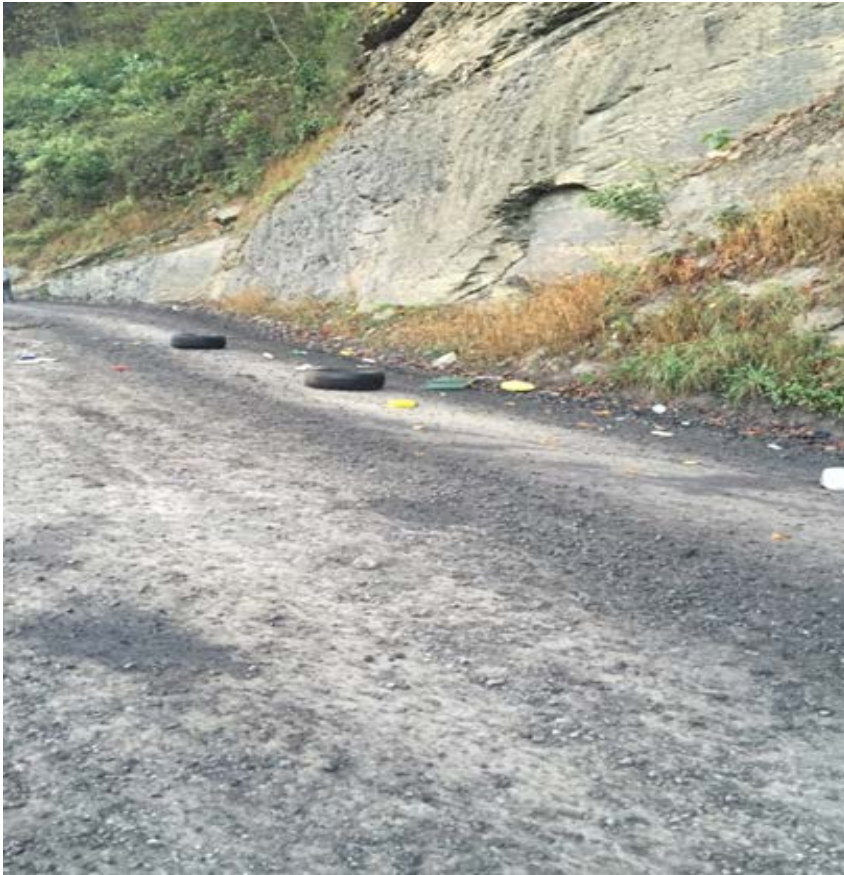
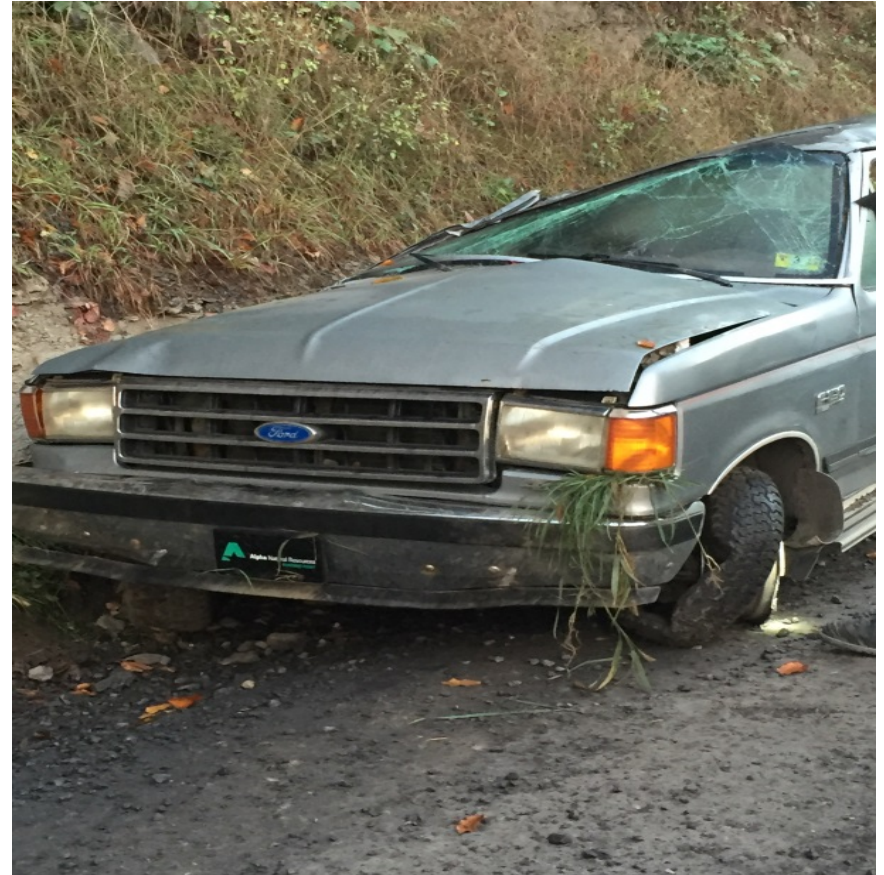
Fatal No. 8 - On Friday September 23, 2016, a 46-year-old miner was fatally injured in a vehicle accident that occurred along a portion of a mine's access/haul road. The victim (passenger) and a coworker (driver) were traveling down an inclined portion of the road when the driver apparently lost control of the pickup truck, causing it to strike the road berm and roll over in the roadway.

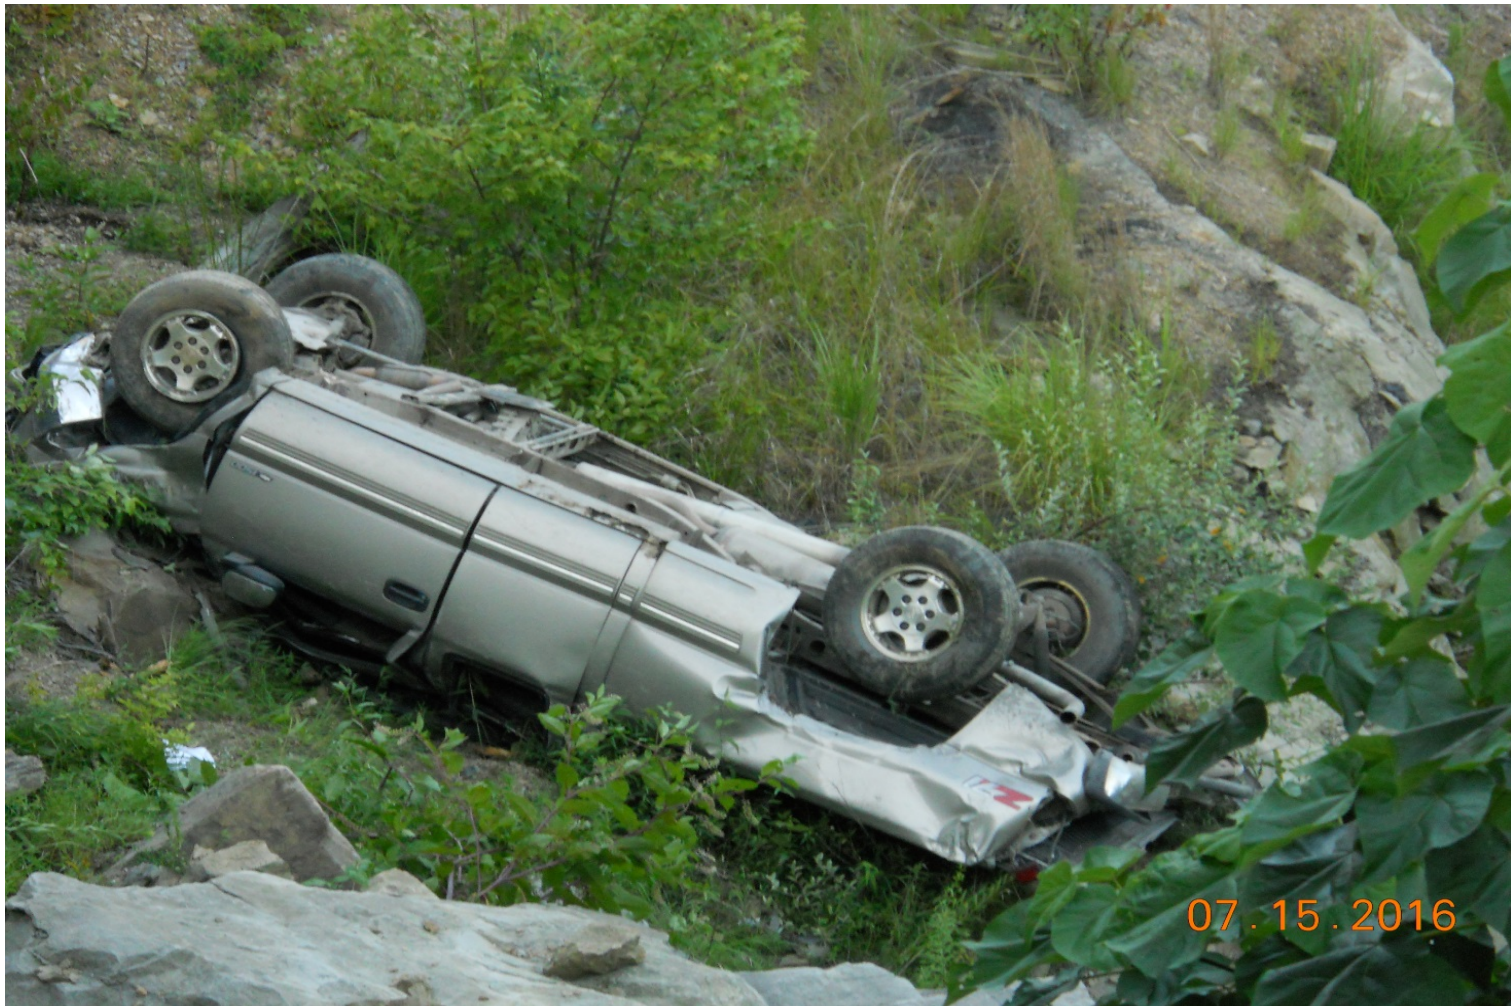
A miner was driving his personal truck to shut off a pump at the end of his shift when the truck lost its brakes and went over the berm of the roadway, traveling over 200 feet and coming to rest at the edge of an impoundment. The driver was transported to the hospital and treated for a broken leg.

- Ensure traffic rules are standardized and properly posted.
- Ensure miners are aware of hazards when operating personal vehicles on mine property.
- Ensure roadways on embankments are safe to travel and properly protected by guardrails and/or berms.

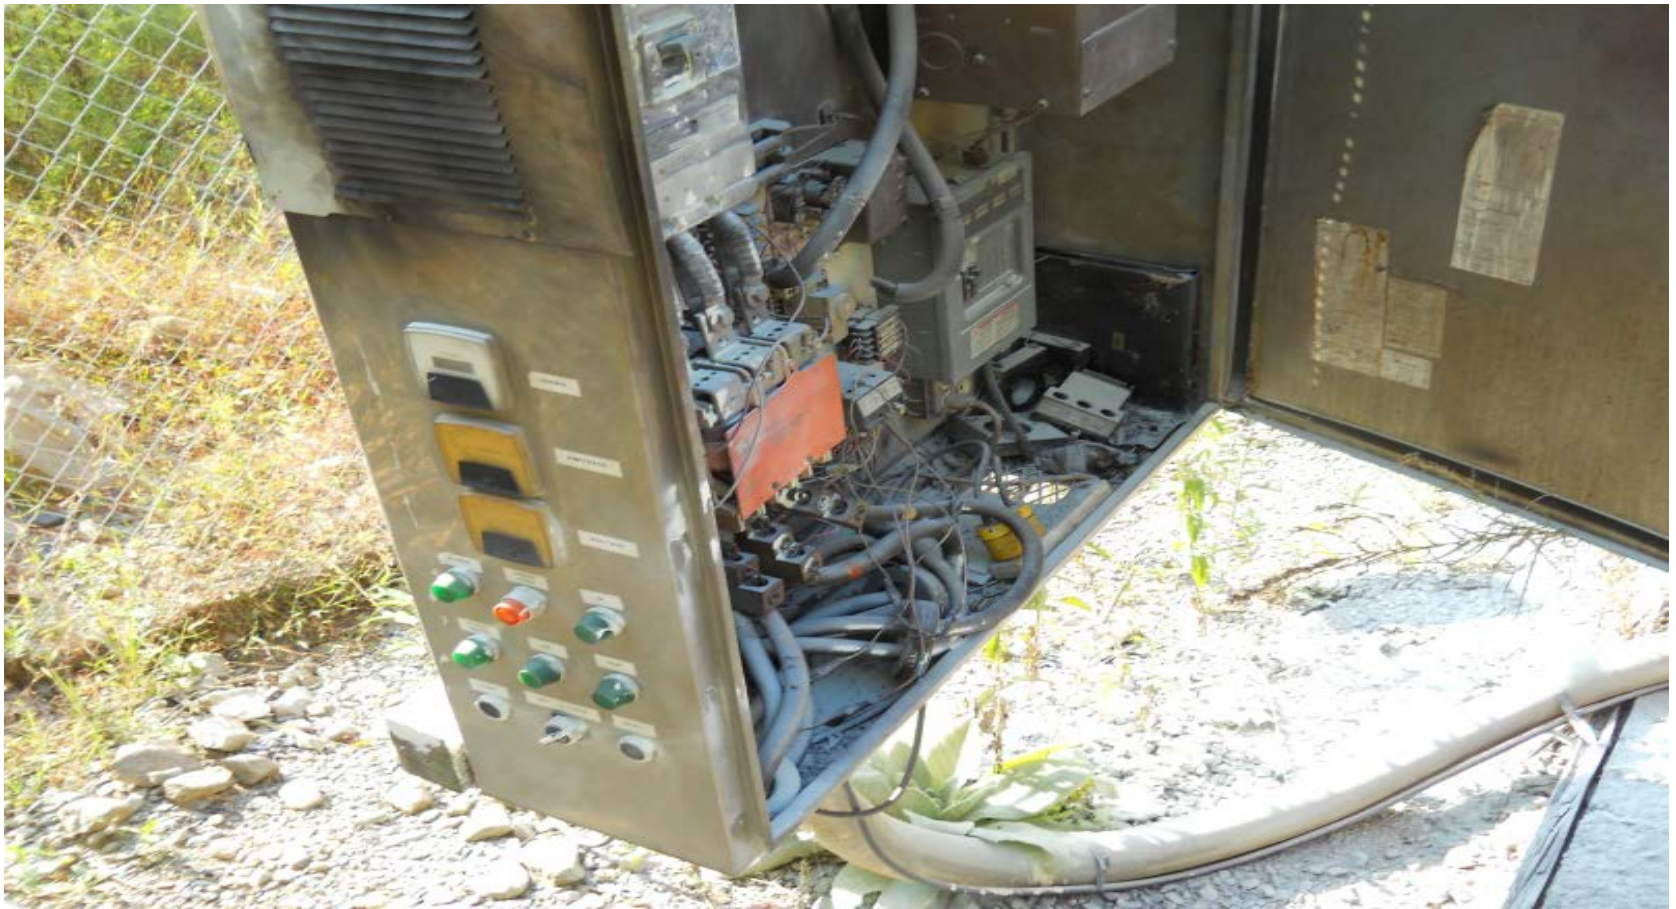
A miner attempted to start a 400 horsepower, 460 VAC pump motor (435 full load amperes) when two phases short-circuited causing an electrical arc. The heat from the arc escaped the starter enclosure and caused second-degree burns. The short circuit occurred because the high amperage of the motor caused the phase connections to the circuit breaker to loosen over time.

- Ensure electrical circuits and switches are safely designed and installed.
- Perform complete and thorough electrical examinations.
- Properly maintain electrical circuits to ensure continued safe operation.

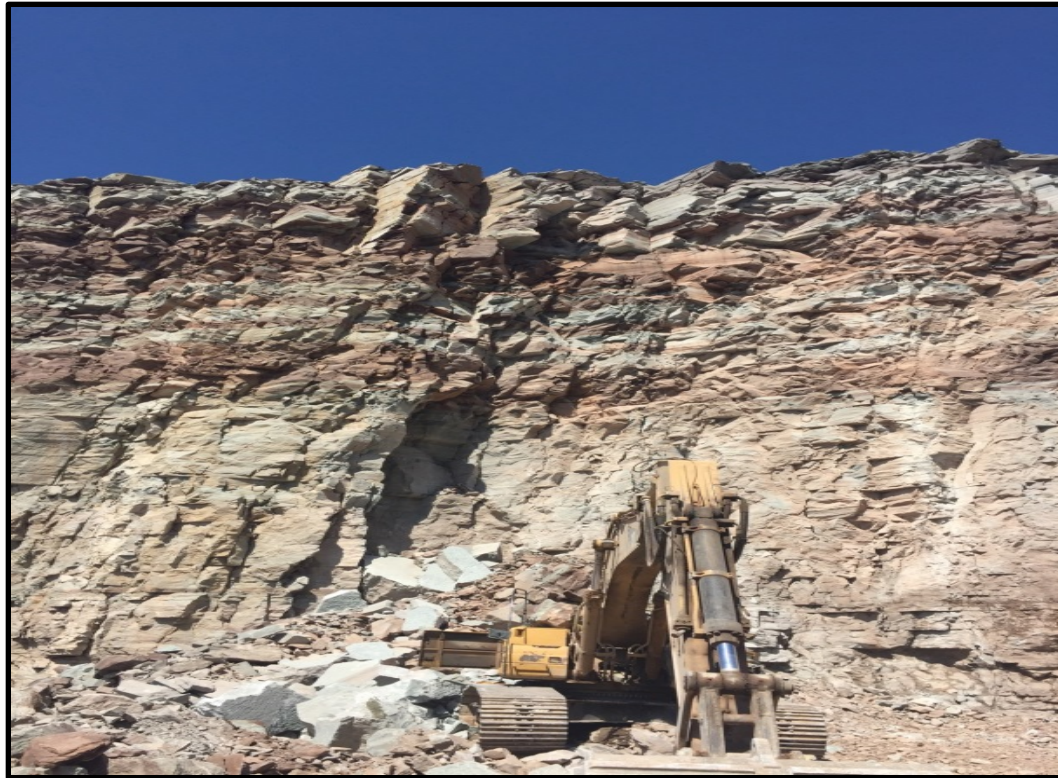
On July 25, 2016, a 59 year old Excavator Operator, with 17 years of experience, was killed at a limestone quarry. Prior to the accident, the victim was loading shot rock into haul trucks. While waiting for the haul trucks to return, the victim was separating out over sized rocks when the cab of his excavator was struck by falling material from the highwall.

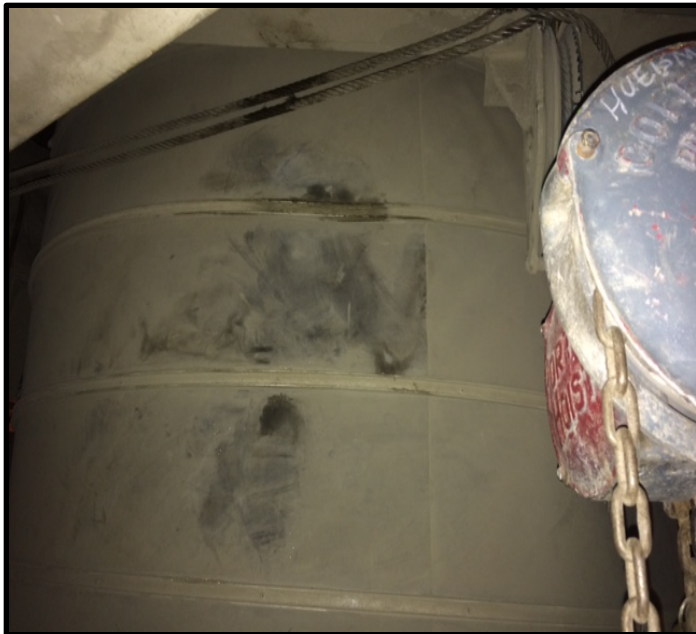
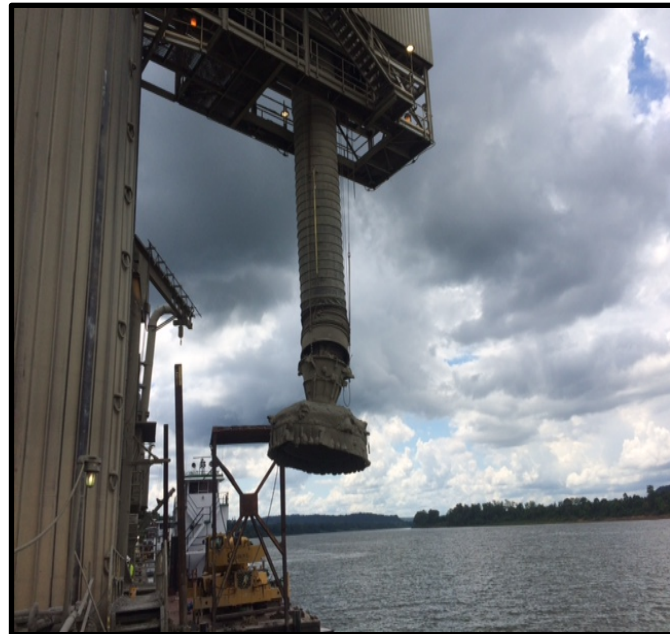
On August 9, 2016, a 33 year old Leadman Contractor, with 4 years of experience, was killed at a cement plant loadout. The victim was attempting to replace the lift cable pulleys on the barge loadout chute, when the anchor point for the temporary rigging separated from the loadout chute and it unexpectedly fell. The falling loadout chute caused the lift cables to tighten and the lift cables pinned the victim to the loadout chute causing fatal injuries.

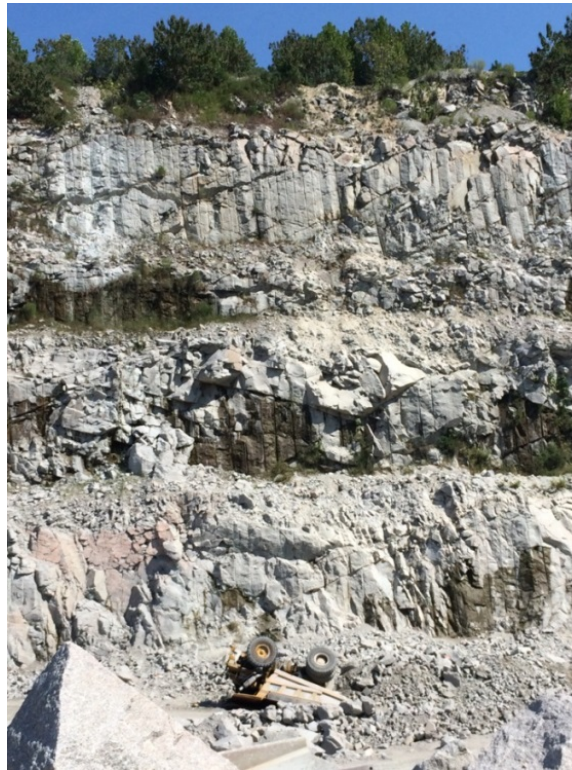
On September 8, 2016, a 58-year old Haul Truck Operator with 23 years of experience was killed at a granite mine. The victim was operating a Caterpillar 773E haul truck and was returning to the pit to be loaded with shot rock. The truck veered from the right side of the haul road to the left and traveled over the berm at the top of the highwall. The truck landed upside down approximately 150 feet below. The victim was found outside the haul truck.

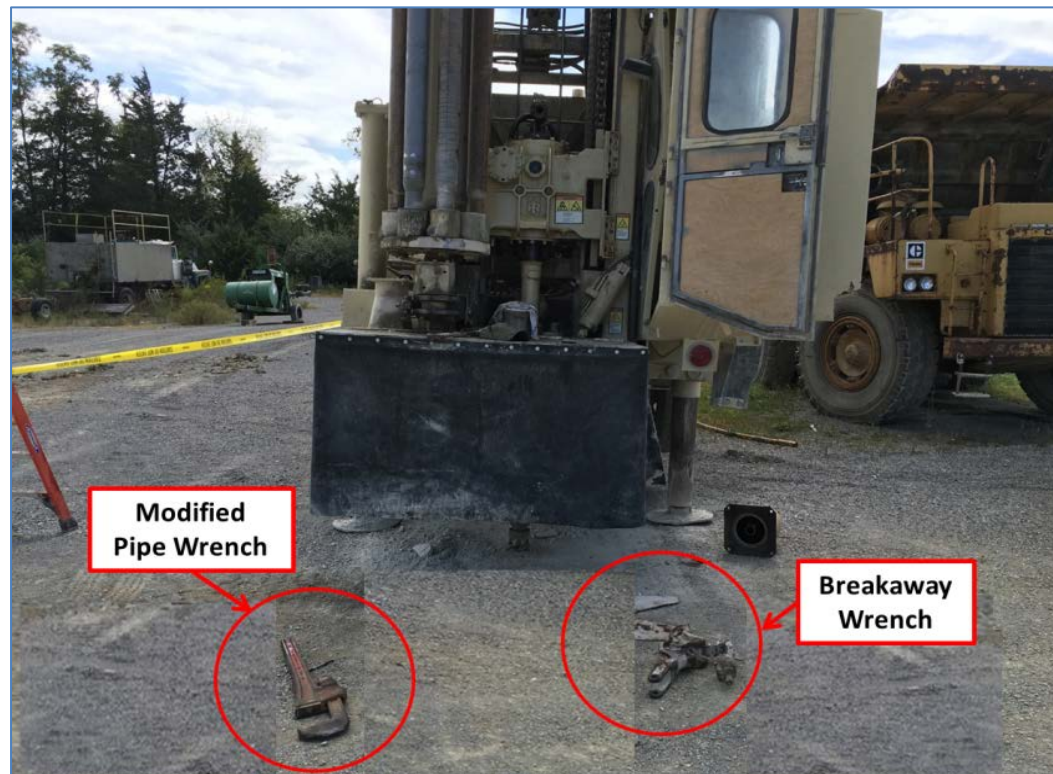
On September 21, 2016, a 52 year old contract drill operator / mechanic, with more than 30 years of experience, was killed at a limestone mine while attempting to remove the spindle cap from the top of the drill head while standing on the drilling deck. The victim was using a modified pipe wrench in an attempt to loosen the spindle cap. As the victim activated the drill's rotation lever, the wrench swung and struck him in his abdomen. The victim was transported to a local hospital and died later that day as a result of his injuries.

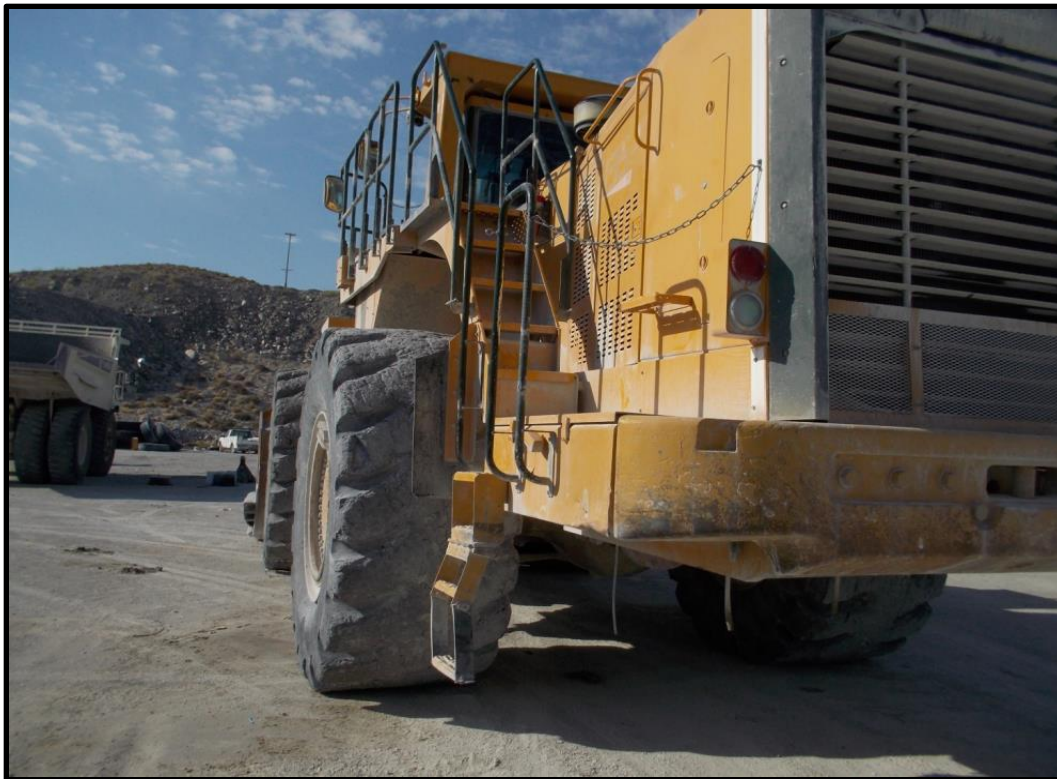
On September 15, 2016, a 60 year old Mechanic, with 28 years of experience, was fatally injured at a Magnesite facility. The victim was seriously injured when he fell while dismounting a front end loader. The victim was hospitalized and died on September 26, 2016.

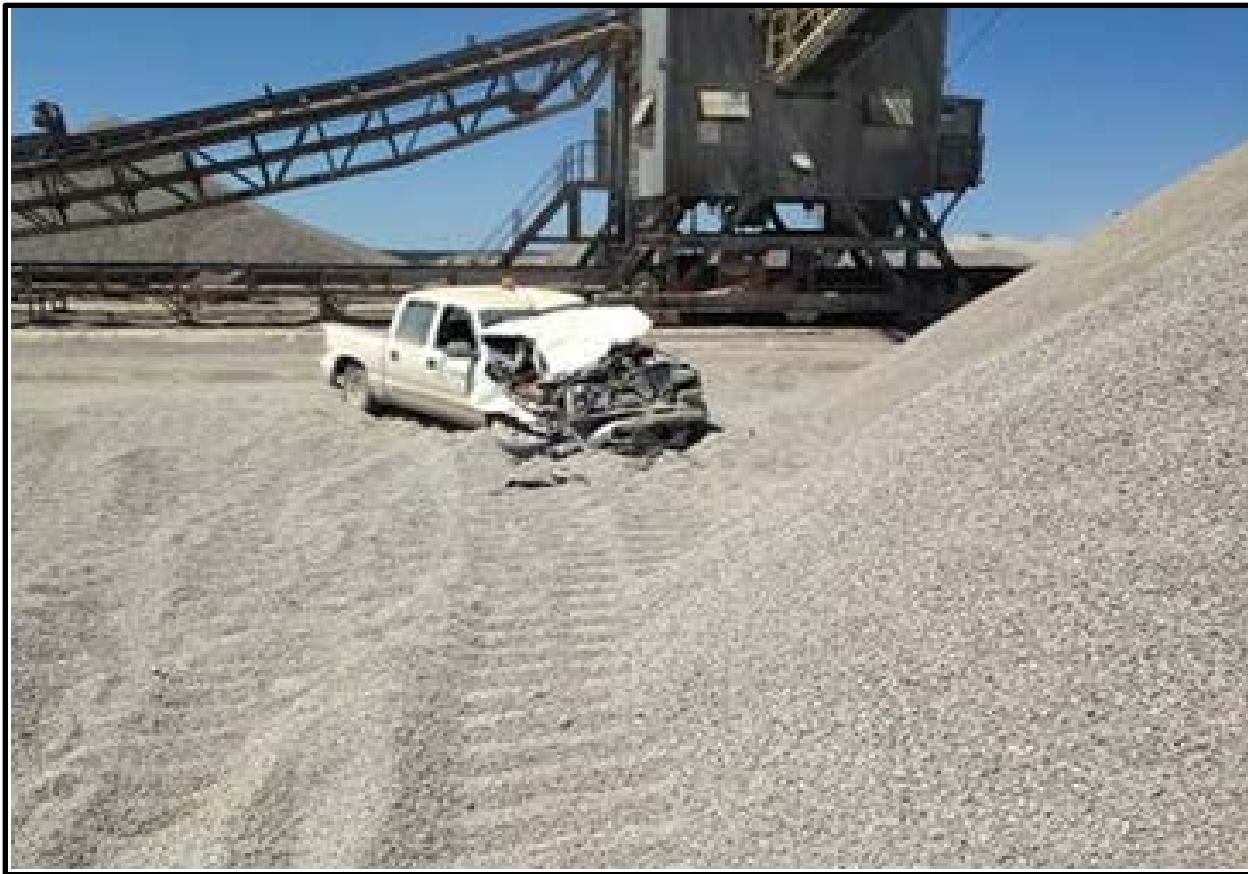
A dozer operator ran over a parked pickup truck. The pickup driver attempted to drive closer to the dozer instead of parking next to the conveyor and got stuck in the loose gravel. The driver was out of the pickup trying to free it and was motioning the dozer operator when the dozer ran over the truck.

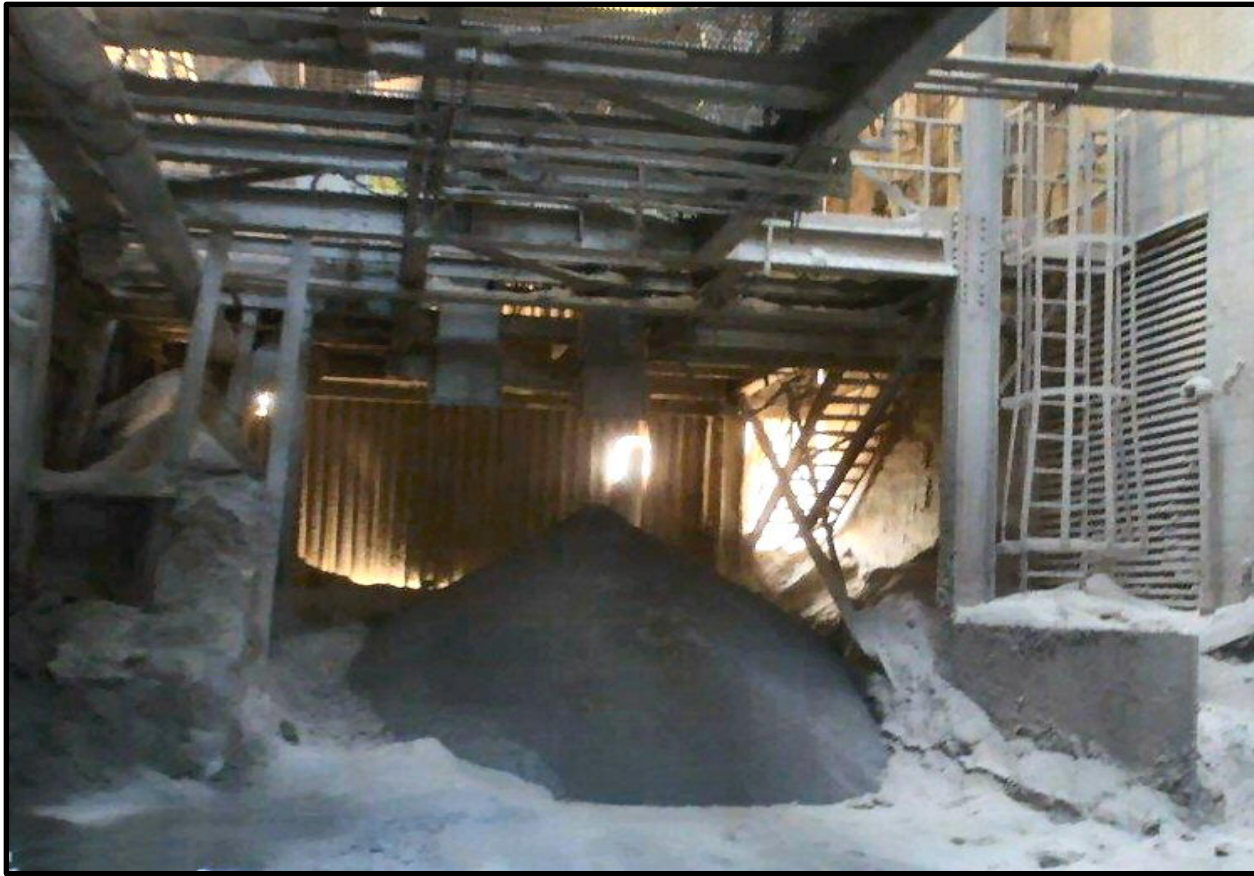
A process control supervisor with six weeks of experience at this facility entered a waste dust discharge and collection area to unchoke a long, nearly-vertical 12-inch diameter pipe. When he struck the bottom of the pipe with a sledge hammer, fine material heated to over 1200oF flushed down the pipe and spilled over him. He suffered life-threatening burns.

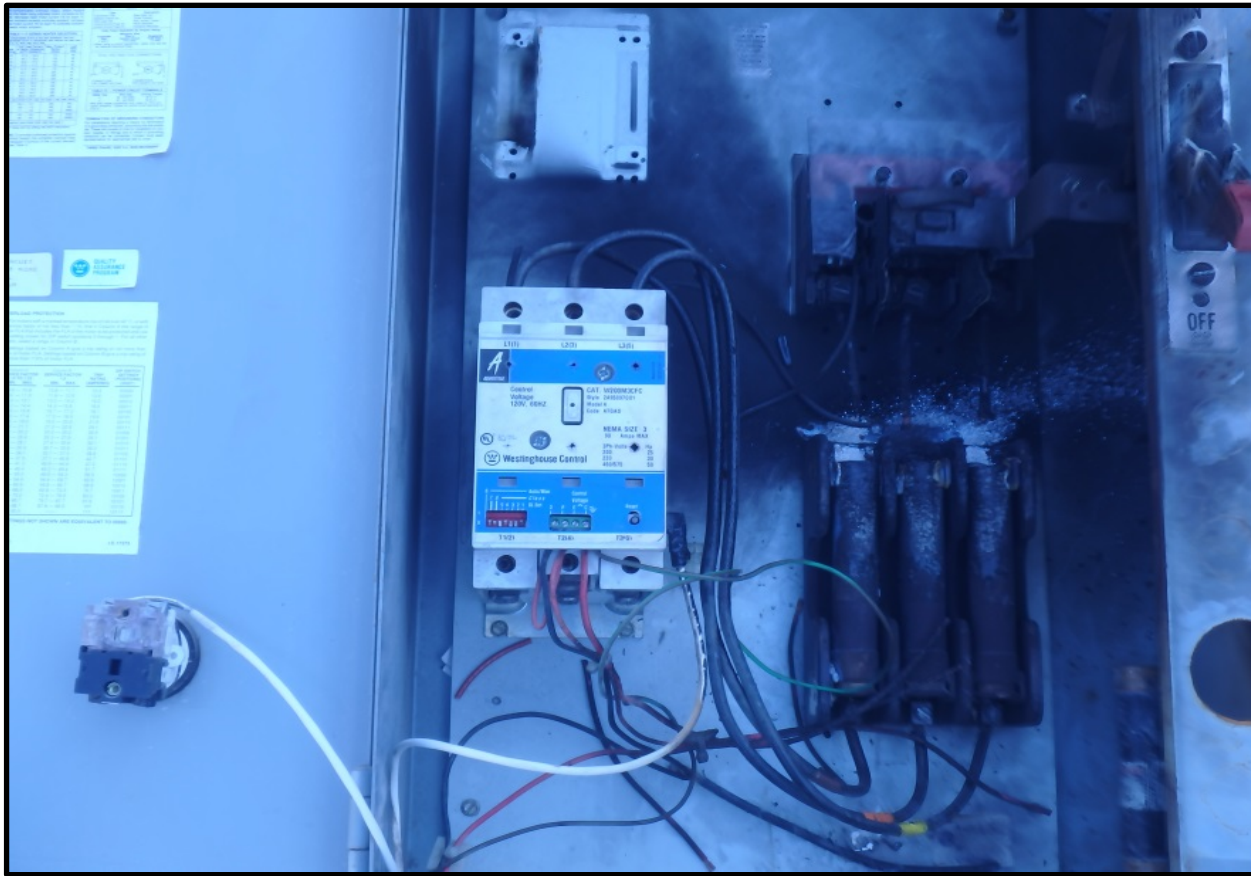
An electrician was working on an energized three-phase electrical circuit for a water pump. After replacing a blown fuse, the electrician noticed the pump motor was single-phasing. While attempting to attach the third phase, he accidentally dropped the wire across an energized lug. The electrician received a severe flash burn to his hands..

- Ensure a travel lane is clear before moving a vehicle. Train miners to not walk or stand in travel lanes.
- De-energize, lock out and tag out all power circuits and electrical equipment before performing any work on electrical circuits and equipment.
- Provide and wear appropriate personal protective clothing, such as high-temperature protective jackets, pants, shoes and helmets, when handling or working around superheated materials
