Massive Pillar Collapse: A Room-and-Pillar Marble Mine Case Study

Sandin E. Phillipson, Geologist
Roof Control Division MSHA
Pittsburgh, PA

31st International Conference on Ground Control in Mining

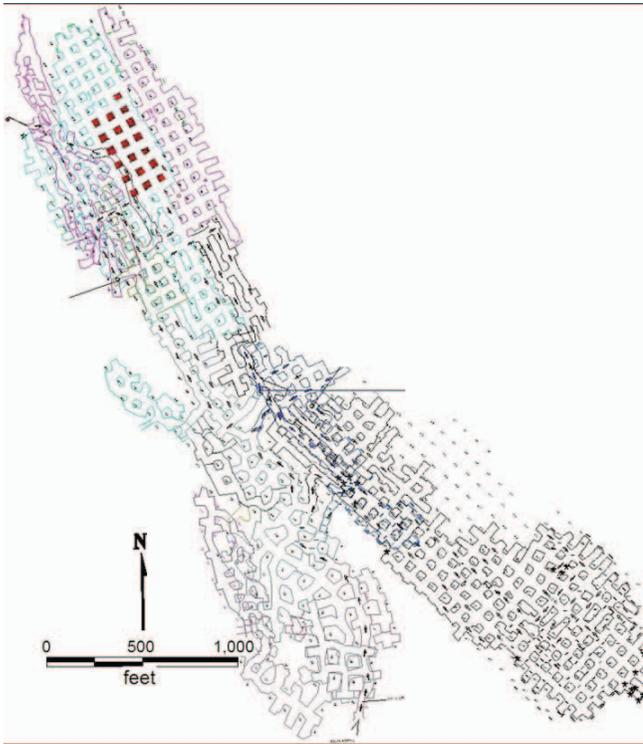
Figure 2. General mine map, showing extent of pillar failure area (red) in relation to the rest of the mine. Prominent “dog leg” represents change in strike and dip of the marble deposit, and coincides with a change in ground conditions.

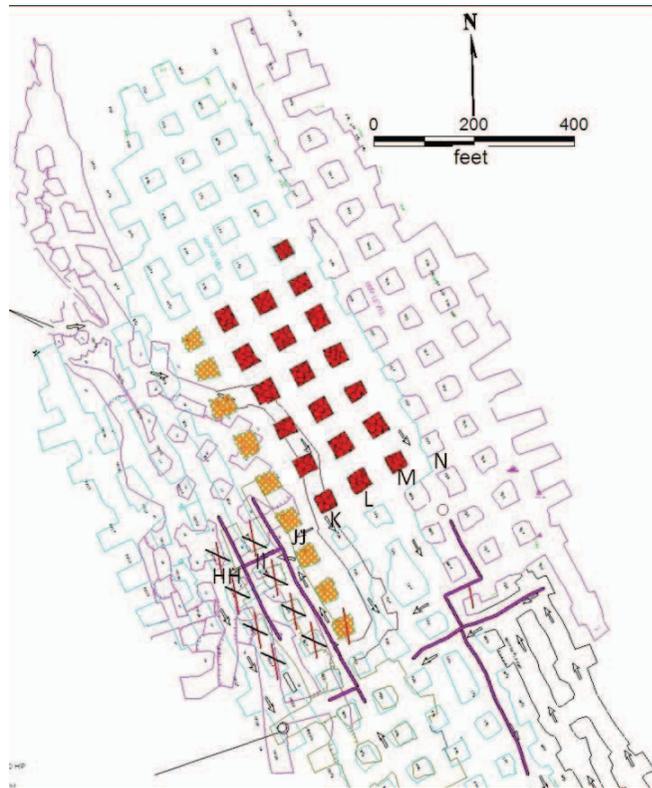
Observations in the collapse area were conducted at the southern and western margin of the benching area (Figure 3). At the southwestern margin of the benching area, the west sides of the pillars are 25 ft high where benching ceased but are 50 ft high on the east side, where they have been exposed by benching or where a ramp had been driven onto the 920-ft level (Figure 4). The roof of the drift, even at the margin of the collapse area, was extensively damaged with what appeared to be recent small falls of rock, accompanied by pillar sloughing, based on the bright, fresh surfaces exposed in contrast to the dark soot coloration on areas that had remained intact for a long period of time. In this area, the contorted marble beds strike approximately N 05° W and dip up to 20° E. Prominent, iron-stained joints strike parallel to the marble but dip perpendicularly to marble banding (N 10° W, 63° W). A second, less prominent joint set strikes N 65° W and is oriented vertically.

Figure 3. Map of collapse area, showing observation traverse (heavy purple line) and damaged pillars (red = believed to have failed; orange = taking weight, exhibiting degradation). Red lines represent prominent, iron-stained joints; black lines represent joints. Collapse was localized to the benched area of the 920-ft level, shown in light blue.

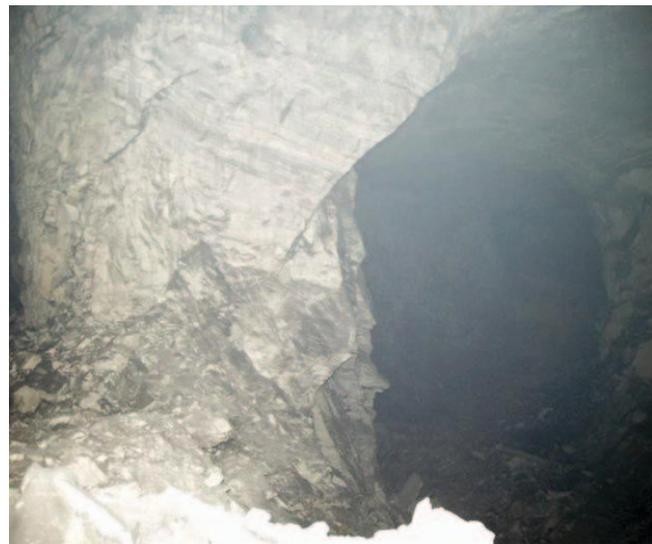
Figure 4. The row of pillars at the margin of the benched area is characterized by extreme degradation, with the eastern portions (facing the benched side) 50 ft tall and exhibiting failure along pre-existing geological structures.

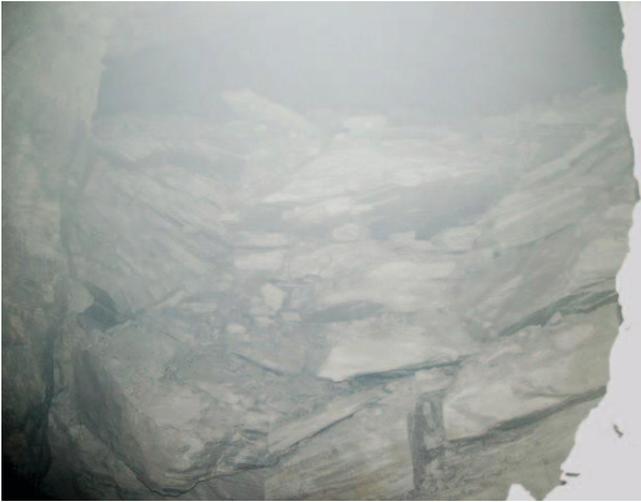
The roof fall material consisted of very large, angular blocks and slabs (6-10 feet long) that were piled up above the 50-ft high roof line, obscuring any pillars that might have remained in the interior of the fall rubble (Figure 5). The lip of a very large fall cavity was visible in the roof, although the top and inside surfaces could not be discerned because of condensation in the air that obscured long-distance vision. The large blocks were jagged-edged and did not generally exhibit flat surfaces that would be indicative of unraveling along joints. Instead, the blocks' jagged edges were suggestive of failure by bending stress.

Figure 5. Roof fall debris is composed of very large blocks. The photo vantage point is approximately 40 ft from the rubble.

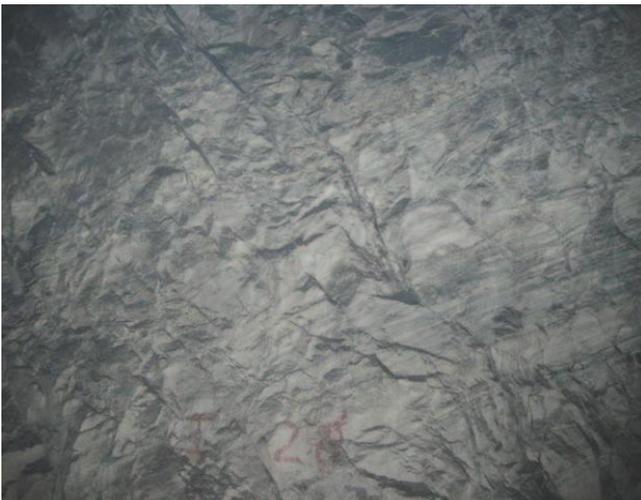
Figure 6. Open-aperture joint, which strikes N 10° W and dips 63° W, is located in the center of pillar II28. This orientation of joints typically runs diagonally from corner to corner in the JJ, II, and HH pillars. White outline represents close-up shown in Figure 7.

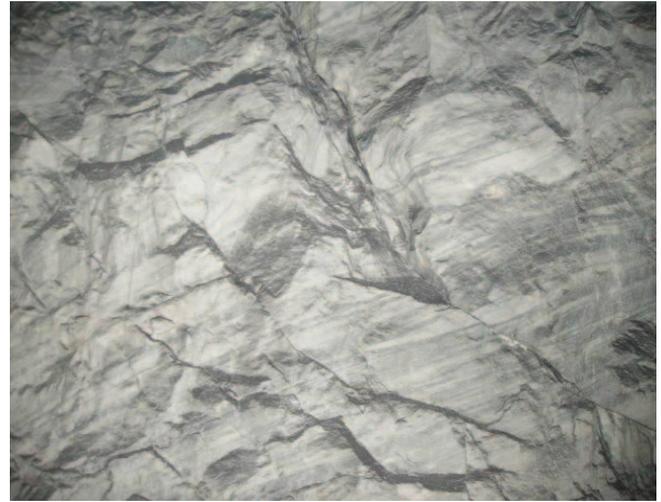
Figure 7. Close-up of Figure 6, showing open aperture along joint that penetrates deeply into the pillar. This feature contrasts with the irregular, localized nature of small fractures that represent blast damage on the pillar skin.

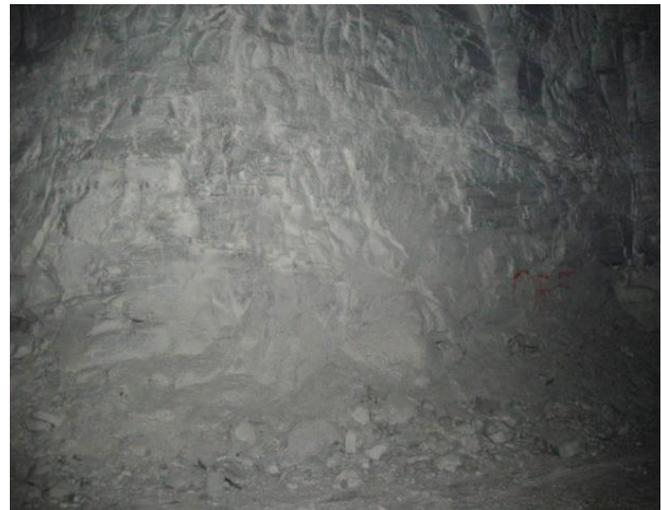
heavy iron staining, indicating open apertures that easily transmit water and offer little to no cohesion between opposing blocks of rock. Second, a change in dip, from up to 20° in the collapse area to less than 10° in the southern, active area results in a more stable roof horizon that is not characterized by a sawtooth profile of intersecting joints. It is interpreted that the sawtooth profile makes it easier for progressive raveling to occur, especially since the mine does not install rock bolts. Although the southern area hosts abundant, closely spaced (10–24 in.) vertical joints that strike N 65° W, they do not exhibit open apertures, and pillars exhibited virtually no evidence of spalling (Figure 8).

Figure 8. Typical condition of pillars on the 820-ft and 890-ft levels, showing an absence of open-aperture joints or evidence of raveling.

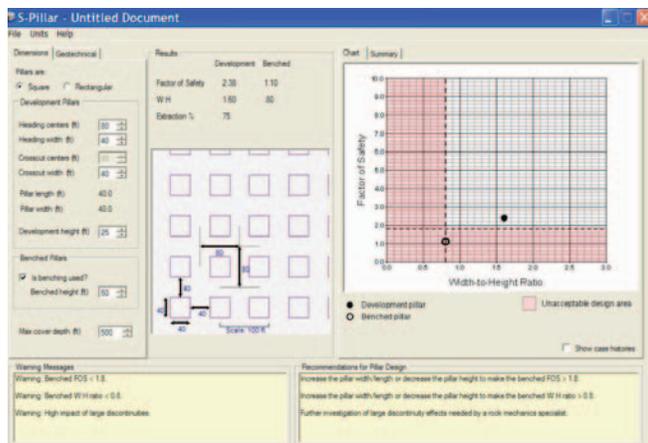
The 920-ft level collapse area shares several similarities with the circumstances of domino-style cascading collapses in coalmines. These types of collapses are commonly characterized by wide panels (350 ft) that encompass more than 4 acres. (The study mine's collapse area encompassed 4.1 acres.) In these collapses, tall, slender pillars (those with a small width-to-height ratio) had been developed (Mark, Chase, and Zipf 1997). It is interpreted that those were finely balanced systems and that the failure of only a single pillar was enough to shed load onto surrounding pillars, precipitating a cascading, rapid failure. Research performed by NIOSH on stone mine pillar performance identified two main factors in predicting pillar instability: 1) width-to-height ratio of 0.8 or less and 2) safety factors of 1.8 or less (Esterhuizen, Dolinar, and Ellenberger 2008; Esterhuizen, Dolinar, and Ellenberger 2011; Esterhuizen, Dolinar, Ellenberger, and Prosser 2011) (Figure 9). Pillar stability was further influenced by the spacing and orientation of planar geologic discontinuities. Pillars in the failed 920-ft level were 50 ft high and 40 x 40 ft, defining a width-to-height ratio of 0.8, cut by high-angle joints that further degraded the strength of pillars that only had a safety factor of 1.1 as calculated by S-Pillar.

Figure 9. Analysis of pillar design on the 920-ft level using NIOSH S-Pillar software for limestone mines. Bench pillars on 920-ft level are solidly outside the acceptable design category, with a safety factor calculated by S-Pillar of only 1.1.

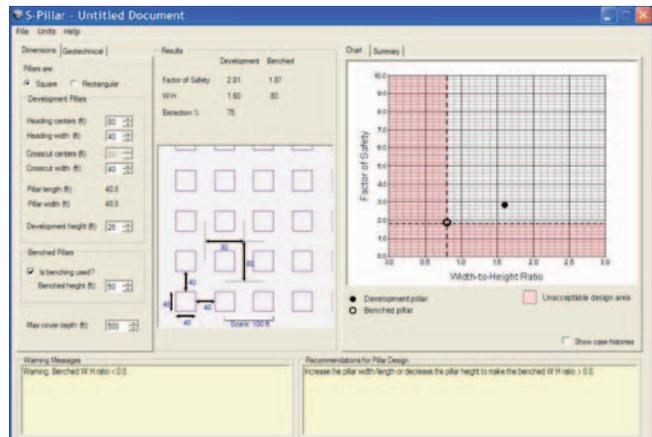
Conditions in the southern, active mining areas appear much better than in the collapse area. The marble exhibits a very low-angle dip so that it is nearly horizontal, greatly reducing the occurrence of wedges in the back. Further, the N 10° W, 65°W joints that represent planes of preferential weakness and negatively influence pillar stability in the north are absent. The 890-ft level is not intended to ever be bench because of the 43-ft sill thickness to the underlying 820-ft level. NIOSH S-Pillar software indicates that for the current 25-ft development height, pillars should display acceptable width-to-height ratio (1.5) and safety factor (2.39) values. The lower, 820-ft level, is intended to be bench. Even though ground conditions appeared good during the underground evaluation, the S-Pillar analysis indicates that, when benching is performed, the resulting pillars will be on the margin of acceptable design (Figure 10). The S-Pillar software illustrates the importance of pillar dimensions used in the pillar strength calculations to determine the pillar safety factor. The software indicates that a 40 x 40 x 50-ft pillar is on the margin of acceptable stability, and the mine must recognize the importance of adhering to the designed dimensions. Despite the intention to mine pillars 40 x 40 ft, with 40-ft mining widths, the widths measured were generally 42–43 ft. The S-Pillar analysis indicates that this loss of pillar volume would be sufficient to transition the resulting bench pillars out of the acceptable design field, as the pillar safety factor is reduced from 1.87 to 1.62.

Figure 10. NIOSH S-Pillar analysis results for benching on the 820-ft level, showing marginal but still acceptable stability.

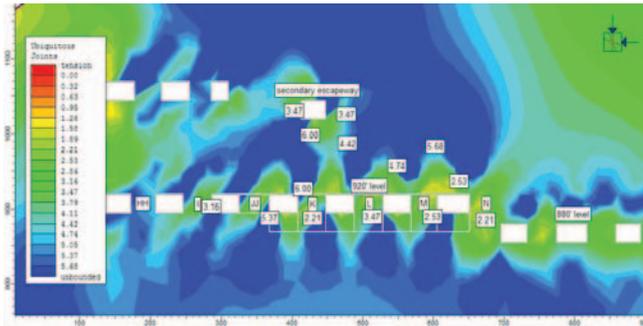
Figure 11a. Distribution of safety factors with development only on the 880-ft and 920-ft levels. Pillar rows are annotated as referred to in the text. Box in upper right portrays orientations of geologic discontinuities incorporated in the model, based on field observations.

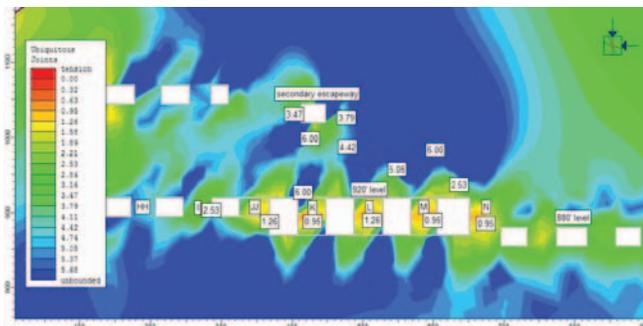
Figure 11b. Distribution of safety factors following benching of the 920-ft level to 50-ft height. Note the significant reduction of element safety factors in benched pillars compared to Figure 11a.

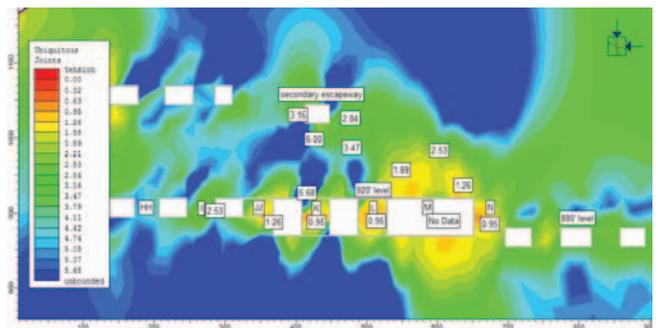
However, the M pillar was chosen as the first pillar row to fail based on smaller-than-planned dimensions on the mine map, and statements from mine personnel indicating that the M pillars had been subject to constant raveling, interpreted as a sign of taking weight, possibly from cantilevering beneath the quartz-biotite schist delamination horizon. Following the loss of the M pillar, interpreted as the most likely to have failed in the benched area, elements in the L pillar also exhibited safety factors of less than 1, and safety factors began to exhibit a marked decrease in the roof of the resulting unsupported area (Figure 11c). With the loss of the L pillar, safety factors in the K pillar were drastically reduced, and safety factor values less than 1 propagated high into the roof,

Figure 11c. Distribution of safety factors following the loss of the M pillar, interpreted to have been the first to fail based on mine personnel accounts.

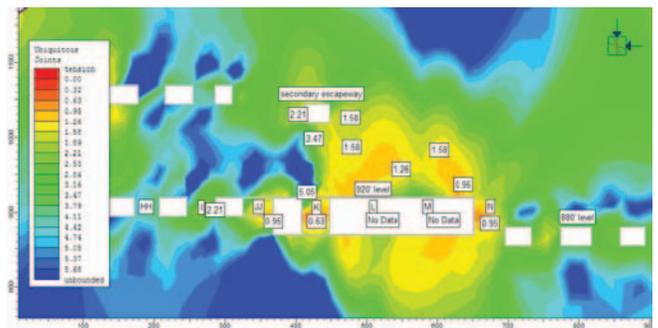
indicating the onset of the large roof fall that occurred (Figure 11d). As failure progressed to include the loss of the K pillar, safety factor values in the JJ pillar were reduced to less than 1, and two arcs of low-value safety factors were shown developing high into the roof, similar to a pair of closing pincers (Figure 11e). Figure 11e represents the observed state of the ground at the time of the investigation, with a large roof fall having developed above the failed pillar area, the JJ (and likely also the N) row of pillars taking weight, and a large reduction in safety factor values for elements in the II pillars. The model results tend to be substantiated by the presence of open joints and freshly spalled surfaces observed on the JJ, II, and HH pillars. It should be recognized that pillars need not have toppled over or collapsed completely in order to represent a state of failure. Instead, it is more likely that the pillars would have gradually crushed out, deforming after a style of strain-softening as incremental movement occurred along numerous joint planes. Most of the pillars likely retained some low level of residual strength and could even exist as remnants among the roof fall debris. However, the pillars are considered to have failed when that residual strength was no longer equal to the axial stress imparted from the weight of the overlying rock mass. With the expected continued destabilization and eventual failure of the JJ pillar, the model indicates the potential for an enlargement of the ground collapse area in the roof so that, even a secondary escape way, prudently abandoned, would be encompassed by safety factor values less than 1, despite being located 100 ft above the roof of the collapse area (Figure 11f).

Figure 11d. Distribution of safety factors following the loss of the L pillar.

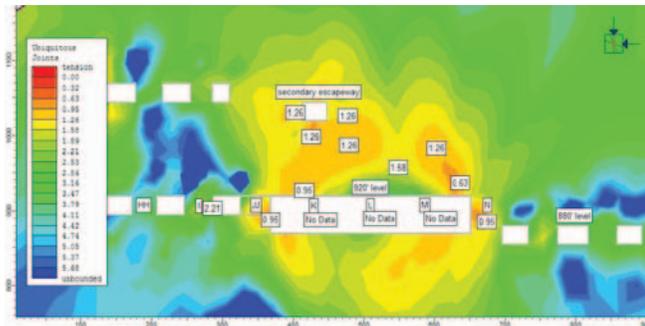
Figure 11e. Distribution of safety factors following the loss of the K pillar. The distribution of low-value safety factors generally mirrors the shape of the large roof fall cavity that was observed during the underground investigation. Note the low safety factors affecting the JJ pillar, which is substantiated by field observations as indicated in Figure 4.

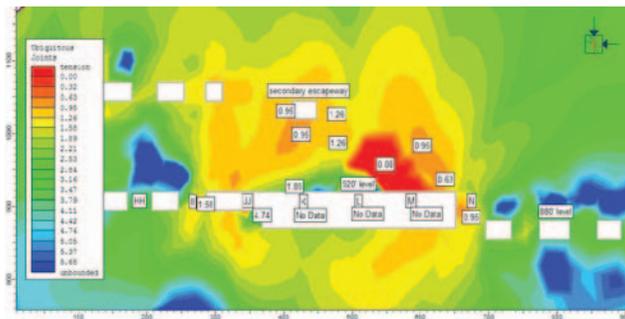
Figure 11f. Distribution of safety factors following potential, but likely, loss of the JJ pillar. With the loss of the JJ pillar, the potential ground collapse area expands to encompass the former secondary escapeway, located approximately 100 ft above the 920-ft level. Safety factor values in the II pillar have been greatly reduced, as substantiated by field observations as indicated in Figures 6 and 7.
