## Fatality Alert

This is the 39th fatality reported in 2023, and the 15th classified as “Machinery.”

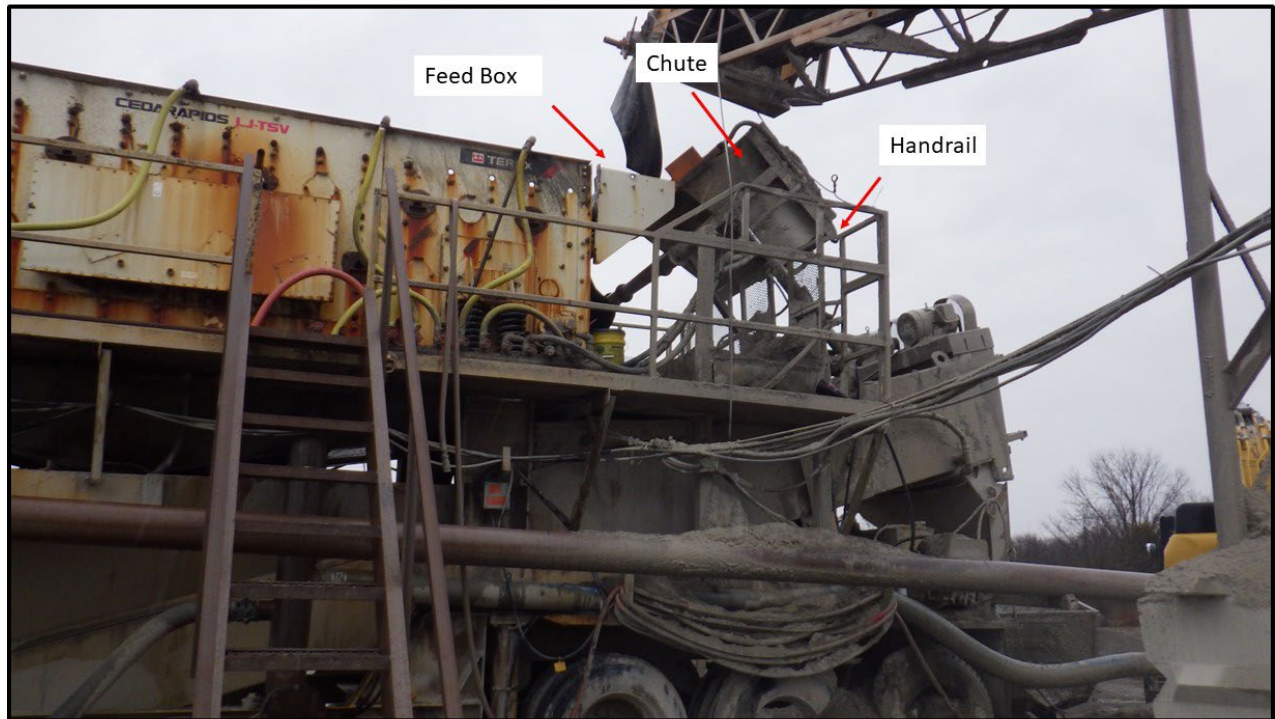
MINE FATALITY – On December 14, 2023, a miner died while preparing to repair flanges on the feed box. In the process of lowering the chute into the maintenance position, the chute pinned the miner between the chute and the handrail.

- Block machinery components against motion before beginning maintenance or repairs and verify miners are in a safe location before moving equipment and components.
- Examine work areas during the shift for hazards that could be created while performing the work.
- When conducting a non-routine task, review safe procedures before starting work and ensure all safety components are in place.
- Do not work under suspended loads.
