METAL/NONMETAL Serious Accident

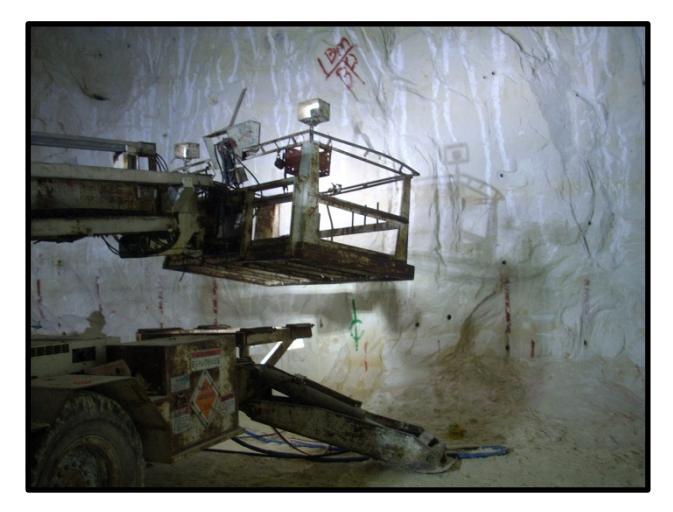
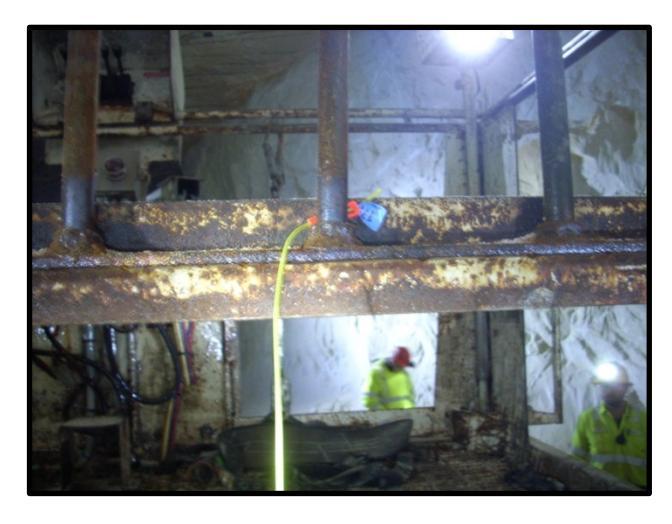
Underground – Sandstone– On March 24, 2018, two miners were using a man-lift to charge (load) blast holes with non-electric blasting caps, 8-grain boosters and ammonium nitrate fuel oil (ANFO) blasting agent. During the loading process, one of the non-electric shock-tubes became wedged on the man-lift basket. As the man-lift operator progressed across the face loading the blast holes, the wedged shock-tube stretched and broke (snapped) causing a pre-detonation of a blast hole. As a result of the pre-detonation, one miner received minor injuries and the other miner serious injuries.

- Explosive materials should be kept organized and under the direct observation of the blaster during loading operations so personnel and equipment does not inadvertently come in contact with them.
- The manufacturer's recommendations regarding maximum loading on the tubing are to be followed (e.g. maximum primer weight lowered into hole by the tubing).
- Shock tubing is not to be subjected to undue tension by pulling, in hole to hole situations.
- Situations in which shock tubing is subjected to impact by falling rock, equipment etc. is to be avoided.
- Excess shock tubing can be coiled, but should not be cut off.
- Shock I tube downlines should be tied to pegs visible to vehicle operators.
- The blast crew should carefully consider the blast design and plan the loading sequence to avoid having to move over or too near to loaded holes.
