UNITED STATES
DEPARTMENT OF LABOR
MINE SAFETY AND HEALTH ADMINISTRATION

COAL MINE SAFETY AND HEALTH

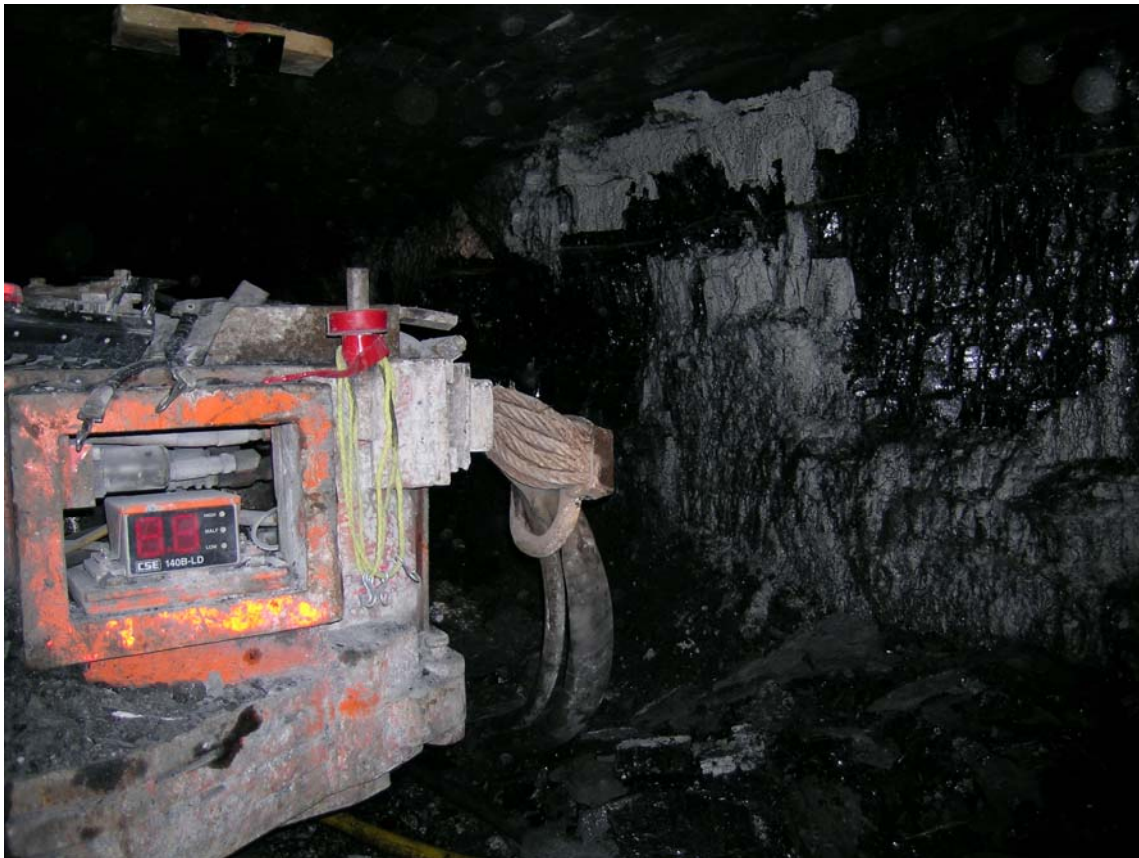
Photograph of the accident scene showing the continuous miner cable standoff and the coal rib in the No. 9 entry of MMU 013-0

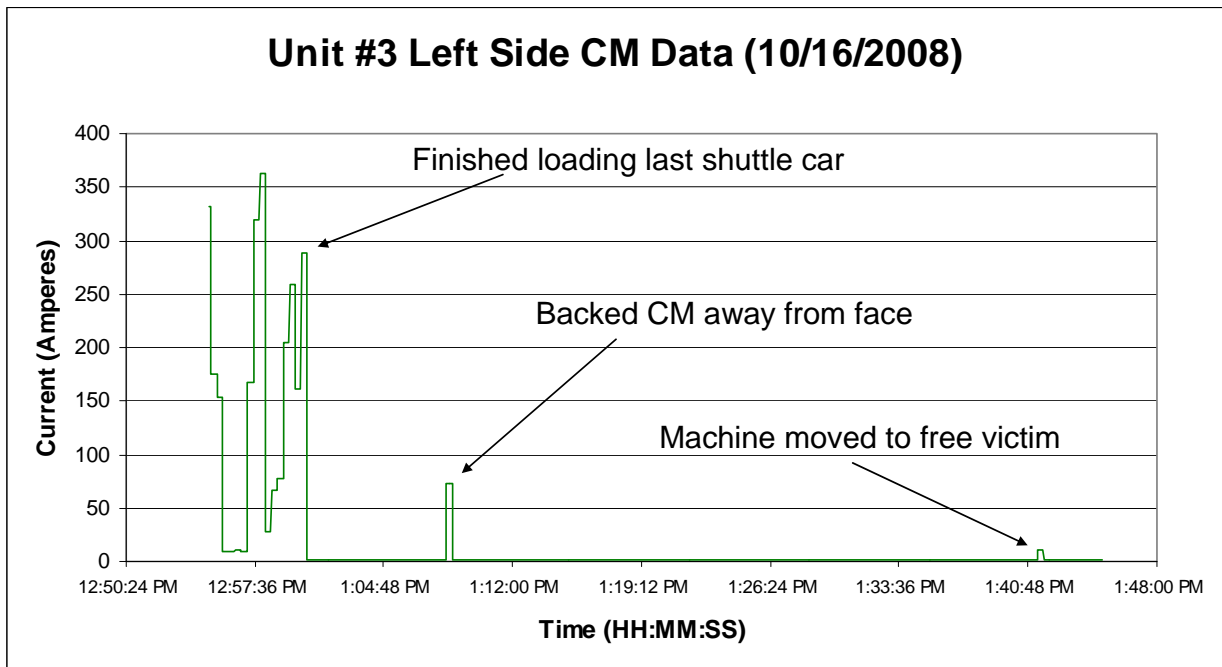
Technical Support Findings
