CAI-2008-29

REPORT OF INVESTIGATION (Surface Coal Mine)

Fatal Accident (Other) December 7, 2008

Thunder Ridge Mine ICG Hazard, LLC. Cinda, Leslie County, Kentucky I.D. No. 15-17746

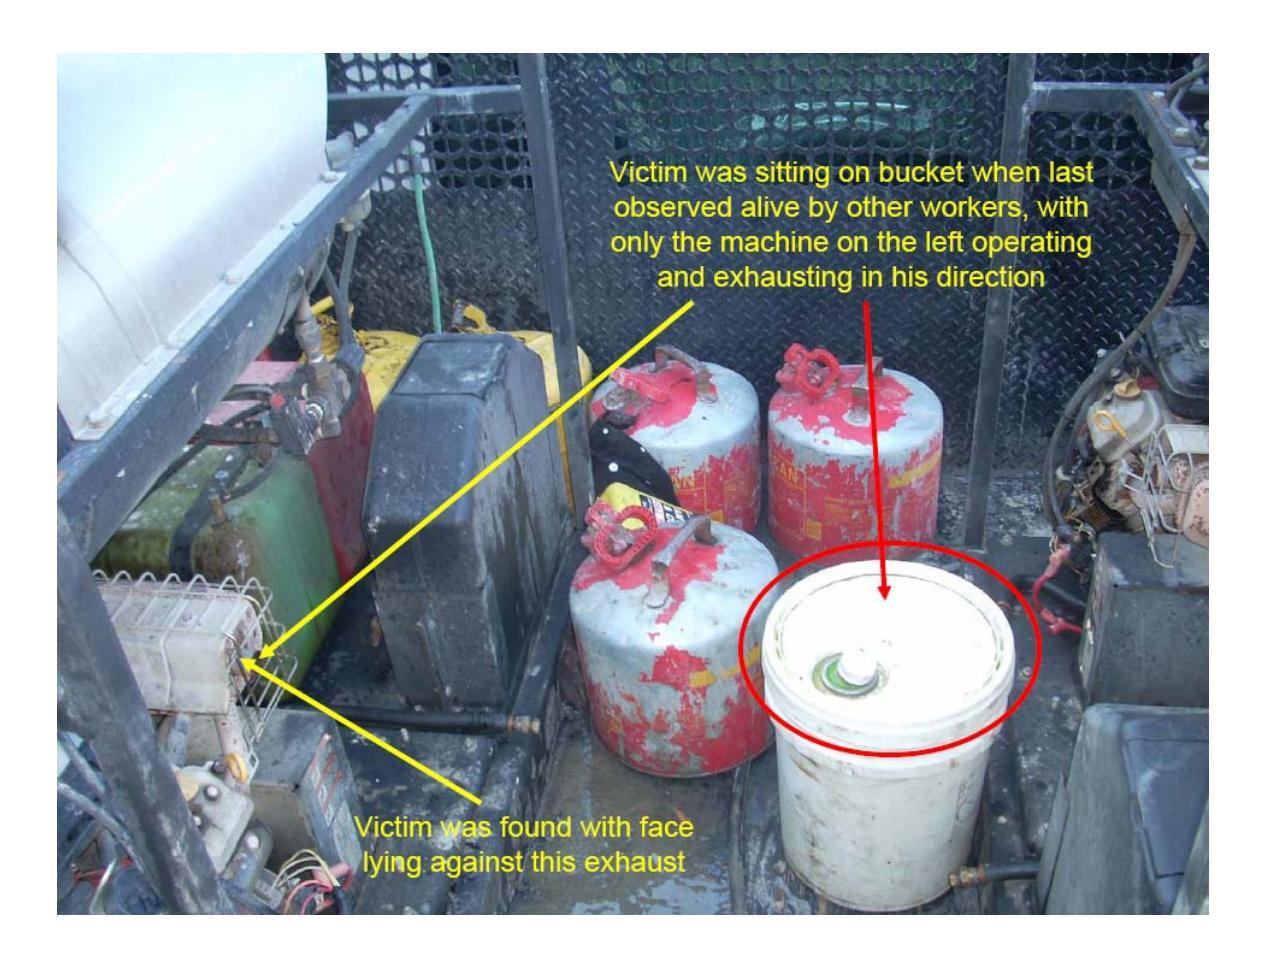
PHOTOGRAPH OF ACCIDENT SCENE

A partial enclosure for the entrapment of exhaust gasses was created by the Chevrolet C6500 truck's flatbed end plate next to the cab, the pressure washers on each side of the flatbed, and the 1,300 gallon tank to the rear of the pressure washers. Exhaust from mufflers of the No. 1 and No. 2 unit pressure washers was directed into an area between the two pressure washers, approximately 25-3/4" wide by 49-1/2" long, by 45" high. At the time of the accident, the flatbed truck was located in an open environment, outside of any buildings or enclosures. The No. 1 unit was the only pressure washer running at the time of the accident.

The victim was positioned directly in the engine exhaust stream and in an area that would have partially obstructed any air movement from quickly dispersing the exhaust gas.

Corrective actions: The mine operator developed and implemented a plan to prevent a similar occurrence of this accident. The miners were trained in accordance with this plan. The No. 1 pressure washer unit was dismantled and removed from the truck. The exhaust systems on the remaining pressure washer units were redirected to expel the exhaust gases to less confined work spaces.
