UNITED STATES
DEPARTMENT OF LABOR
MINE SAFETY AND HEALTH ADMINISTRATION

COAL MINE SAFETY AND HEALTH

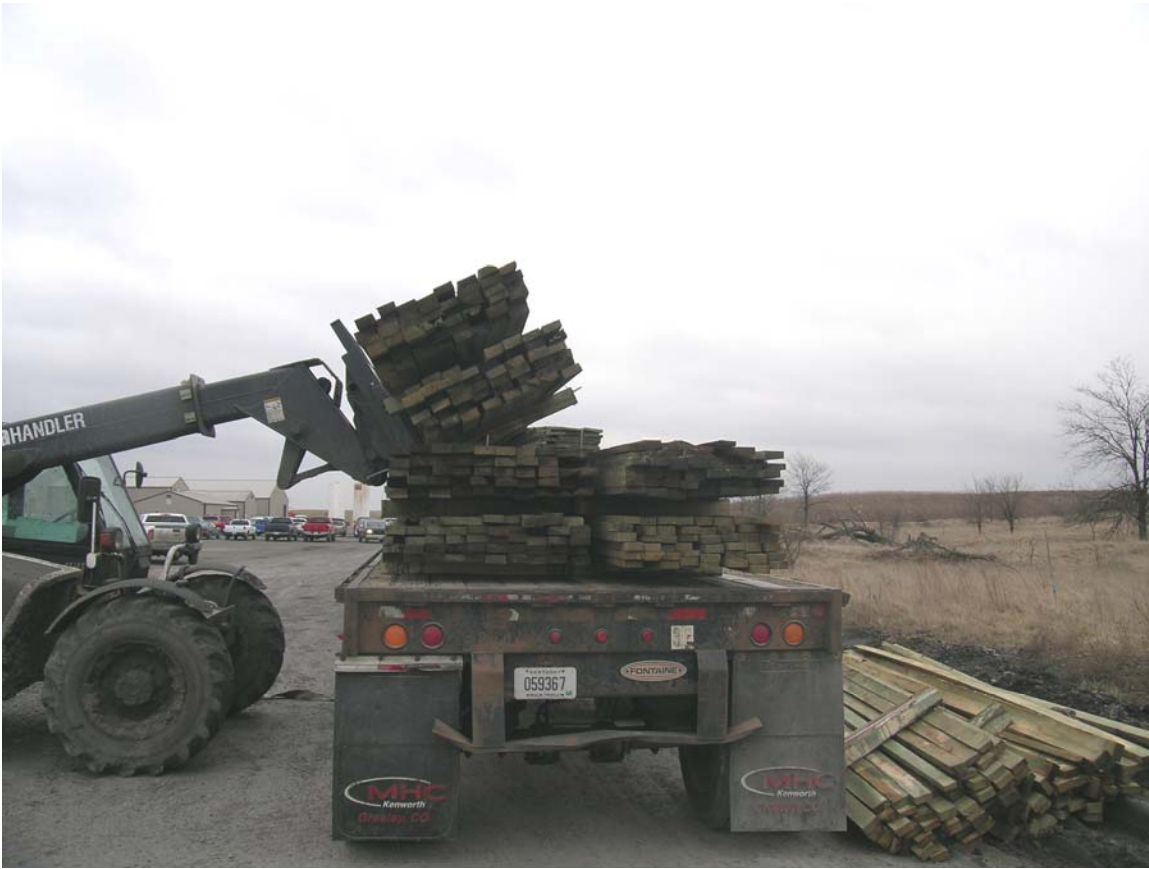
Photograph of accident scene
