CAI-2009-06

REPORT OF INVESTIGATION

Fatal Surface Haulage Accident May 21, 2009

J&A Mining, Inc. Friday Branch #1 Ermine, Letcher County, Kentucky I.D. No. 15-18955

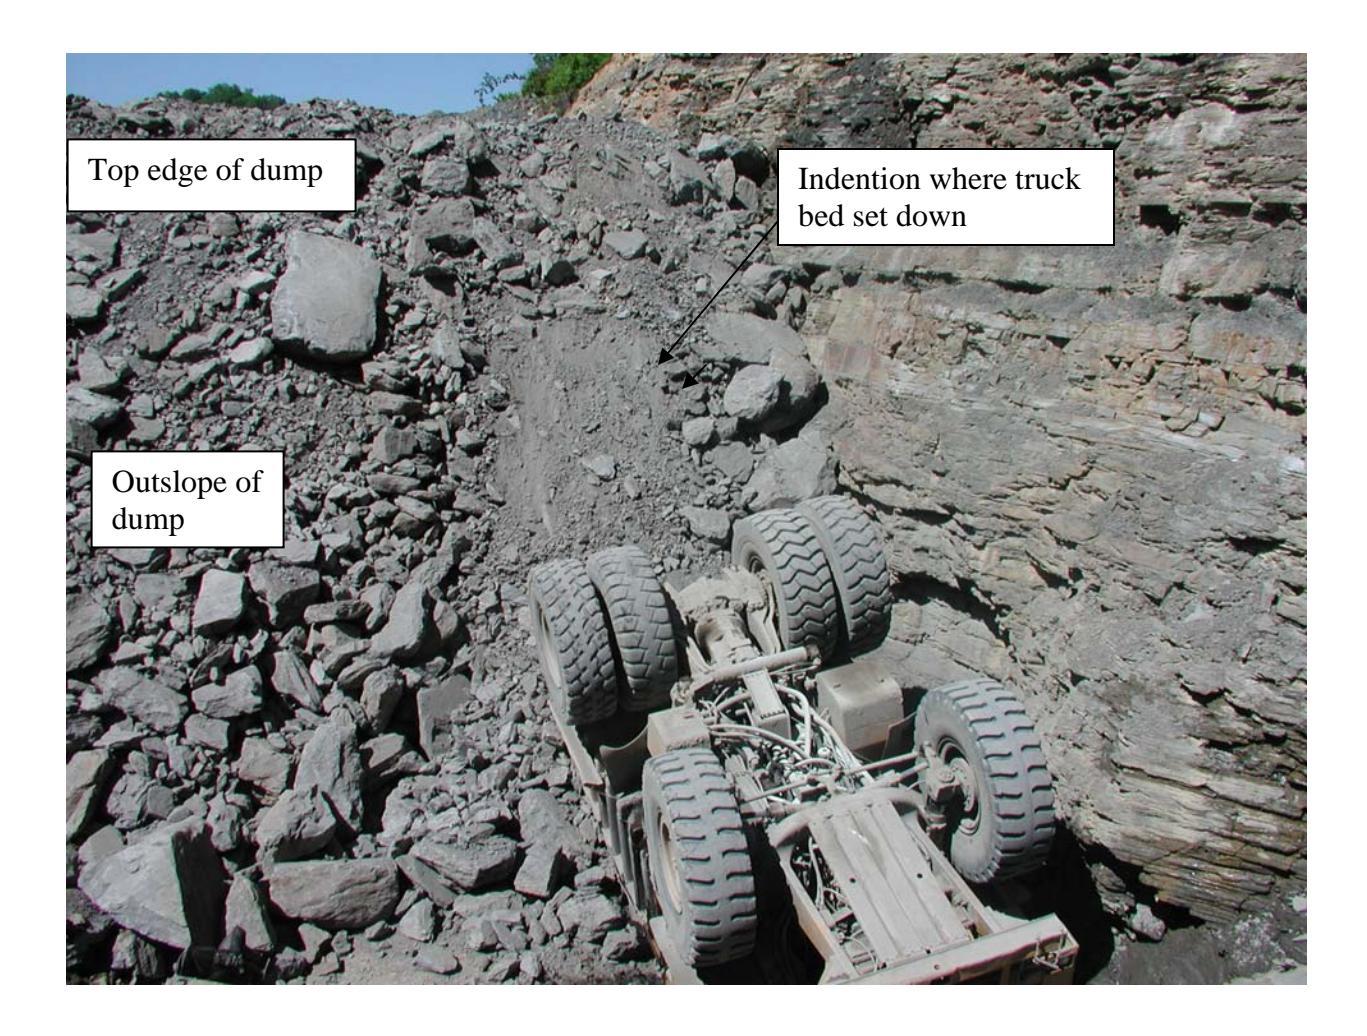
Photo of Accident Scene

At approximately 7:55 a.m., on Thursday, May 21, 2009, Jeremy L. Stewart, a 32-year old superintendent/equipment operator for J&A Mining, Inc, received fatal injuries when the Caterpillar (Cat) 773B rock truck, which he was operating, traveled over the edge of the spoil dump. The truck overturned length-wise onto its top, at the base of the spoil dump, approximately 63 feet below. Stewart had approximately 13 years mining experience in operating equipment, 11 months at this mine. Stewart was in the process of backing the loaded truck to the edge of the spoil dump in order to dump rock hauled from the pit, located approximately 1200 feet away. The accident occurred during Stewart's first load of the shift. There were no eyewitnesses to the accident.

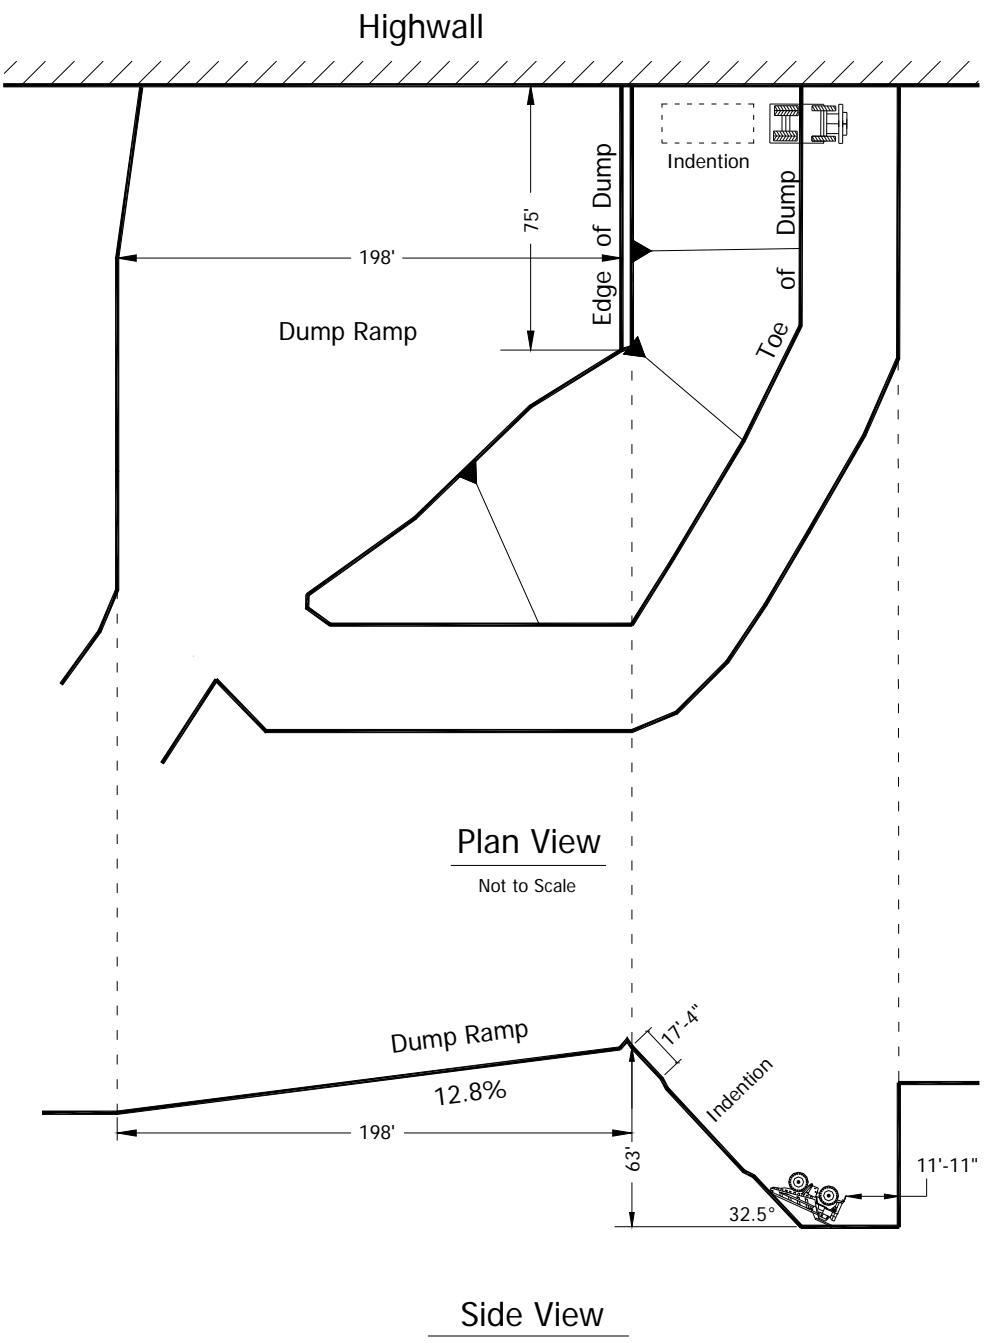
Sketch of Dump Site

A sketch of the dump is provided in Appendix A of this report. At the time of the accident, the vertical height at the end of the dump was 63 feet. The ramp for the trucks to back up before dumping was elevated 7.3 degrees (12.8%) and was 198 feet long. The end of the dump site was 75 feet wide. The angle of the outslope, from the top edge of the dump down to the toe, was 32.5 degrees, which is the angle of repose. An indention was identified on the outslope, beginning at a point 17 feet, 4 inches from the top, indicating the rear end of the truck bed contacted the slope at that point. The indention continued down the outslope to a point near the end of the bed, sliding down the outslope as it rotated 180 degrees over the end of the bed, sliding down the outslope as it rotated over. It then fell onto its top, coming to rest with the front end past the toe of the outslope and the rear end elevated on the lower portion of the outslope. The cab of the truck was partially collapsed. When the truck was turned

Measurements taken indicate the original berm was 12 ½ inches high on the left side and nine inches high on the right side, when facing the end of the dump at the location where the truck went over the edge. However, the measurements are not conclusive due to the added material overlapping the base of the original berm on the downhill side.

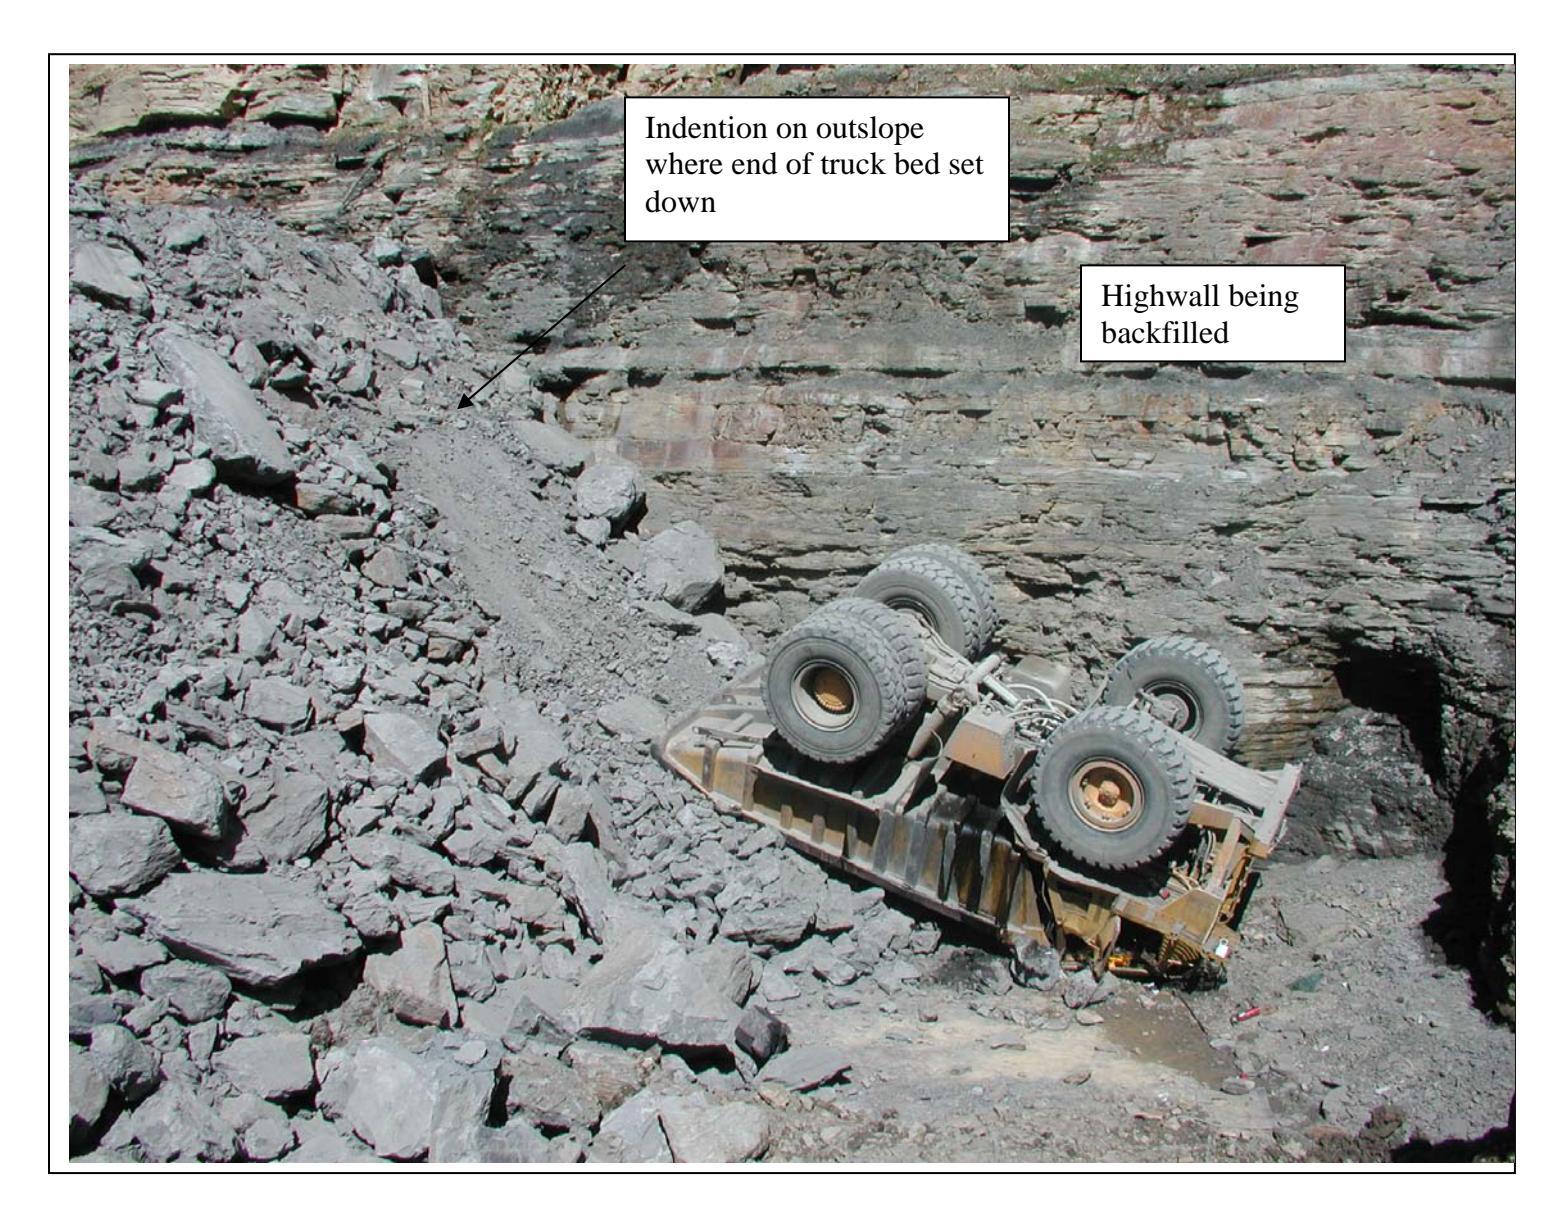
upright during the investigation, a pile of rock material was under the truck bed, indicating the truck was loaded when it went over the edge.

Photo 1. The Caterpillar 773B truck in the post-accident position at the toe of the outslope of the dump

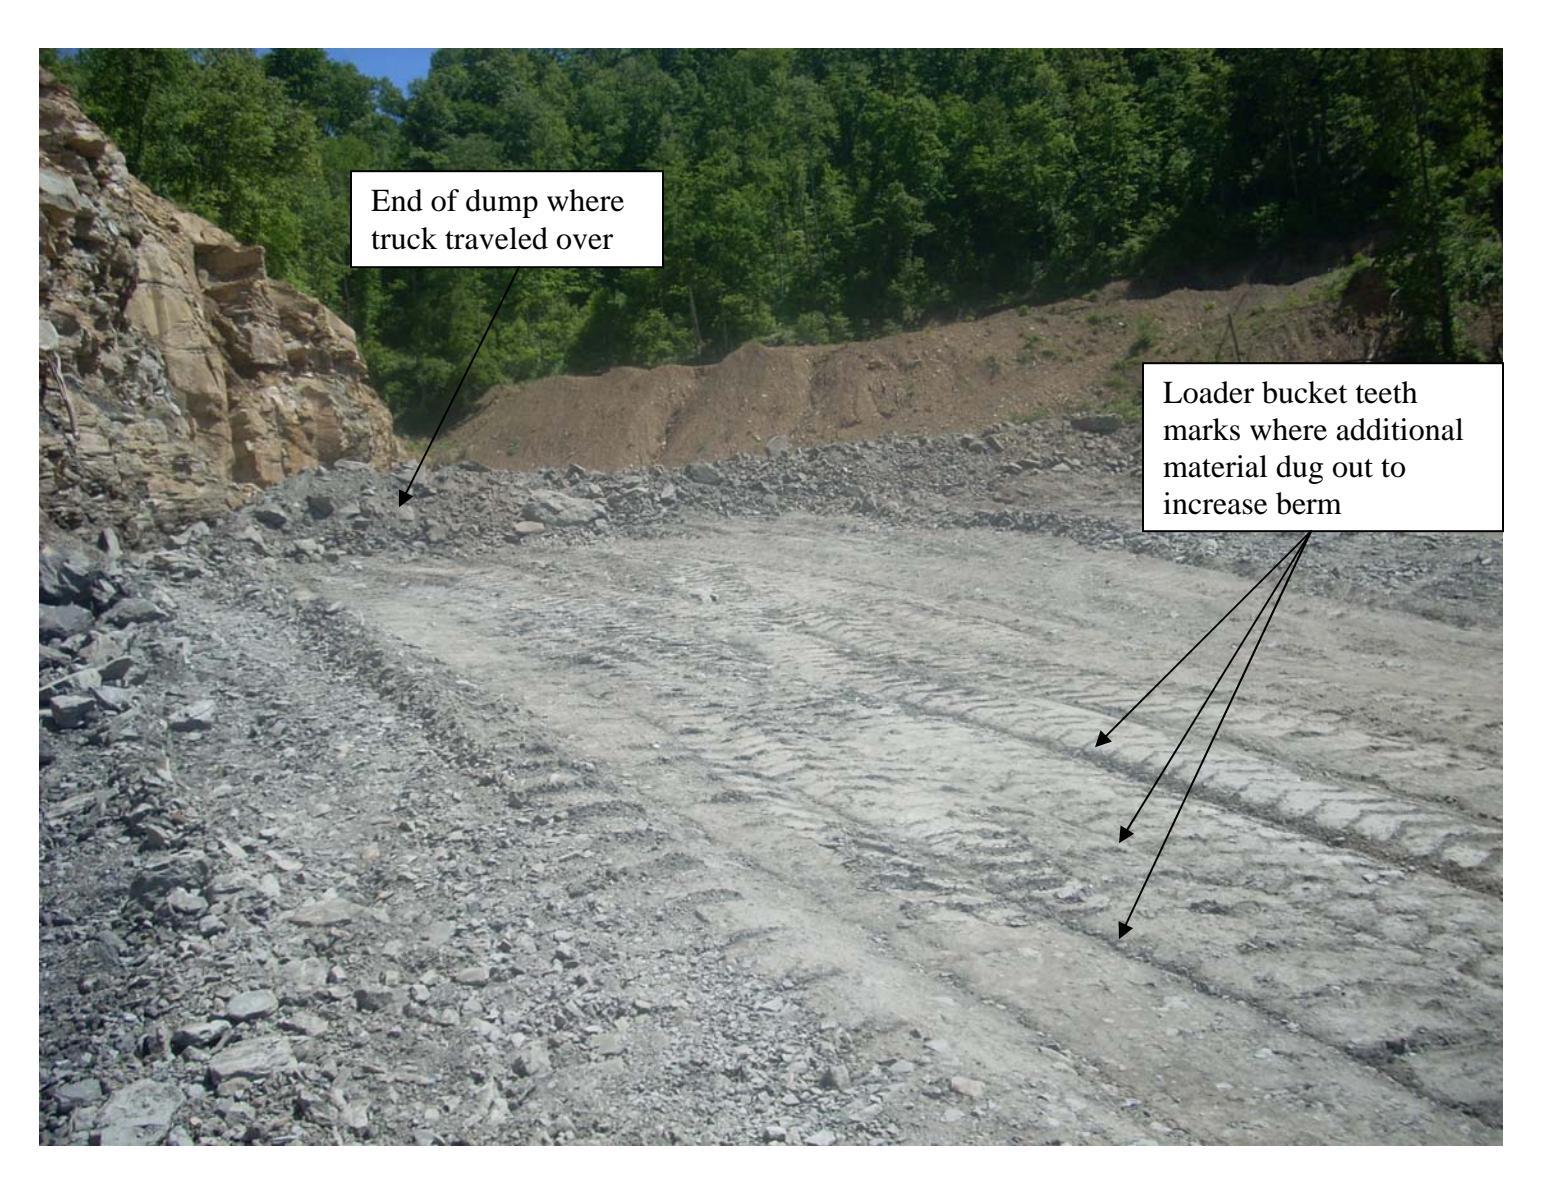
The 12.8% uphill grade of the dump ramp may have been a factor in the accident when combined with limited visibility. In order to maintain a constant speed while backing the loaded trucks up the dump ramp, the drivers were required to utilize a high rate of fuel throttle. It is possible that the victim was backing the truck under high throttle, and misjudged the location of the edge, due to limited visibility when he drove through the berm.

Photo 2. Top of dump site

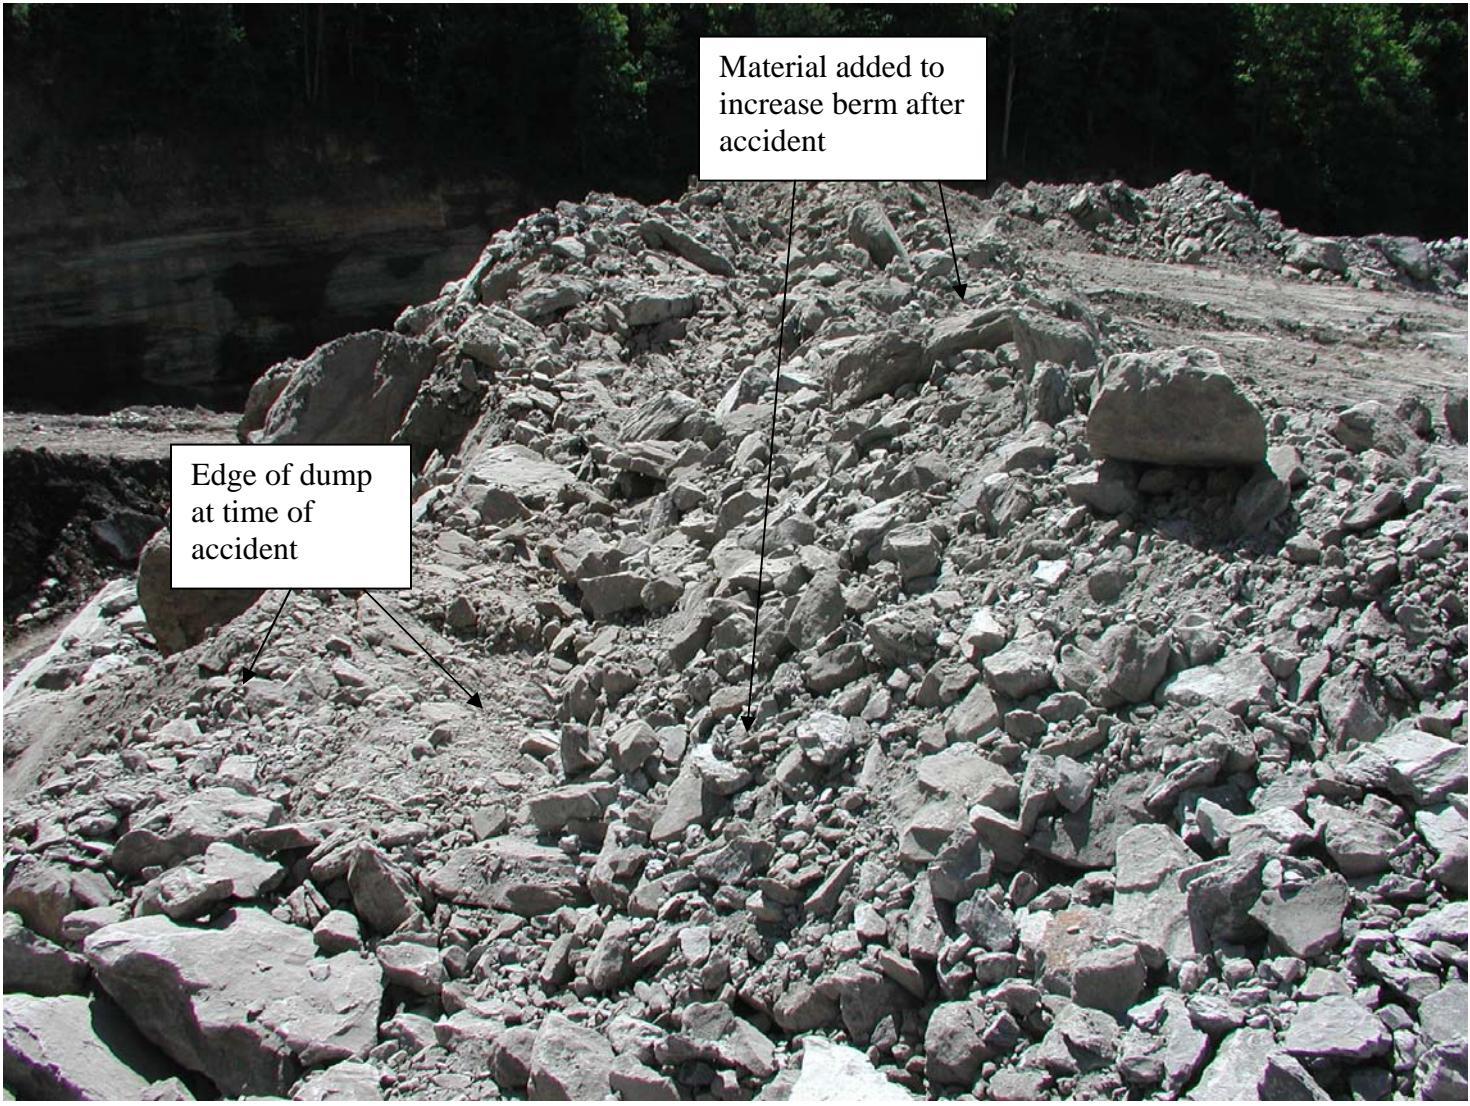
The exact size of the berm at the edge of the dump prior to the accident could not be conclusively determined due to the berm being altered before MSHA investigators arrived. The berm was built up by Joe Frazier, Loader Operator. Frazier stated during the investigation that after the accident occurred, a voice on the CB radio told him to "beef up" the berms at the dump. Frazier did not know whose voice he heard on the radio. He operated the 992C loader to dig out the road surface near the end of the ramp and used the material to build up the front of the berm along the edges of the ramp and the end of the dump site, including the location where the truck went over the edge. There was no opening left in the altered berm where the truck went over. Mine management and other employees stated they did not direct Frazier or hear any one else direct him to build up the berm. A non-contributing citation was issued because the accident site was altered.

Photo 3. Edge of dump after accident

<u>*Corrective Actions*</u>: The operator retrained all the equipment operators and supervisors in the requirement to maintain an adequate berm in dumping areas and directed the equipment operators to report inadequate berms to supervisors.

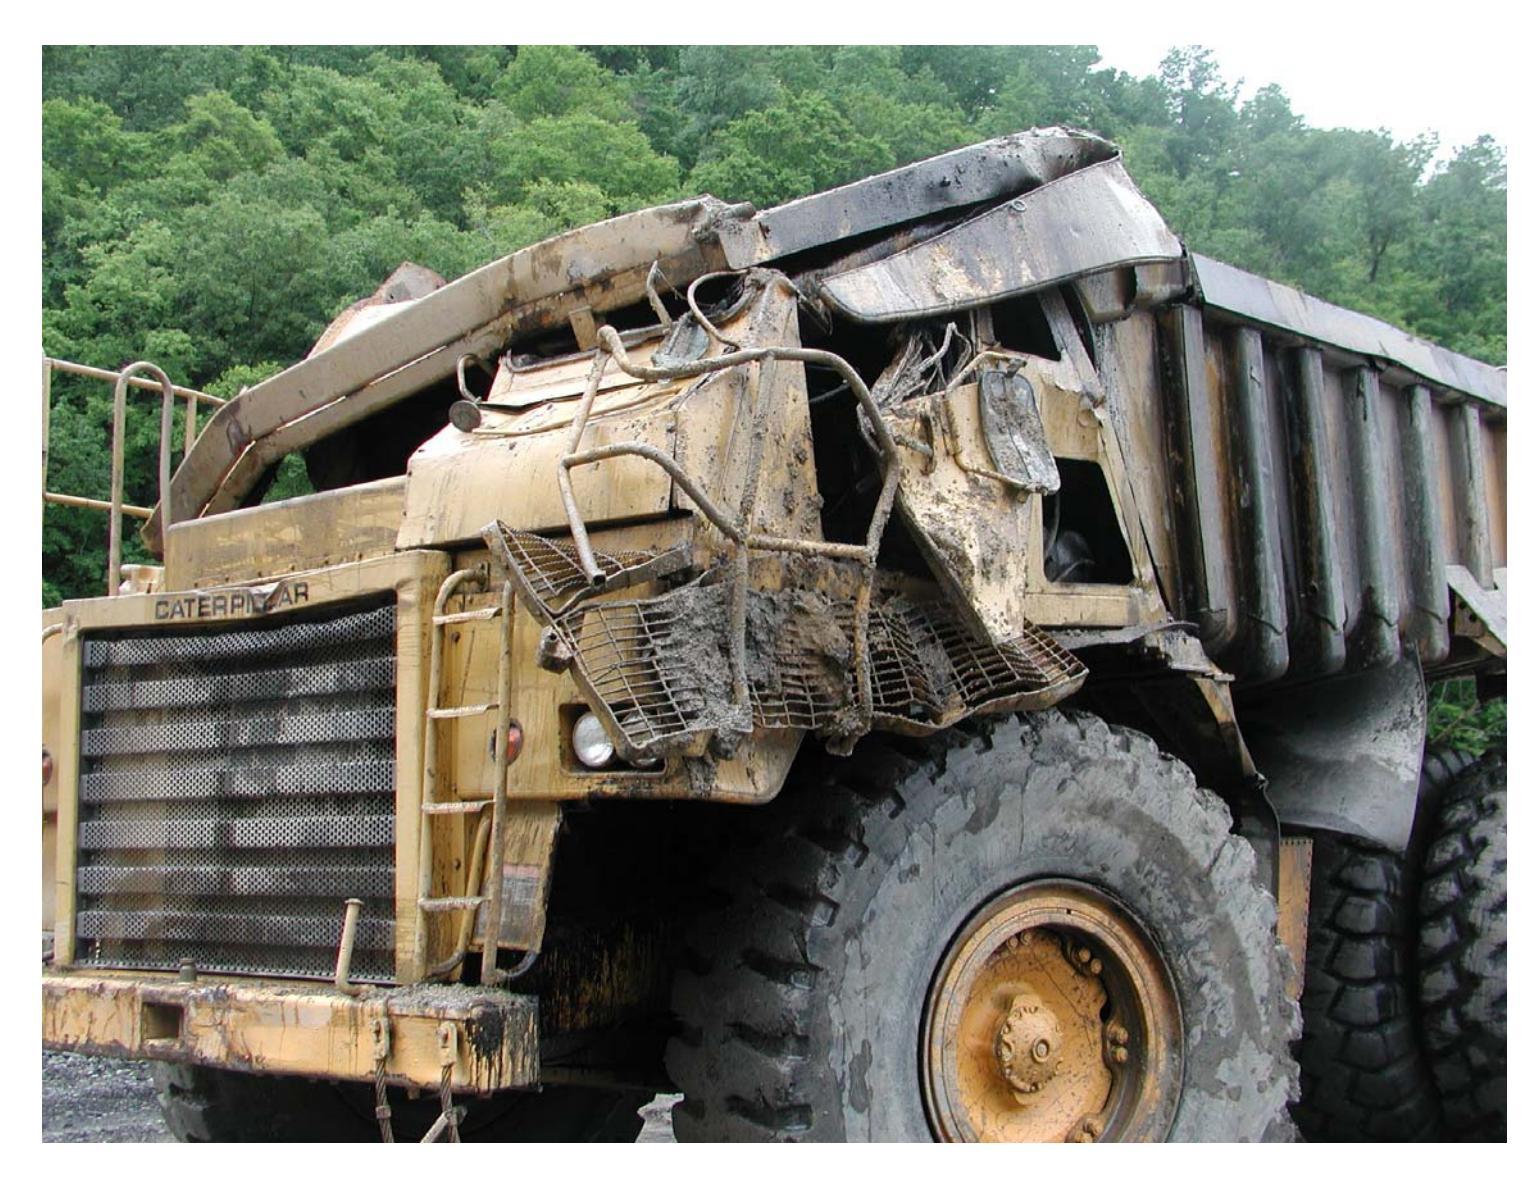
The truck was equipped with a seat belt and not equipped with a ROPS cab. 30 CFR, §77.403-1(a) does not include haul trucks in the list of equipment which is required to be provided with ROPS. A seat belt was provided, but was not worn by the victim. 30 CFR, §77.1710(i) only requires that seat belts be worn in a vehicle where there is a danger of overturning <u>and roll protection is provided</u>. It is not known that a ROPS cab and the use of the seat belt would have prevented fatal injuries in this accident, but it is probable.

The truck was equipped with service, parking, and secondary brake systems. A switch on the dashboard enabled the operator to switch the front brakes out of service. The front brake switch was "OFF" when observed after the accident and was likely to have been "OFF" during the accident. Audy Stewart stated that he task trained his men not to use the front brakes, since he considered the front brakes to have an adverse effect on steering and handling of the vehicle. The front brakes were not operational initially during testing. Hydraulic oil was added to the reservoir supplying the front brake master cylinder and the front brakes were bled. After several applications of the front brakes, they began operating with 300 psi of hydraulic pressure. The manufacturer's recommended hydraulic pressure is 600 psi.

Tests revealed that the rear service brakes, parking brake, secondary brake, and retarder were operational. The air and hydraulic operating pressures and brake wear of these systems were within the manufacturer's specifications. The condition of the front brakes is not considered to contribute to the accident because the front brakes were switched "OFF."

Photo 4. Caterpillar 773B rock truck after being up righted and moved to evaluation area
