REPORT OF INVESTIGATION

Fatal Powered Haulage Accident September 3, 2010

National Coal of Alabama, Inc. Kansas Mine Carbon Hill, Walker County, Alabama I.D. No. 01-03398

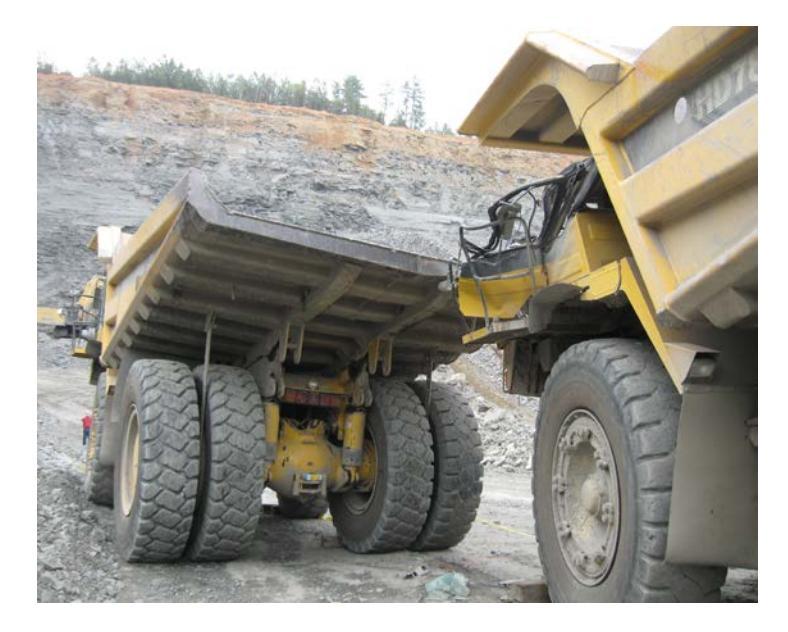
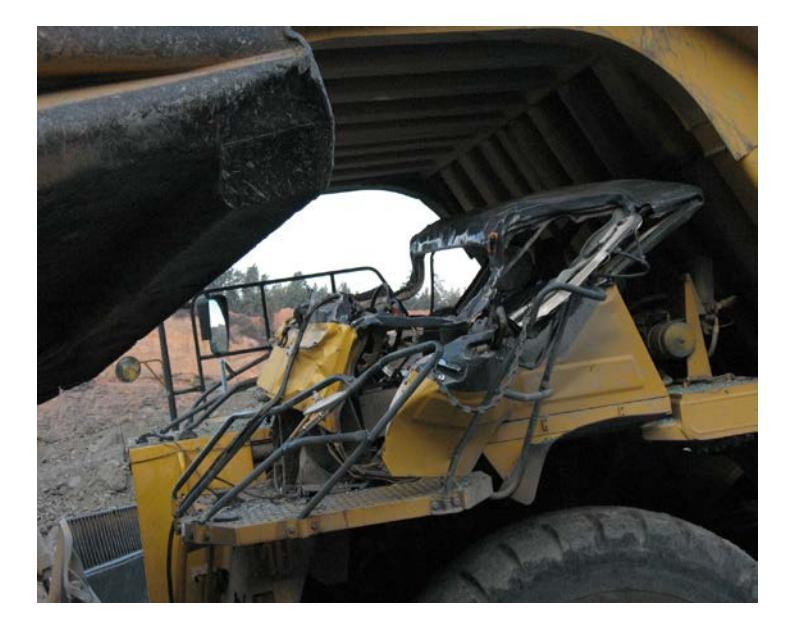
The trucks are 34.8 feet long by 18.6 feet wide by 17.25 feet high. The top of the operator's compartment is 14.4 feet high and the center rear of the dump bed is approximately 12 feet high. The rear portion of the dump bed (of the lead truck) that would have impacted the operator's compartment of the victim's truck extends down vertically approximately one foot. The bottom of the bed then slopes down toward the rear tires. The horizontal distance from the rear edge of the bed to the rear tires is approximately 6.5 feet. This is the distance the victim's truck would have traveled under the lead truck's bed. The horizontal distance from the victim's truck front bumper to the operator's compartment is approximately 2 feet. After the accident, the lead truck's dump bed would have extended approximately 4.5 feet into the upper portion of the victim's compartment (Overview and Appendix D).

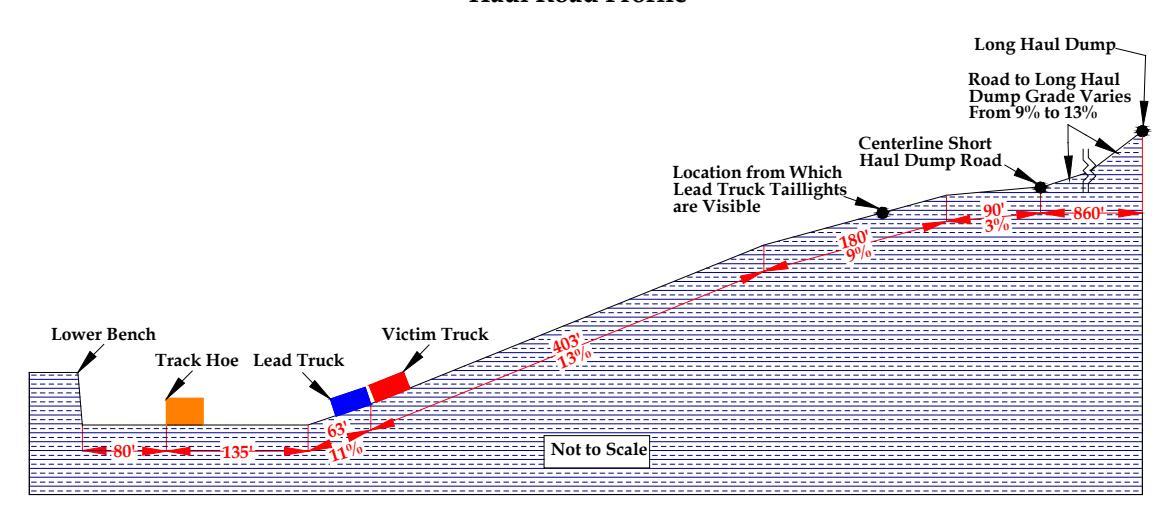
APPENDIX B Haul Road Profile

The active mining work area consisted of the pit area, where the excavator removes the overburden. The connecting haul roads, where the trucks would stage for the next load, had grades up to 13 per cent that connected to a short haul, lower overburden dump area and a long haul, upper overburden dump area (Appendix B).

The work area at the time of the accident consisted of the pit, the haul road, and the long dump area, located 0.3 mile from the pit (Appendix B). The average cycling time was approximately 5 minutes for the drivers to receive the load in the pit, drive up the 9 per cent to 13 per cent grade haul road to the long haul overburden dump, dump their load, and return to the pit. Drivers had a pre-determined location for staging when stopped and waiting for the truck ahead of them to clear, then back their truck into the pit for their next load. On the day of the accident, the travel time was a longer interval because of dumping at the upper area of the dump site and two of the three trucks were in transit to or from the long dump as the third truck was being loaded. Trucks would stage in place on the haul road while the dig face of the lower bench was being cleaned and pushed by the dozer (Appendix C).

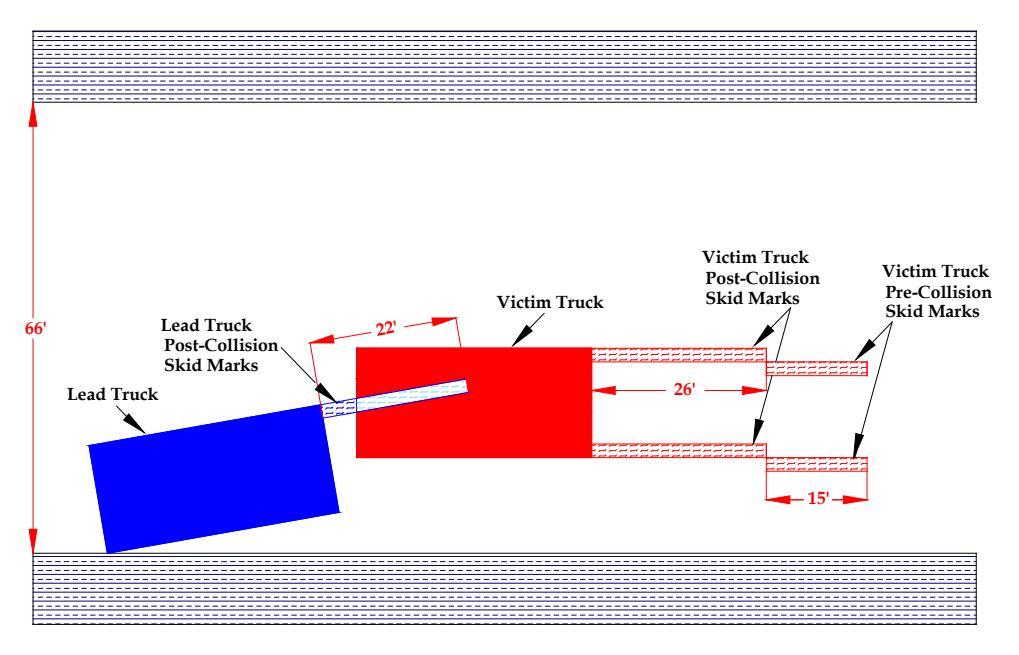
Accident Scene

<u>Victim's truck No. 10373</u>: The brake systems were inspected and tested. No damage to the service brake system from the accident was found. Inspection of the front brake fluid reservoir found that the reservoir was empty. The lack of any evidence that the accident damaged the front brake system indicates that the front brakes were not functioning prior to the accident. If the front service brakes had been "on" and functioning, they would have provided additional stopping ability. However, from the approximate 15 feet-long skid marks prior to the collision, observed at the accident scene (Appendix B and D), it is considered that the front brakes would not have

provided sufficient additional stopping force in this distance to have prevented or reduced the severity of the collision.

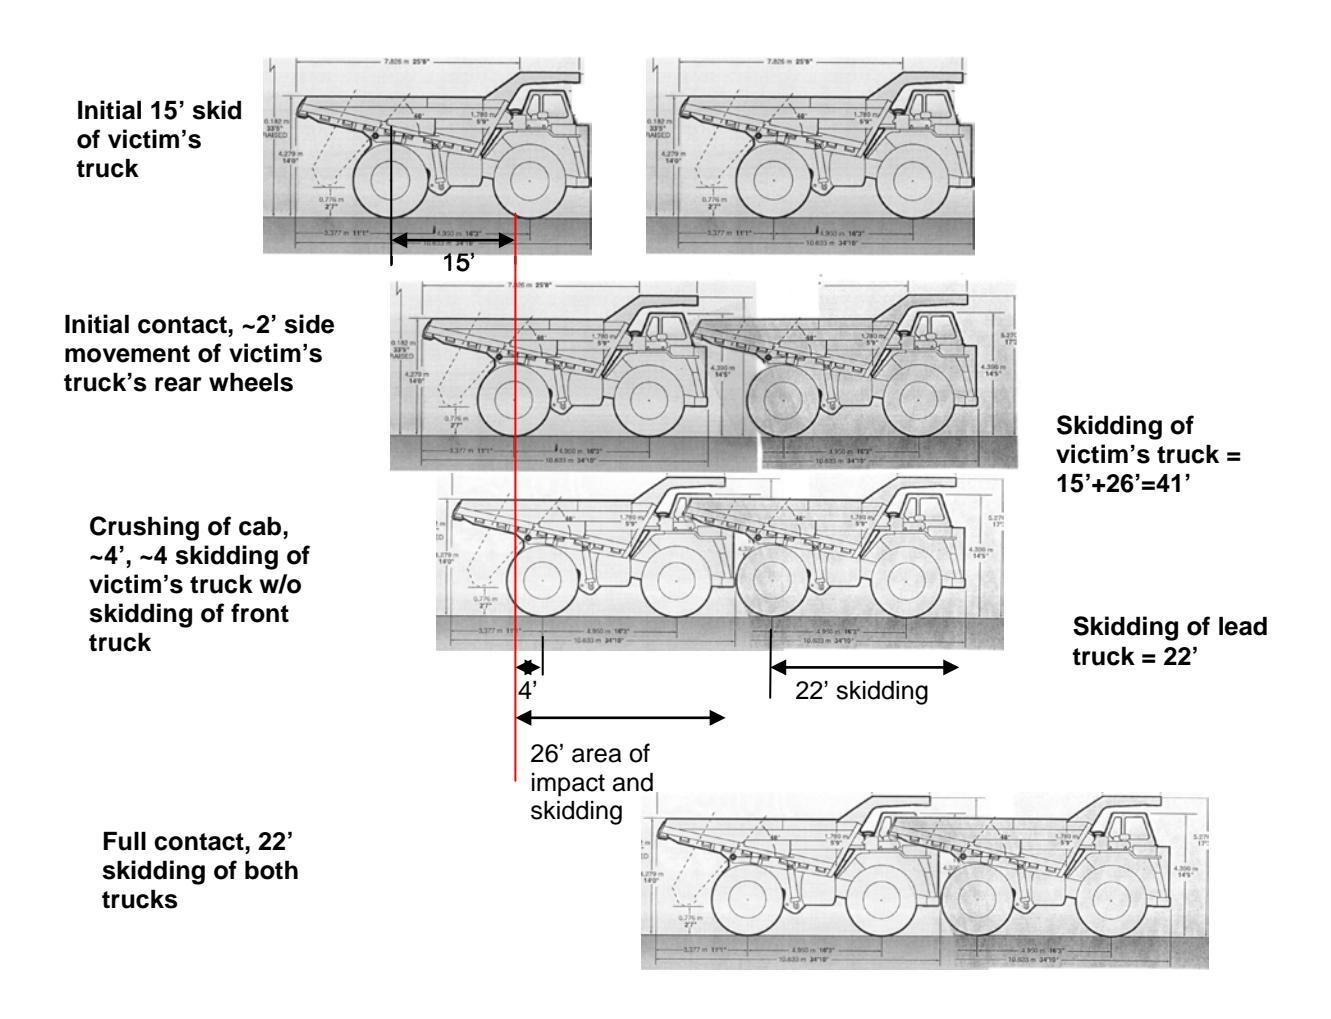
APPENDIX D Collision Analysis

Although maintenance related problems with the braking system were found and the front brakes may have been switched off at the time of the accident, there is no indication that these factors contributed to the accident. The skid marks produced by the victim's truck prior to impact indicated that the coefficient of friction between the tires and the ground was the limiting factor in the deceleration of the truck and not the deficiencies noted with the truck's brake systems (Appendix D).
