REPORT OF INVESTIGATION

Fall of Face, Rib, Pillar or Highwall September 13, 2012

Blacksville No. 2 Mine Consol Energy Wana, Monongalia County, West Virginia MSHA I.D. No. 46-01968

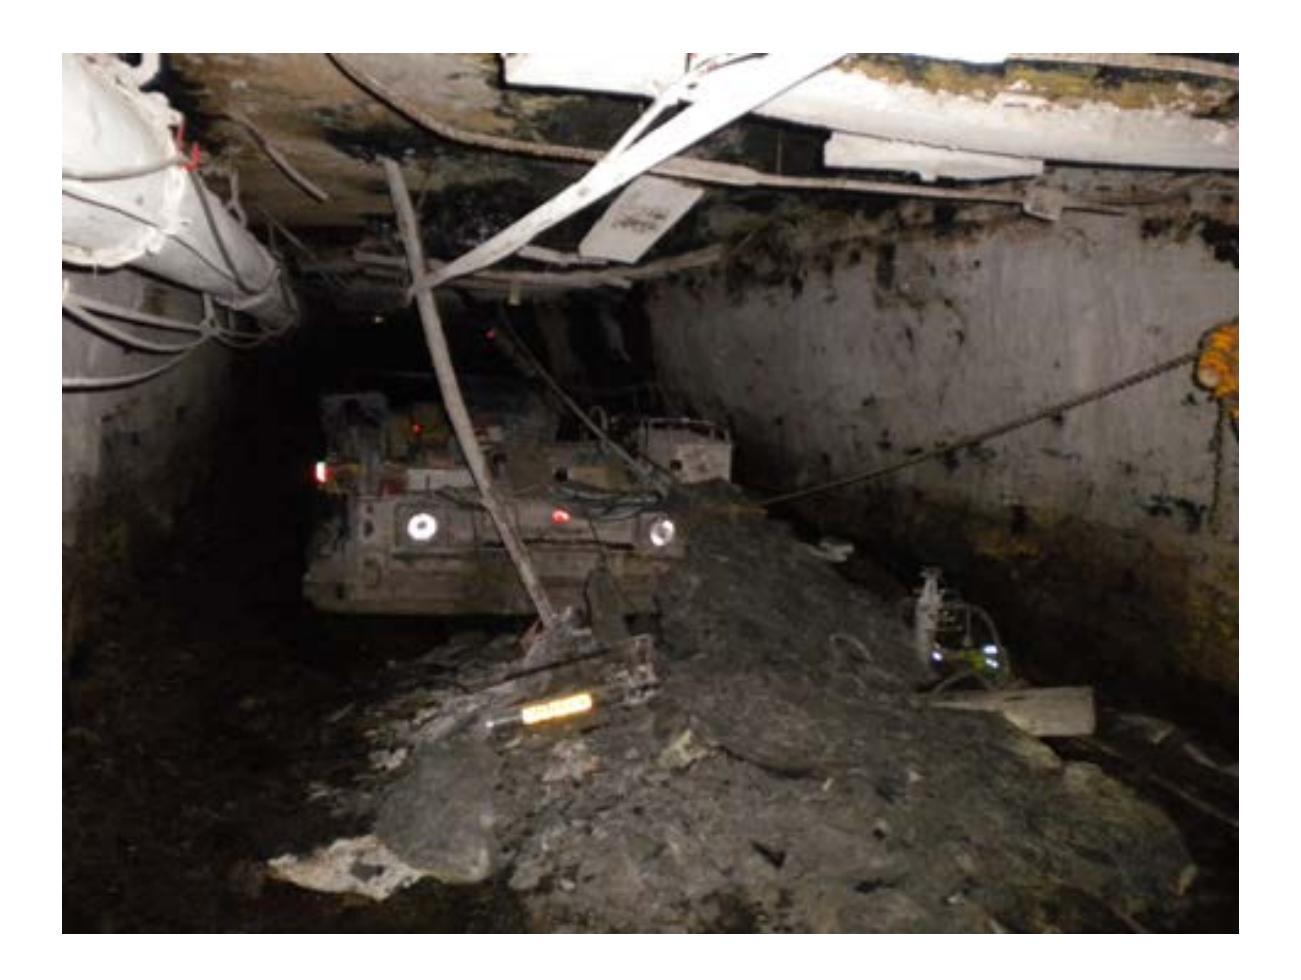
PHOTO OF ACCIDENT SCENE

On Thursday, September 13, 2012, at approximately 3:30 P.M., victim, William E. Mock, a 61-year old, General Inside Laborer, sustained fatal injuries. A piece of mine roof measuring 11 feet long, 5 feet wide and ranging in thickness from 4 inches to 11 inches, fell and stuck the victim. Mock and Doug Ice Jr., General Inside Laborer, were attempting to increase the vertical clearance between the track and the trolley wire near the No. 117 block on the Main North Track Haulage. Mock and Ice were removing a roof bolt and wooden plank, which were initially installed as permanent roof supports when the area was mined.

The rock field at the accident site was in two large sections, measuring approximately 137 inches long, up to 44 inches wide and ranged from 4 to 11 inches thick. The approximate weight of the fallen rock was 3,000 pounds.

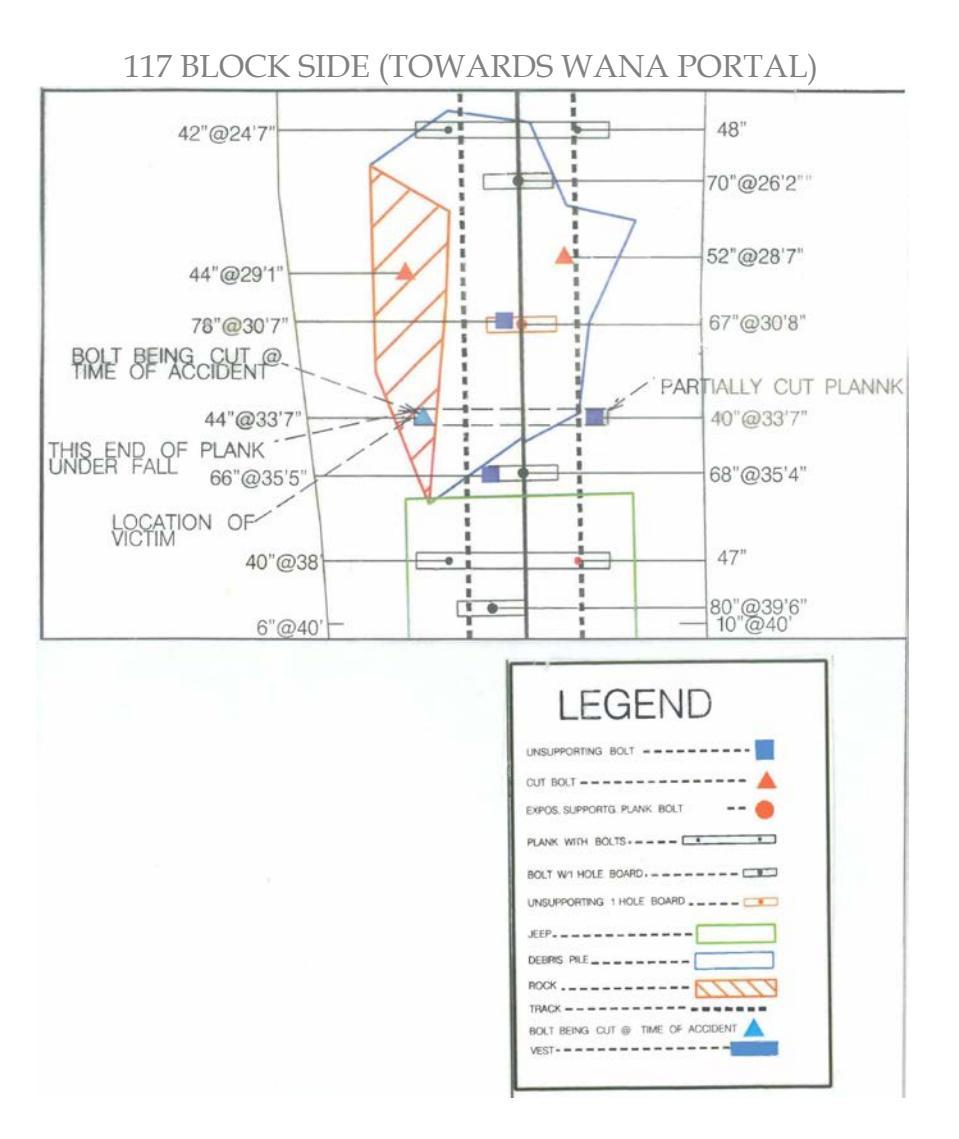
APPENDIX I SCHEMATIC OF THE ACCIDENT SCENE

The accident occurred on the 117 side of No. 116 block of the Main North Haulage in the track entry, which was developed in March of 1977. This location is approximately two miles from the Kuhntown Portal which is near the midpoint between the portals. The area was mined utilizing a Martin Marietta, twinborer continuous mining machine. The width of the entry, when developed, was less than 14 feet. Continuous mining machines with a bore-type cutting head leave an arched area in the rib and the roof. In this instance, the result was the arch exhibiting lesser signs of taking weight and minimal sloughing. Primary roof support installed during development was a three-part system, consisting of two 9-foot long, 5/8 inch diameter, mechanically-anchored roof bolts. The bolts were installed through wooden planks, 6 feet long and 2 inches thick. The bolts were spaced a maximum of 48 inches apart, with the maximum distance of 5 feet between each plank.
